20 Pump Fire Preliminary Report

New Providence Wharf
1 Fairmont Avenue
London E14 9PL
Borough of Tower Hamlets

Date of Incident: 7th May 2021
Date of report: 25th May 2021

Fire Investigation Team Report

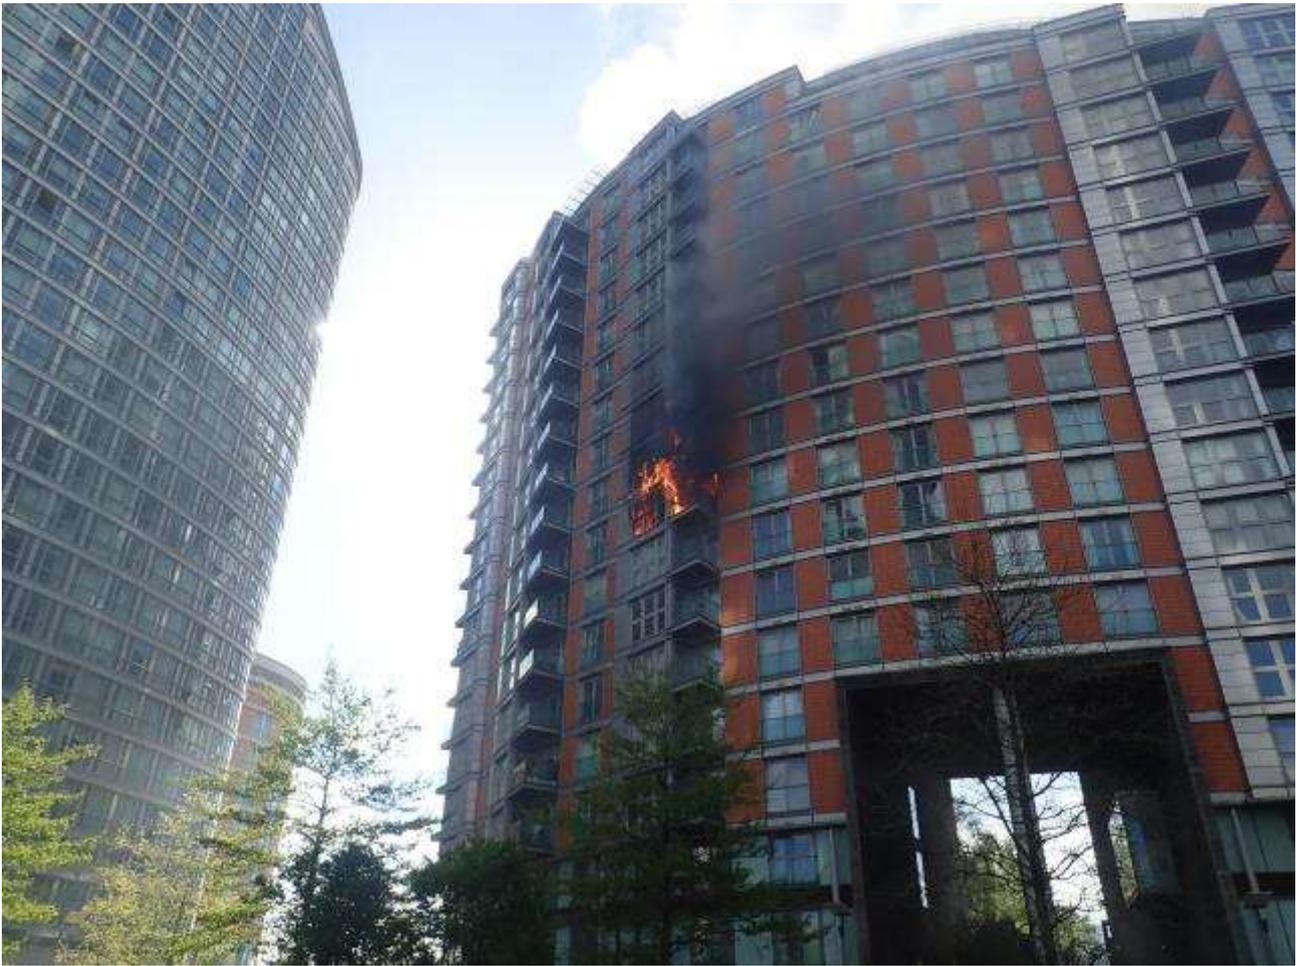
Image showing the fire in progress on the North face of NPW

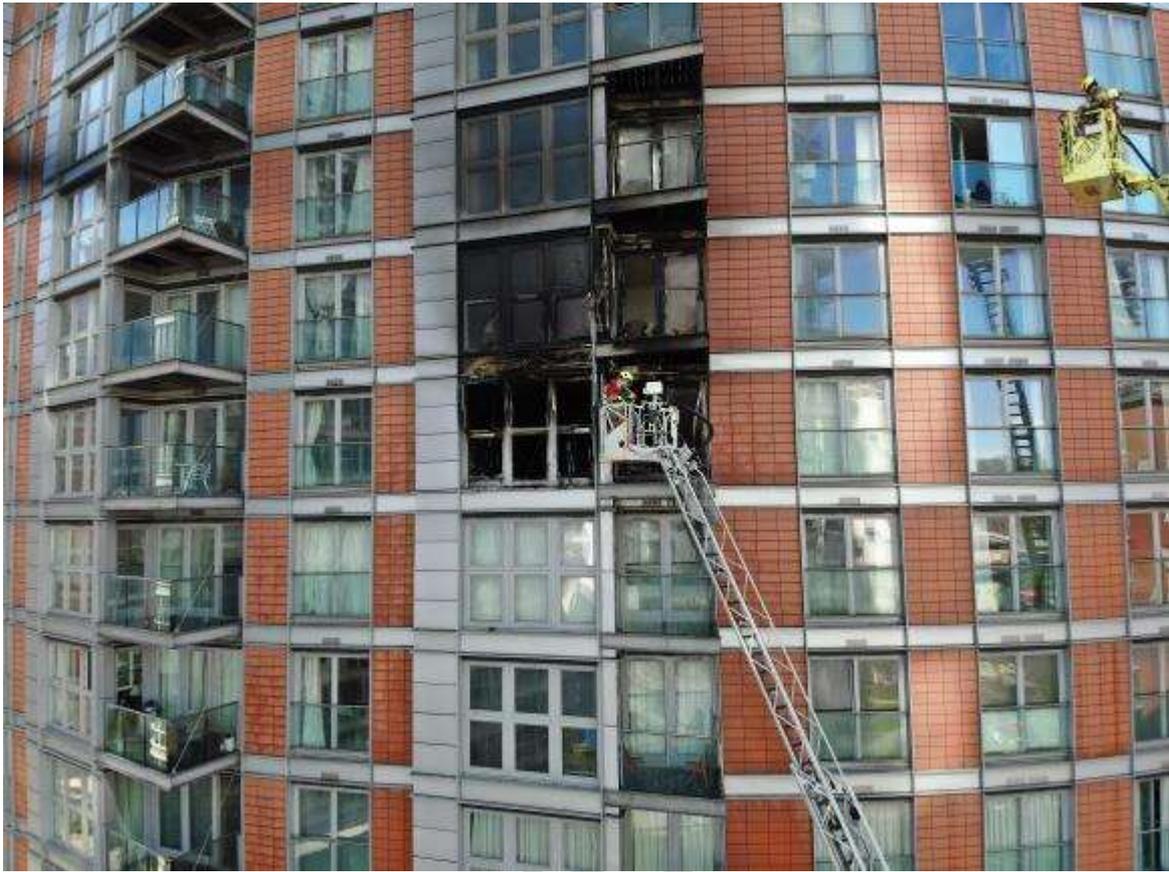
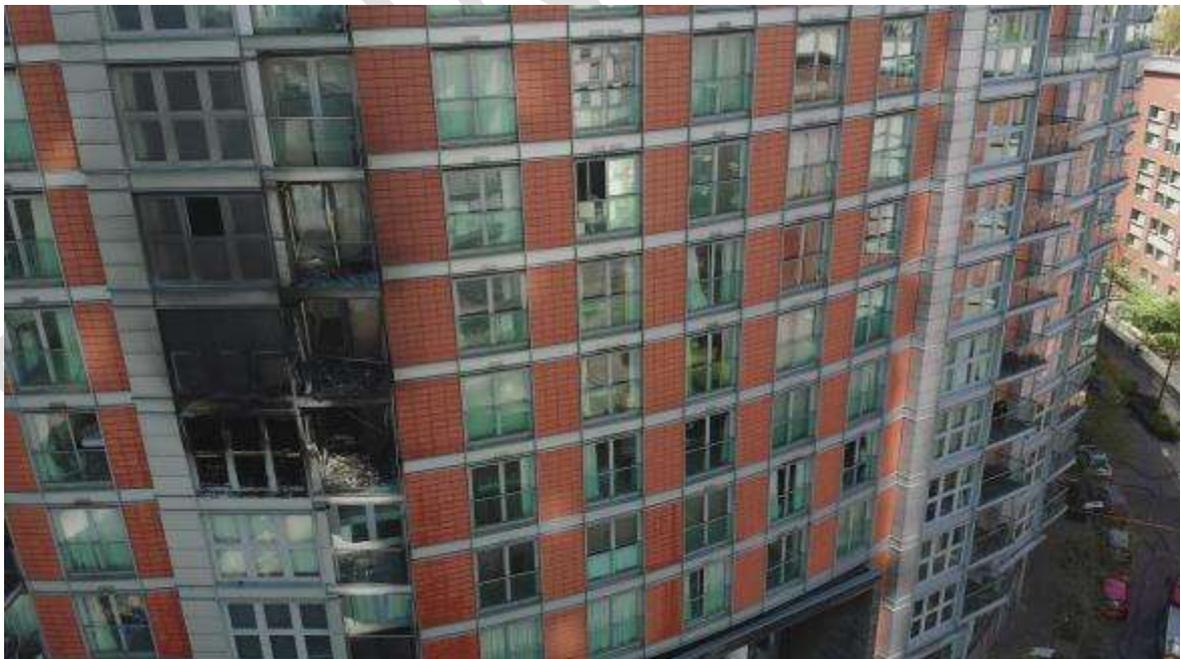
The flat of origin was approximately 80% damaged by fire. Fire spread externally up the building affecting balconies directly above on the 9th, 10th and 11th floors. The windows of the flat directly above on the 9th floor were also fire damaged. External ACM cladding on the 8th and 9th floors was also involved, but in this particular case, the cladding did not significantly add to the fire's development. All internal communal areas on the 8th floor were damaged by smoke, with fire and heat damage affecting the communal corridor around the entrance to the flat of origin. This was exacerbated due to the failure of the AOV

Images showing the damage to the exterior North face of NPW

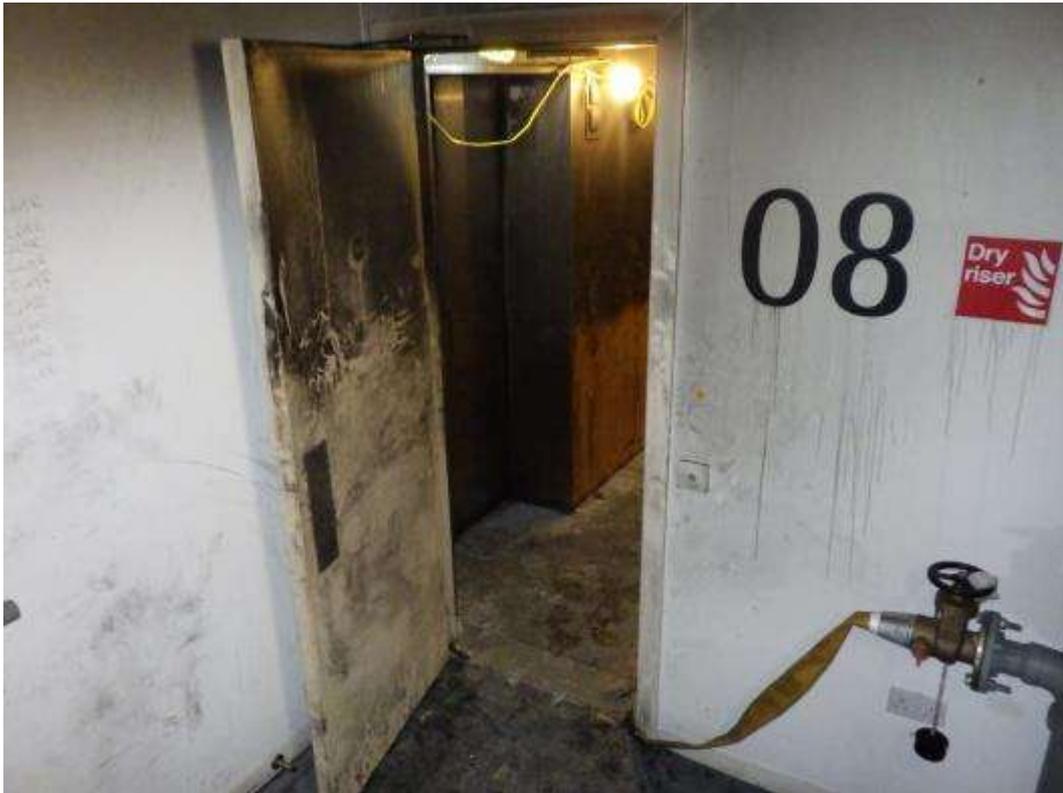
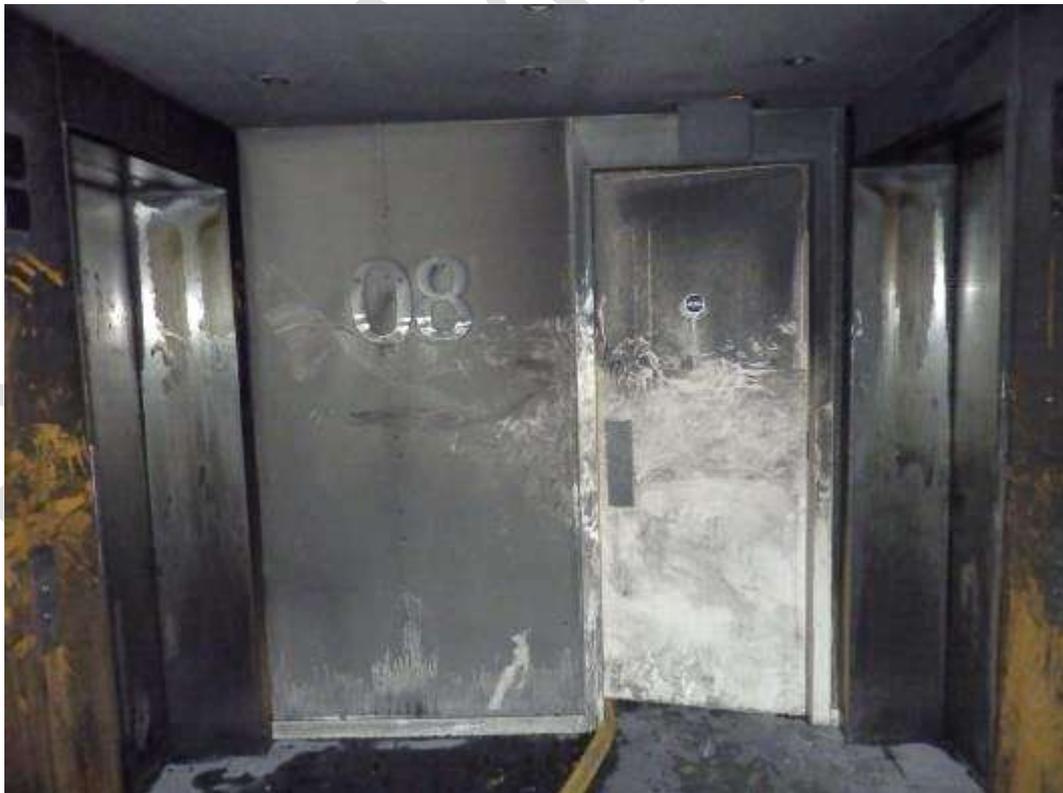
- 6.1.2 The 8th floor was accessed via the fire door between the stairs and the lift lobby. This door was heavily smoke stained across its top third on the side of the lift lobby, but the side facing the stairs remained relatively clean. The edge of the door was also relatively clean, indicating that it had held back smoke on the eighth floor and had only been compromised as people escaped the floor and once firefighters gained access.

Images showing the external and internal view of the door at the head of the 8th floor stairwell

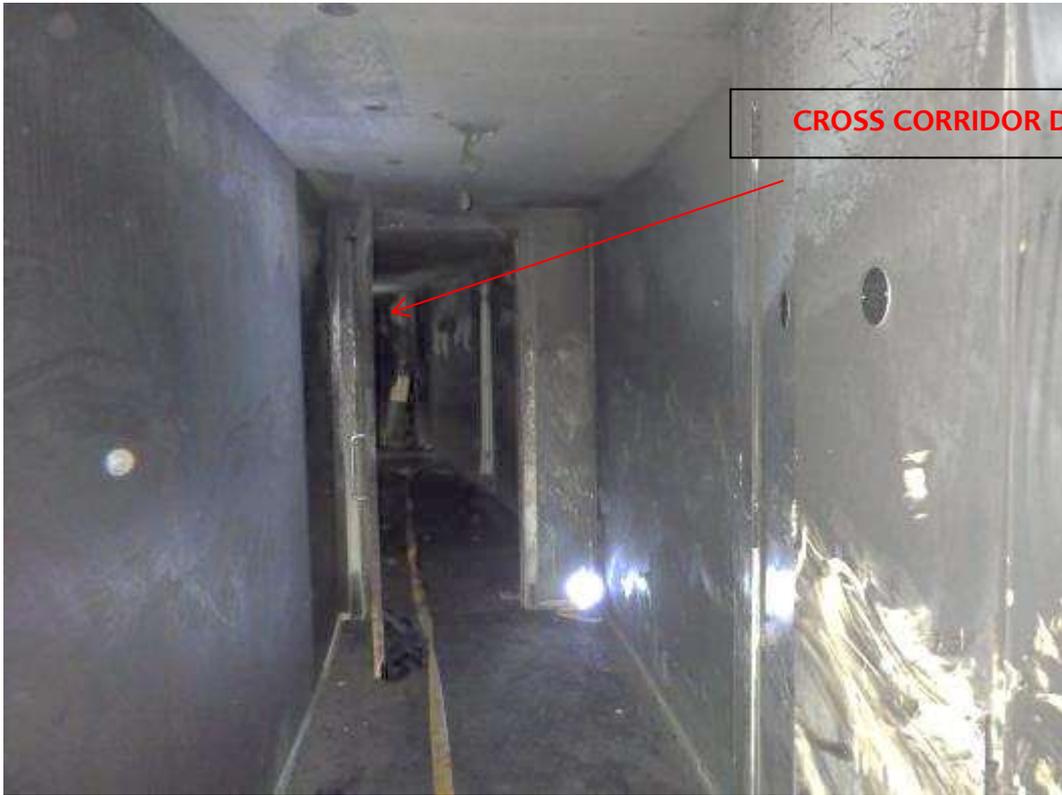
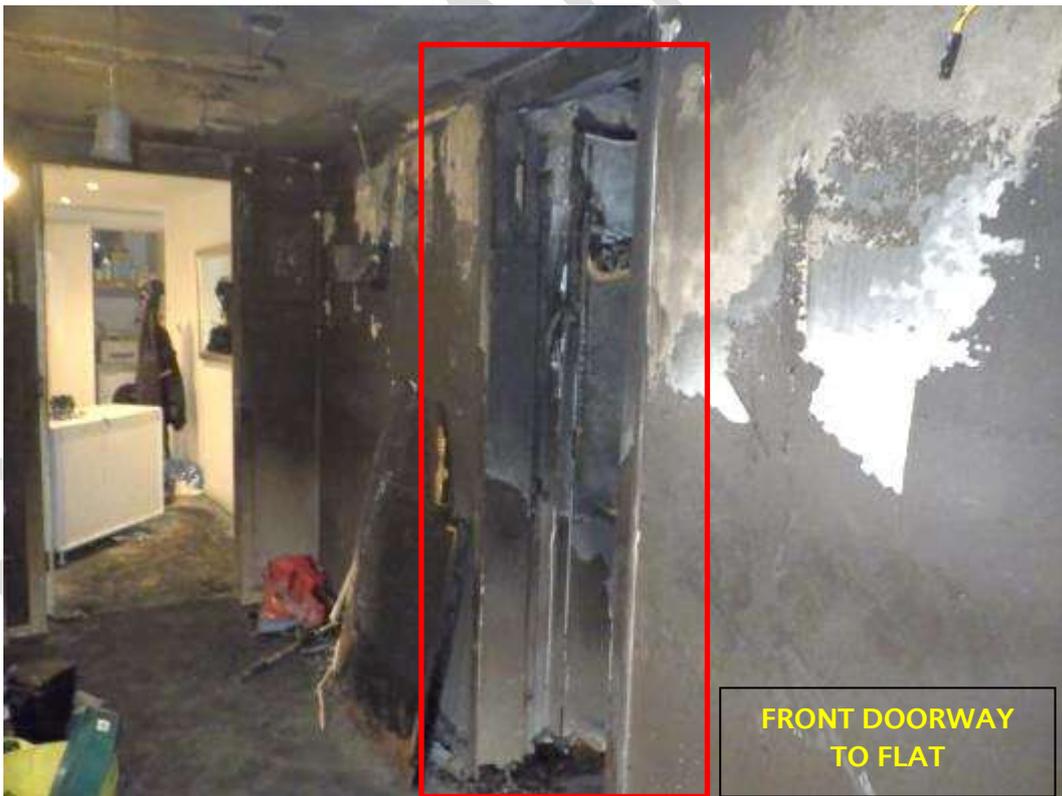
- 6.1.9 This corridor provided access to flats including the flat of origin. The 8th floor corridor was extensively damaged, with fire and heat damage to the ceiling and top surfaces of the walls, particularly outside the flat of origin.

Images showing the 8th floor corridor looking towards the flat of origin

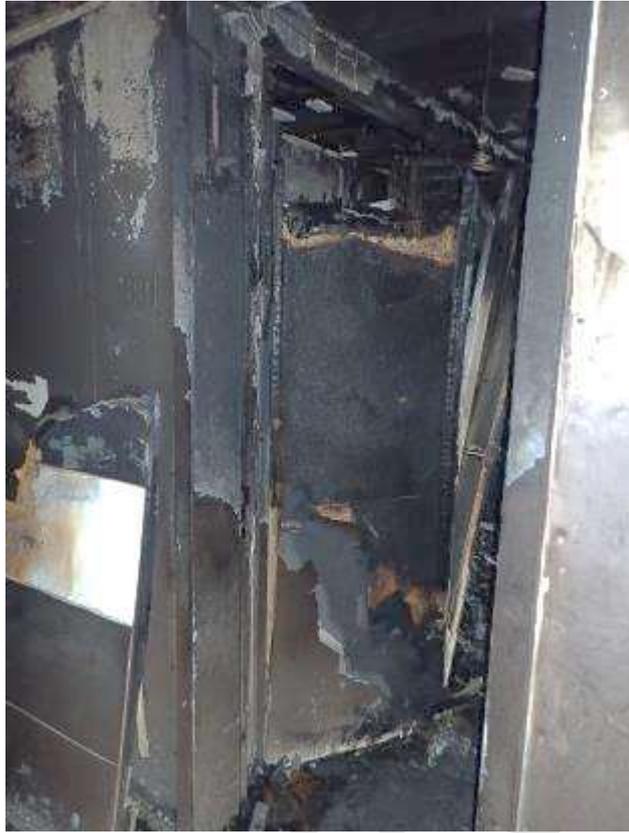
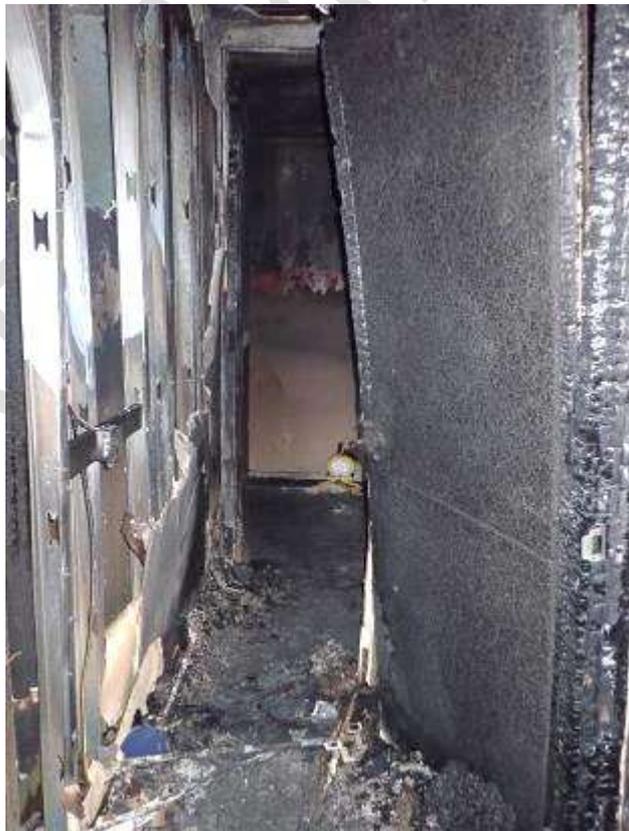
- 6.2.1 The front door to the flat had been removed or fallen from its original position and had been placed in the communal corridor. The top half of this door had been consumed by fire. The inside face of the remainder of the door had an even charring. The outside face of the door was heat and smoke damaged to its top section. The self closing device for the door was found on the floor on the left hand side of the door frame. The upper sections of the door frame and timber boxed sections had been consumed by fire.

- 6.2.2 The front door led to a hallway, where the suspended ceiling plasterboard was missing, however the metal strut work was still in place. All cables within this void had been fire damaged. Towards the end of the hallway the concrete ceiling had spalled. On the right hand side of the hallway was the stud wall separating the kitchen. Apart from one small section at low level the majority of the plasterboard was missing. On the left hand side, initially there was a built in cupboard. The timber doors to this cupboard were charred on their exterior face and partially consumed on the top edge. The lower contents of this cupboard were mainly undamaged and consisted of a hot water cylinder and a washing machine. All cables that had been in the suspended ceiling above the cupboard were fire damaged.

Images showing the front entrance (looking from outside) and hallway (looking from inside) of flat. Note the remains of the door to the left of the doorway

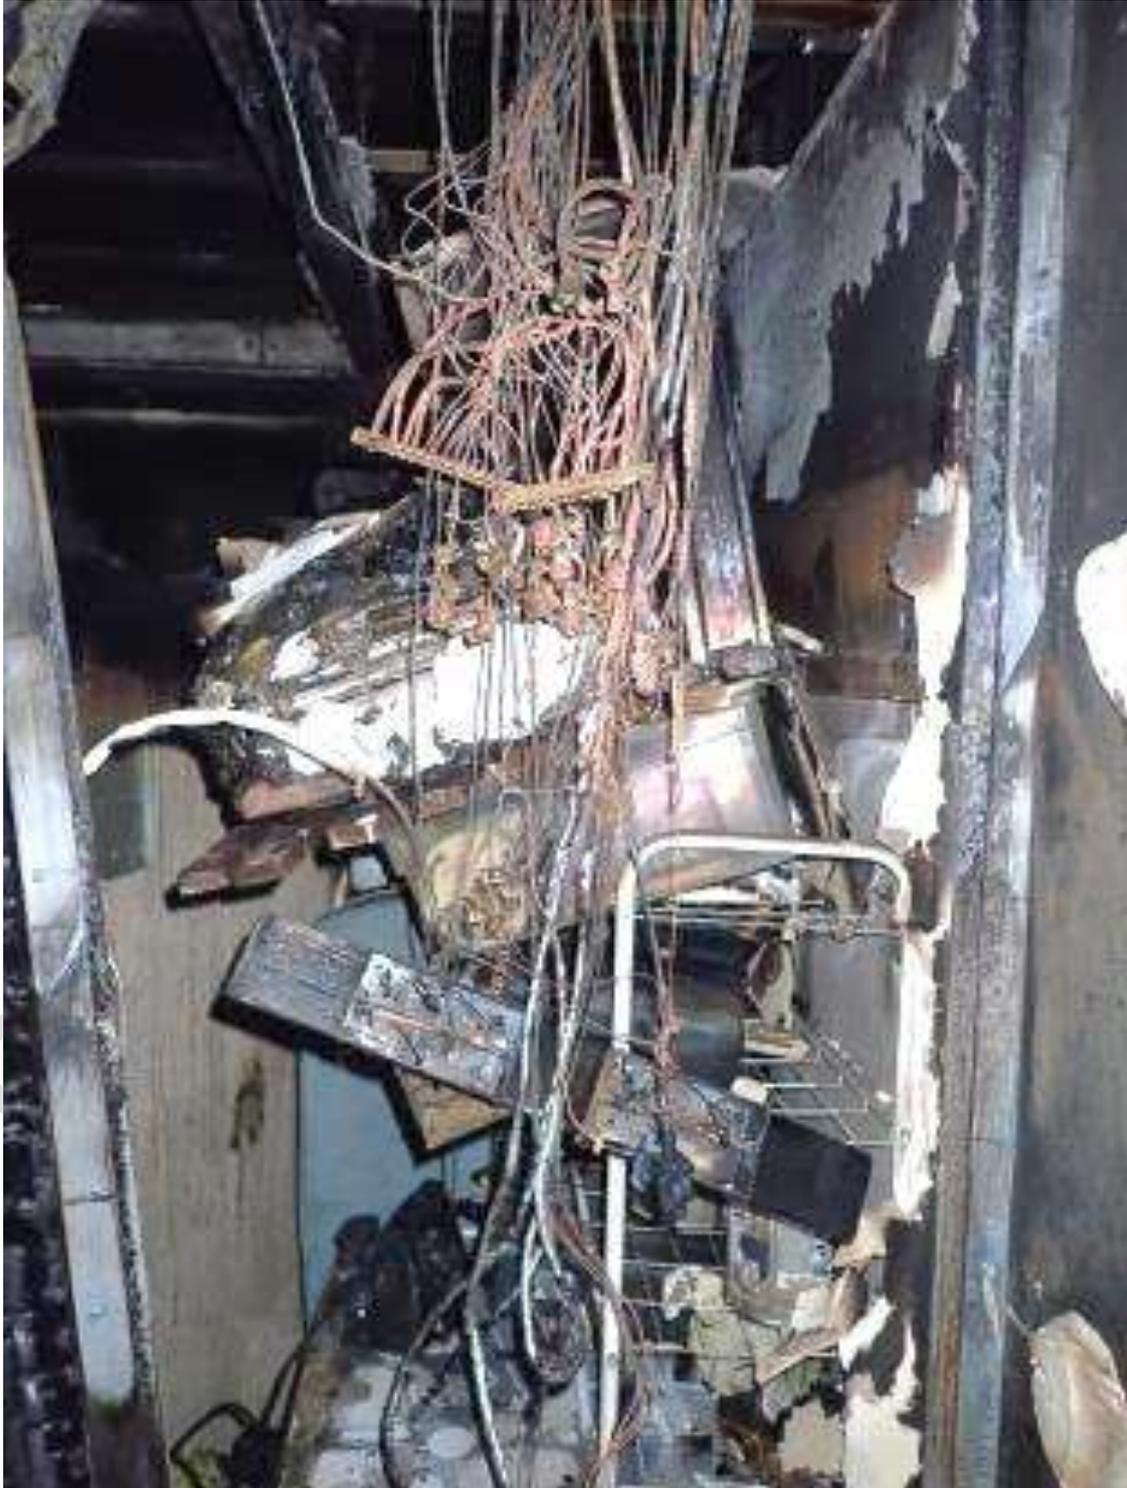
7.4.3 The consumer unit suffered 100% fire damage and had evidence of arcing damage to six of the circuits. There was also internal melting to the lower braid arm below the area where the timer switch for the hot water system would have been positioned.

Images showing the remains of the consumer unit in position

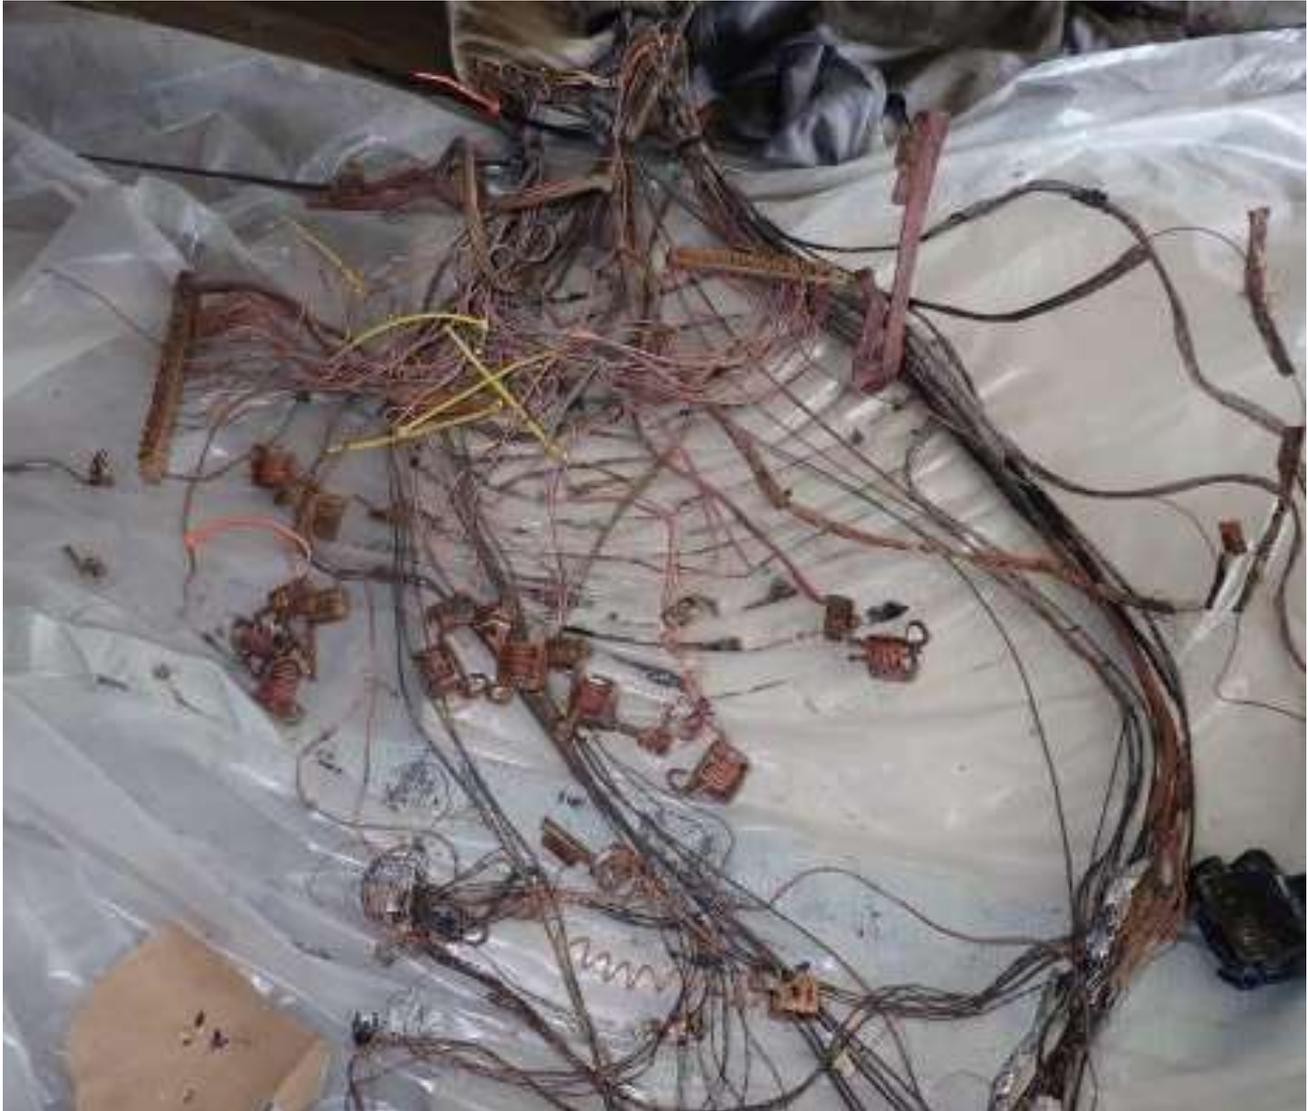
Image showing the remains of the top half of the consumer unit

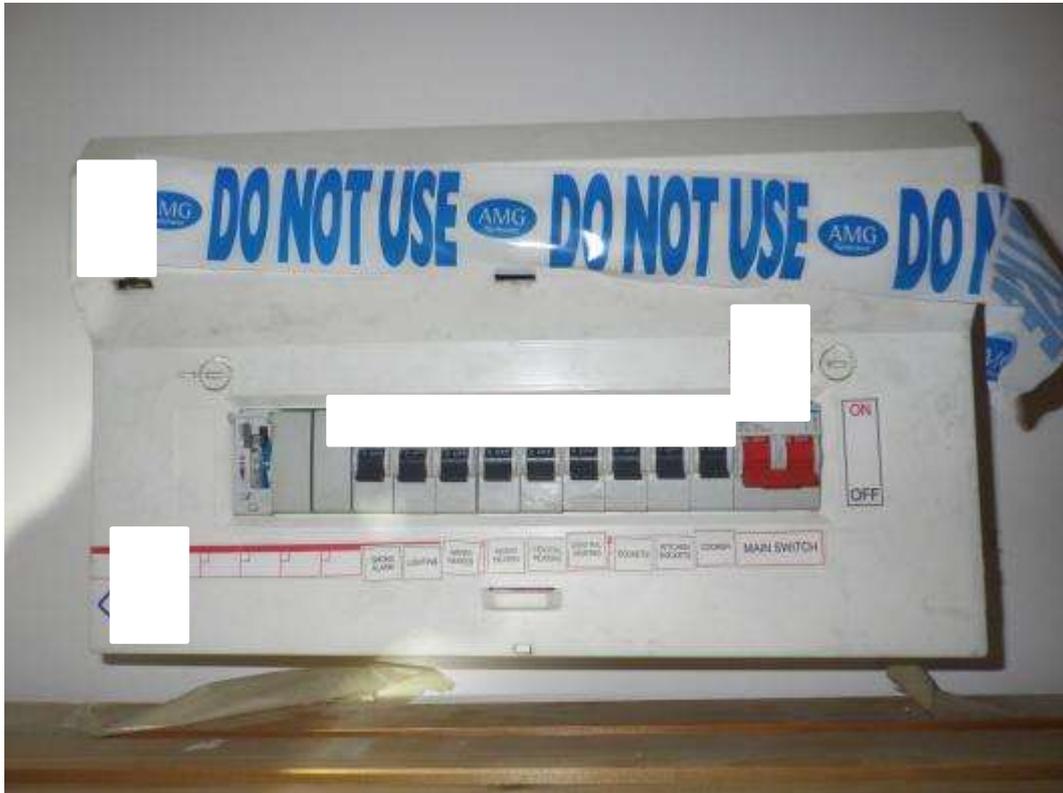
Image showing an exemplar consumer unit found in flat on 9th floor

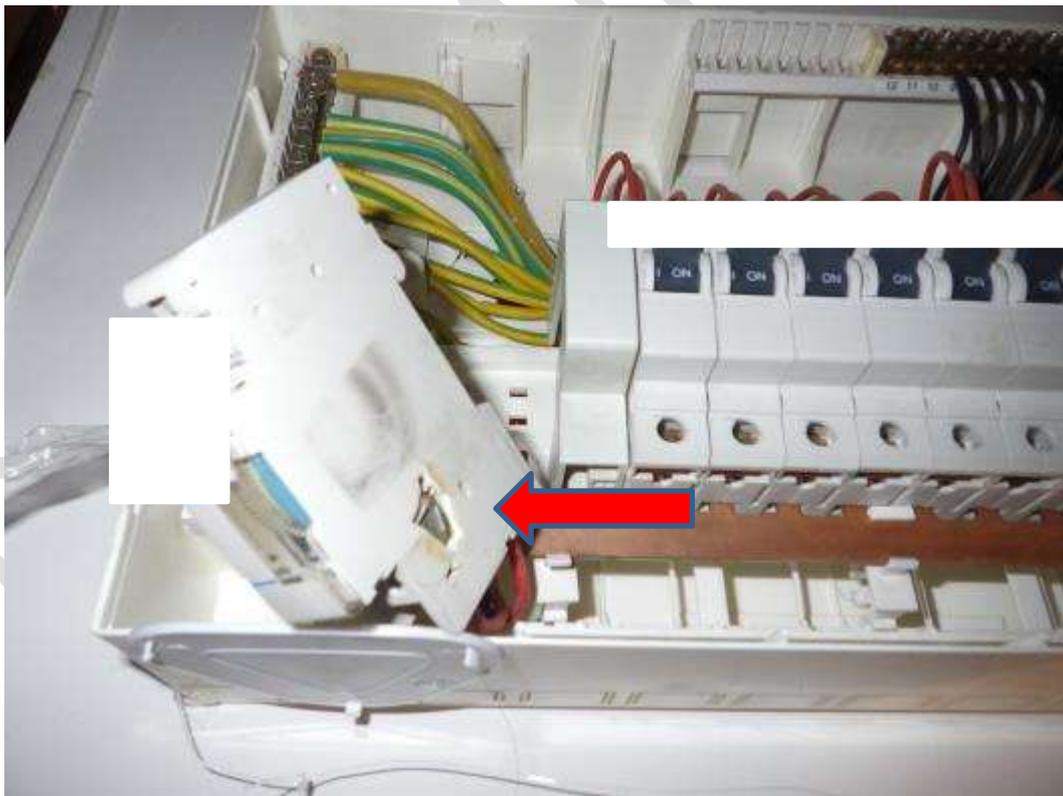
- 6.7.9 The original timer switches found on the 8th and 9th floors were then examined. In one flat where an original timer switch was found installed in a modern metal consumer unit, the timer switch was removed and a small burn was found on its side, adjacent to terminal 4. The red PVC insulation on the cable into terminal 4 was also blackened. This device was sampled for further examination by the Scientific Advisors, Bureau Veritas.

Image showing an internal heating fault on the Timer Switch in exemplar flat

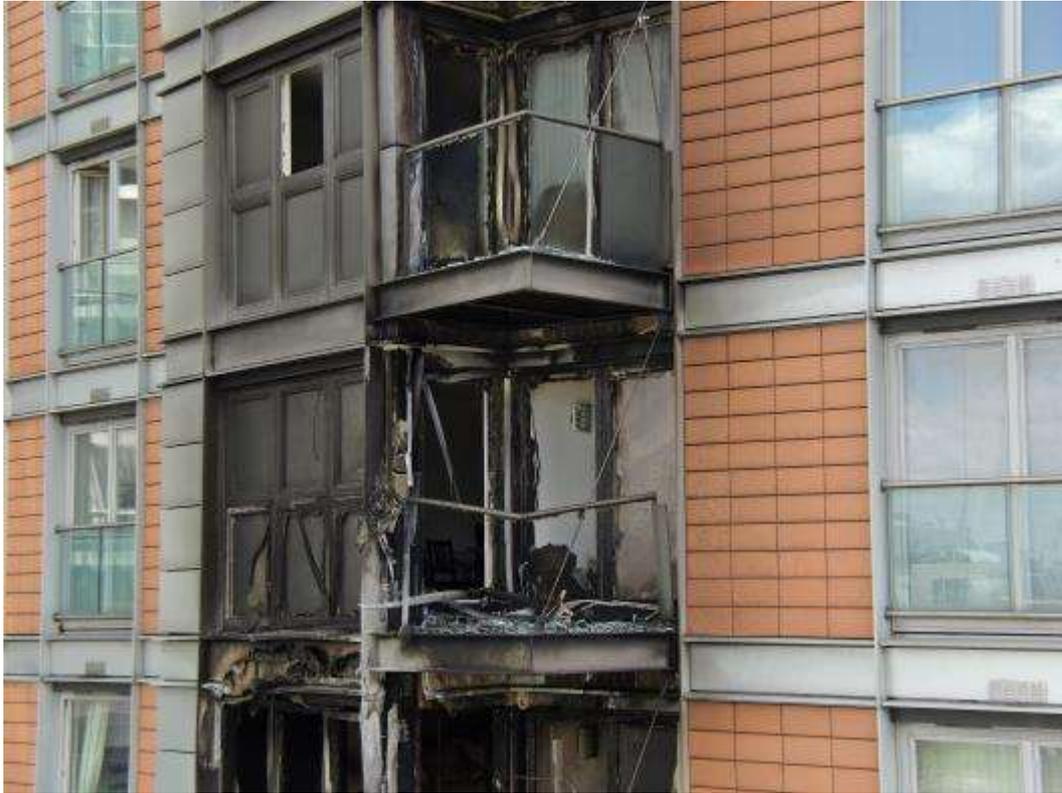
- 6.1.11 The flat located directly over the fire flat was examined. The fire had attacked the windows to the living room area and the doors to the balcony from the living room and second bedroom. Glass to both sets of doors to the balcony had broken, whilst the glazing to the living room windows was fractured but remained largely in place. The flat sustained only minor smoke damage internally, adjacent to the balcony doors.

- 6.1.12 The flat located two floors above the fire flat was examined. The exterior of the windows to the living room had been damaged by fire, but the glazing had not failed. The door between the living room and balcony had been fire damaged externally and the outer pane of its glazing had broken, but the inner pane remained intact, although fractured. The exterior of the door from the second bedroom to the balcony had sustained similar damage. There was no damage by fire, heat or smoke into the flat.

Image showing the external fire damage on the 9th and 10th floors

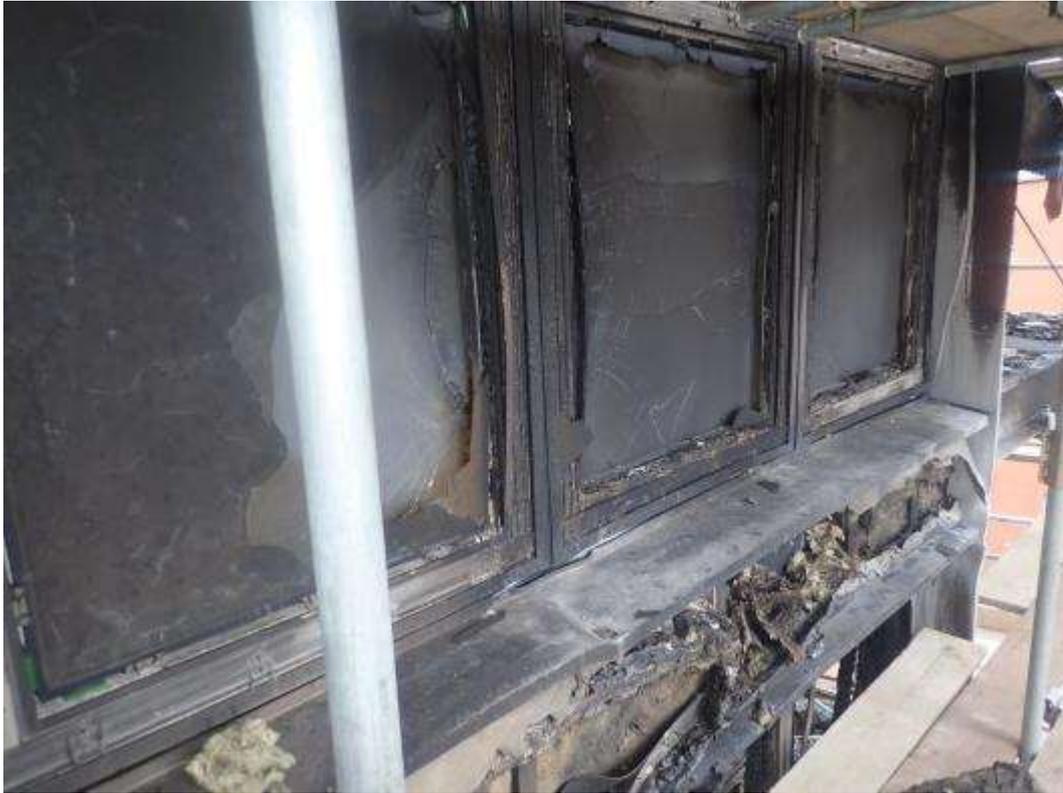
- 6.8.1 Exterior ACM panels were examined using an LFB aerial ladder platform. ACM panels were clipped in to a fixing at the bottom of the panel. The top of panels were fixed using pot rivets. Rivet heads were cut off and two panels were removed and brought to ground level for examination. A further section of fire damaged ACM cladding was removed from the right hand side of the balcony.

Image showing the damage to the ACM cladding between the 8th and 9th floor windows

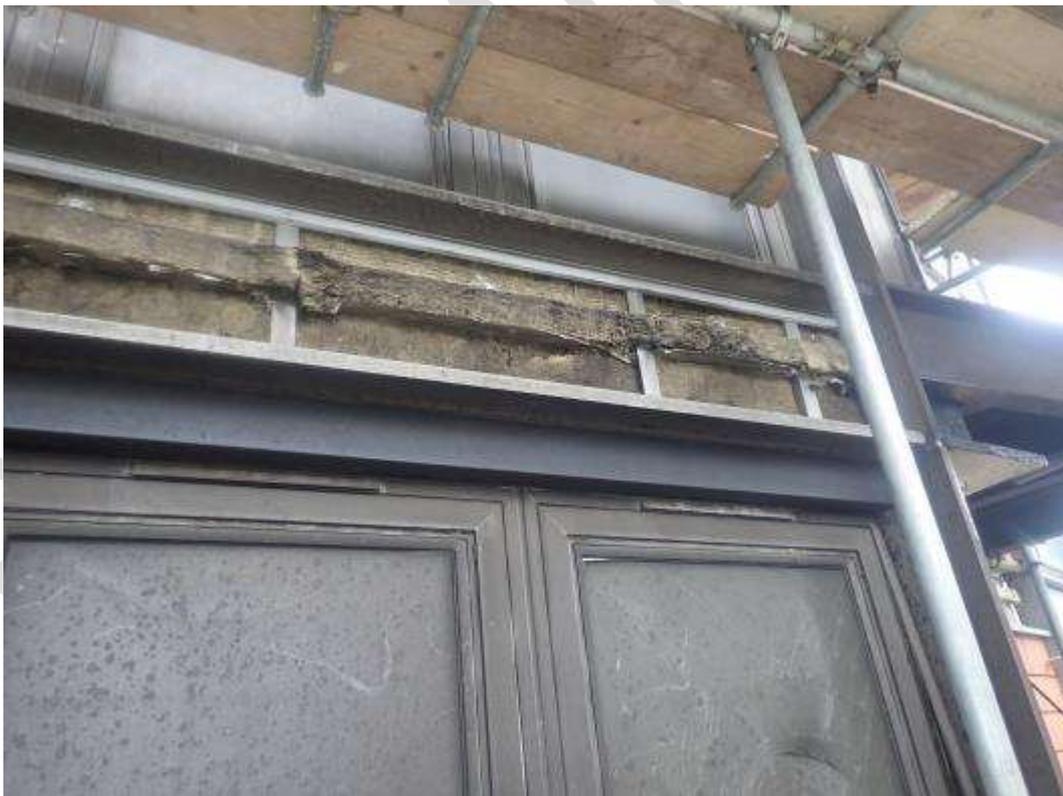
Image showing the internal construction of the ACM cladding between the 9th and 10th floors

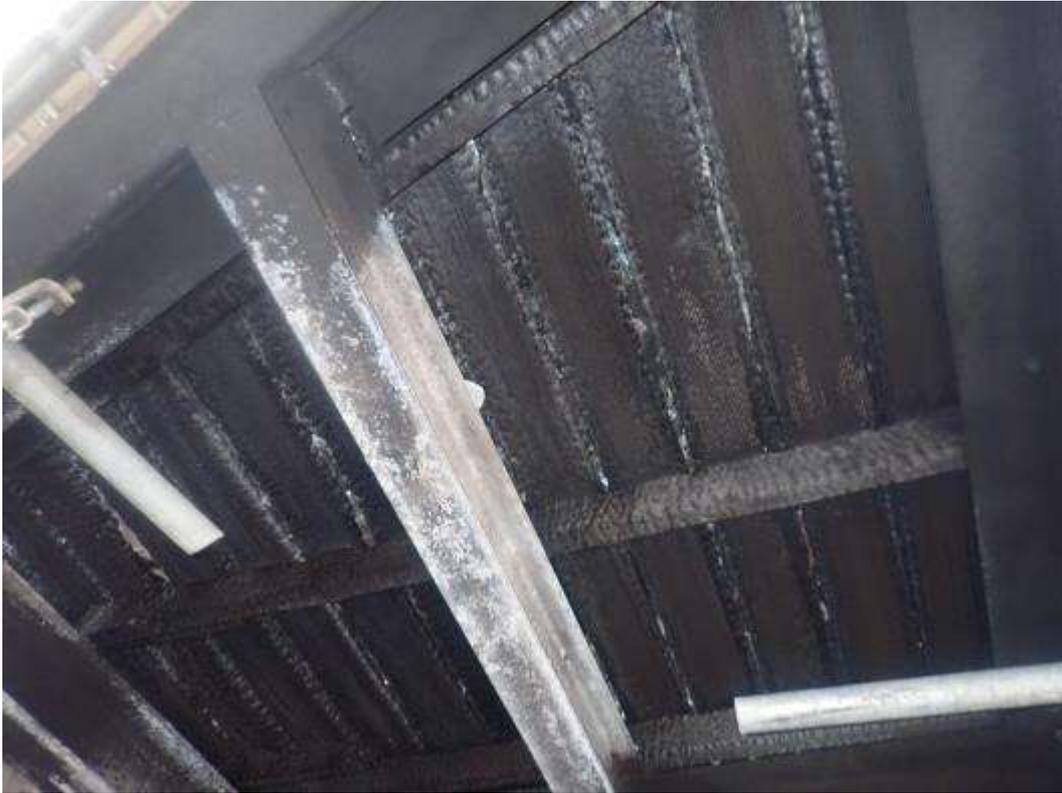
Image showing the charring to the underside of the 9th floor balcony timber decking

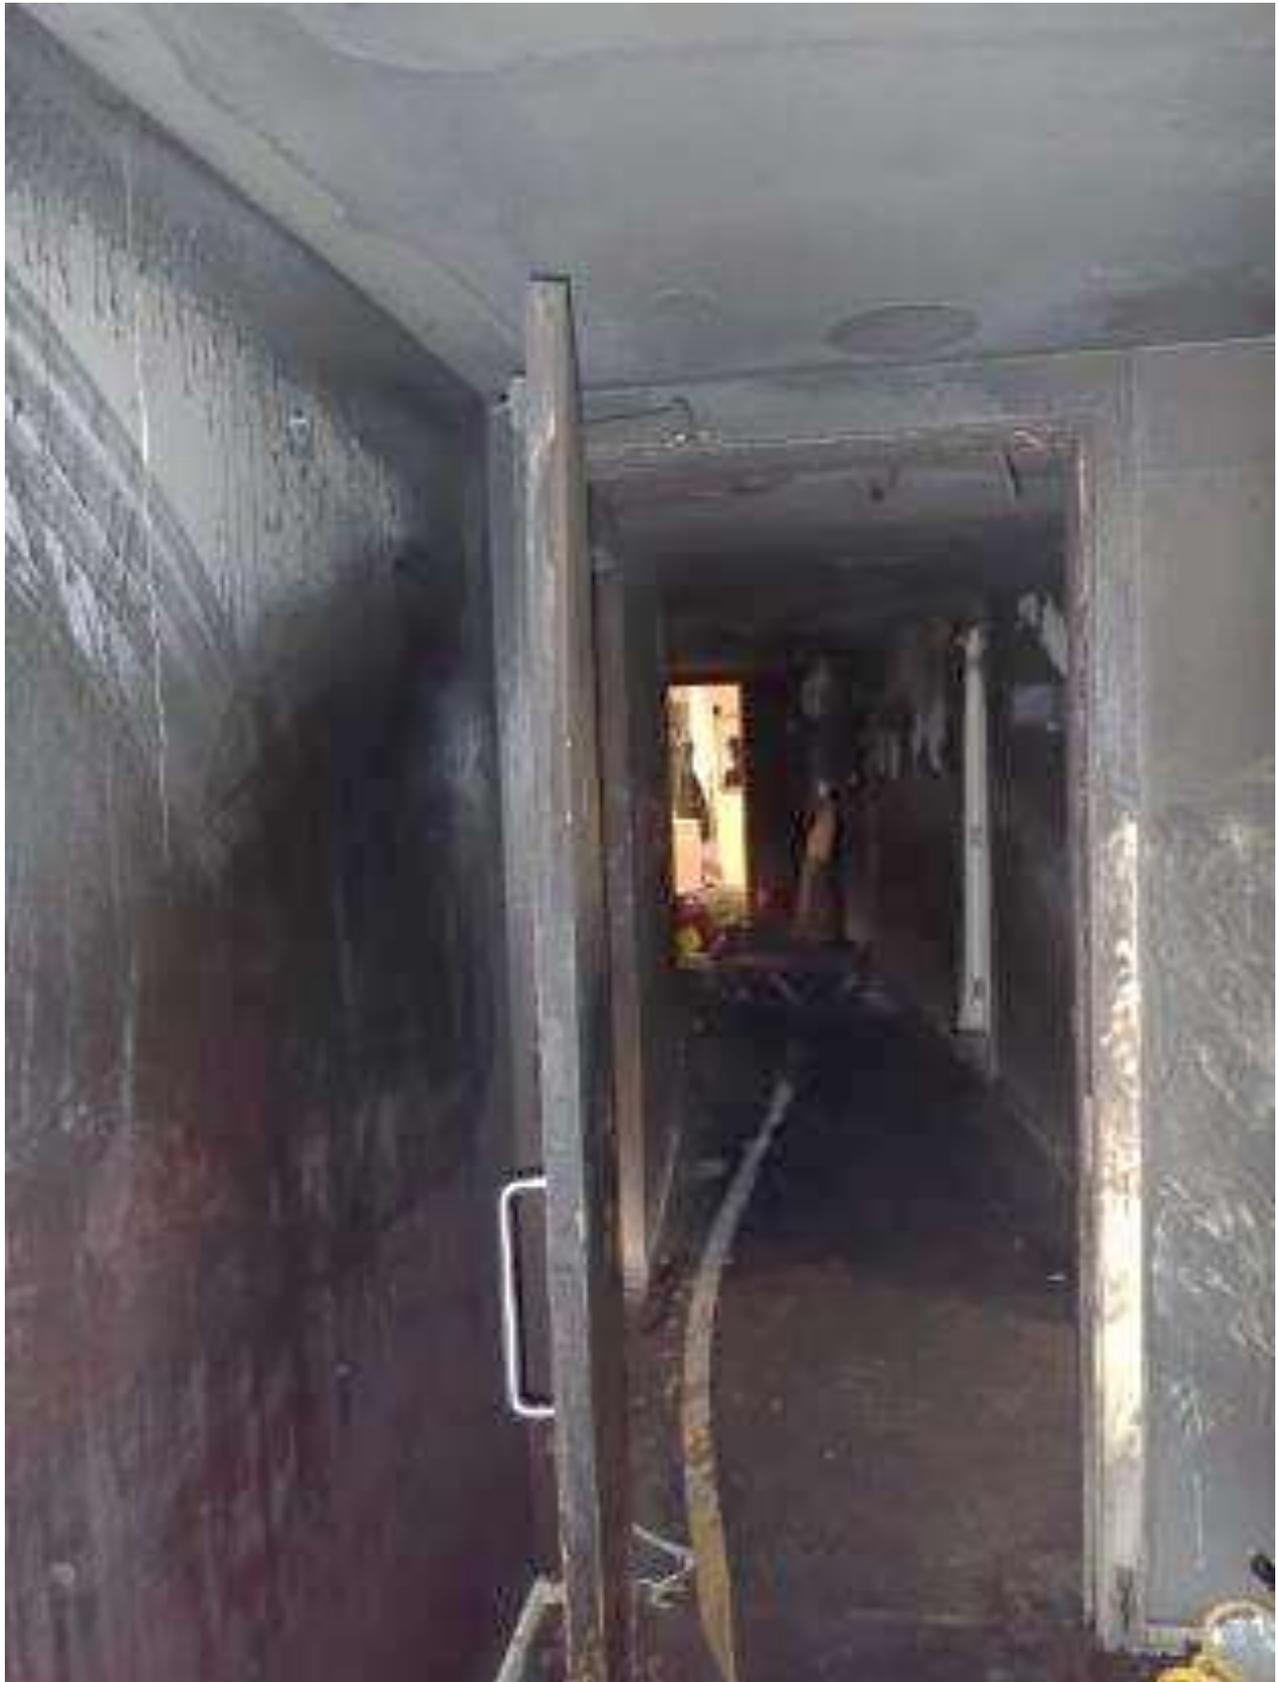
- 6.1.8 The corridor serving flats along the western side of the building was accessed via a fire door across the corridor. On other floors this door was held open on an electromagnetic door holder, but post-fire, this door was wedged open. Its magnetic door holder had been damaged and fallen to the floor. The top of the door had been damaged by heat and the whole door and wall surfaces adjacent to it were covered in a heavy layer of soot. The intumescent strip in the frame of this doorway was found to be expanded and charred, particularly around the top half of the door. The illuminated exit sign that had been mounted over this door in the corridor had been fire damaged and the plastic hanging sign was missing.

Image showing the cross corridor door on the 8th floor

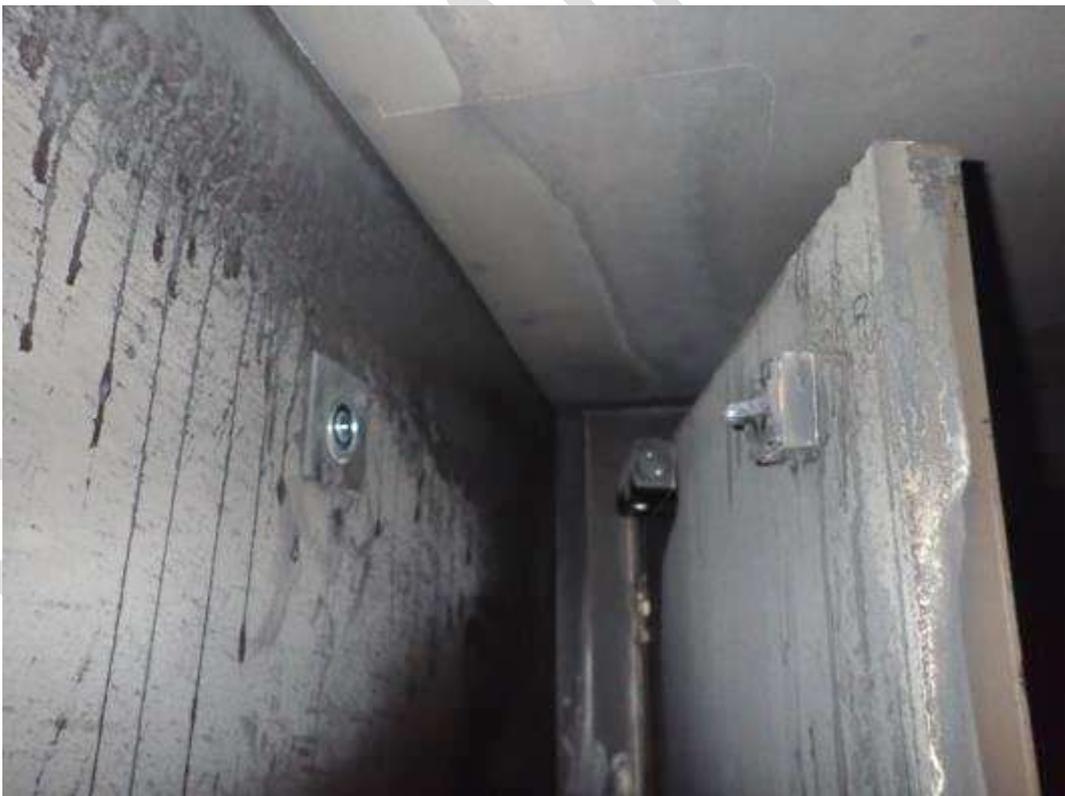
Image showing the magnetic holder for the cross corridor door on the 8th floor

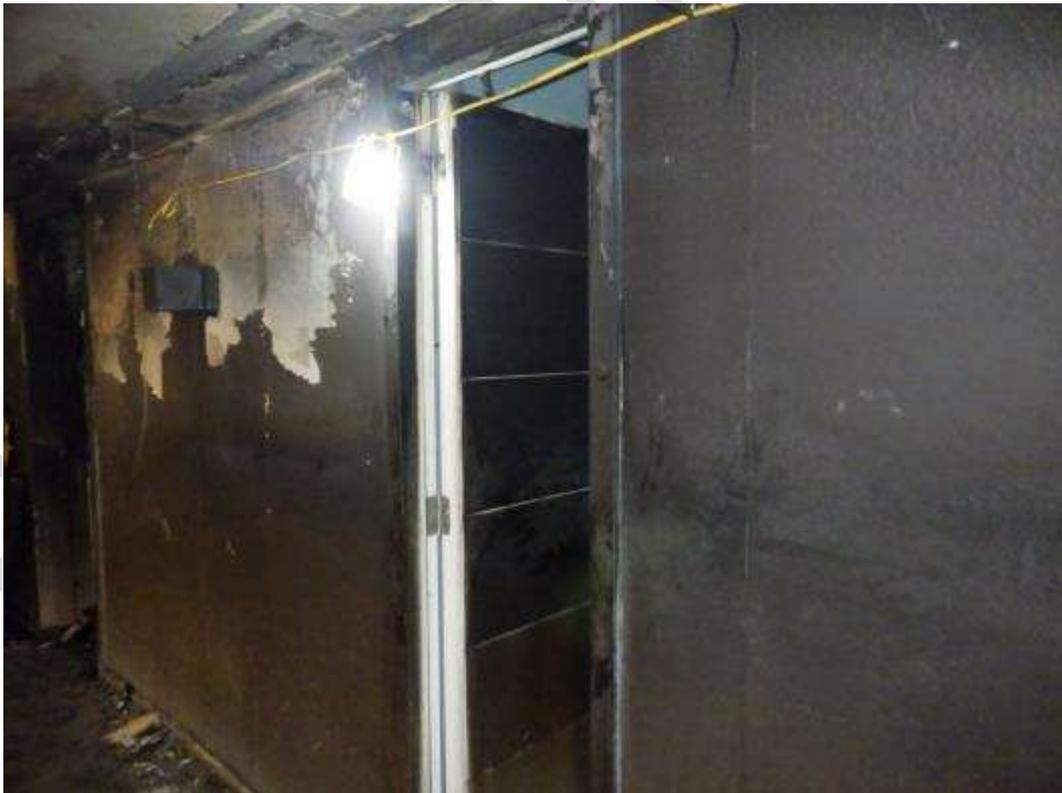
Image showing the AOV door on the 8th floor

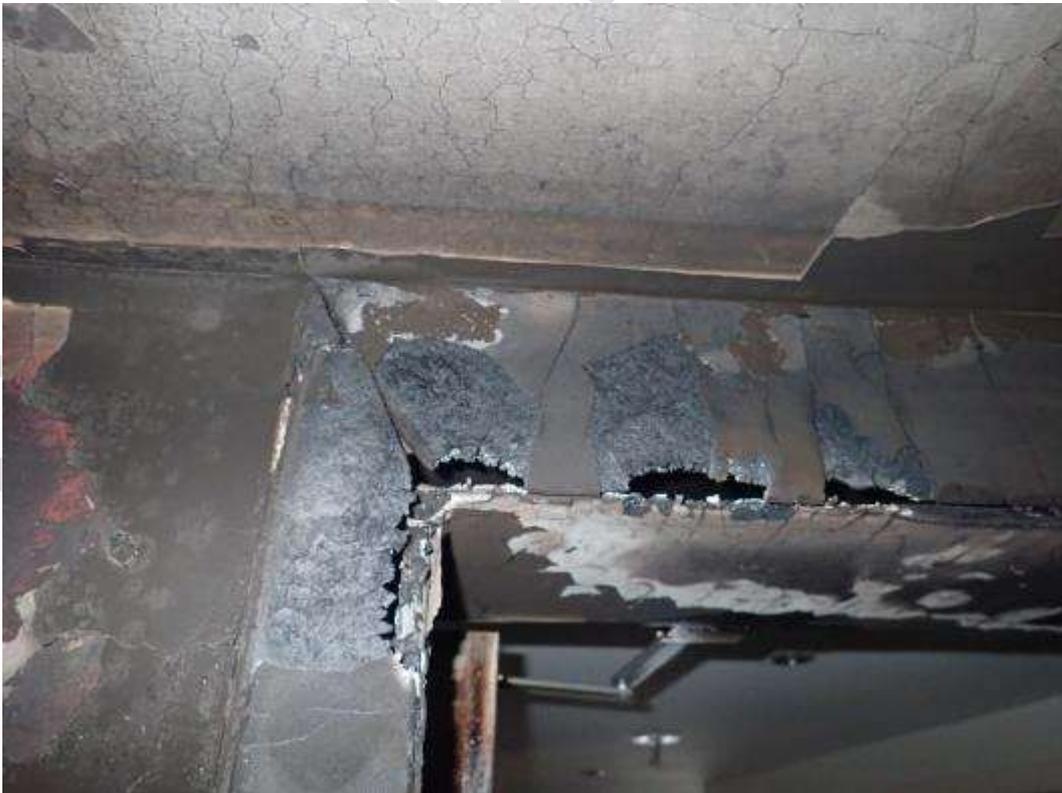
Image showing the timber boxing around the front door frame of flat next to flat of origin

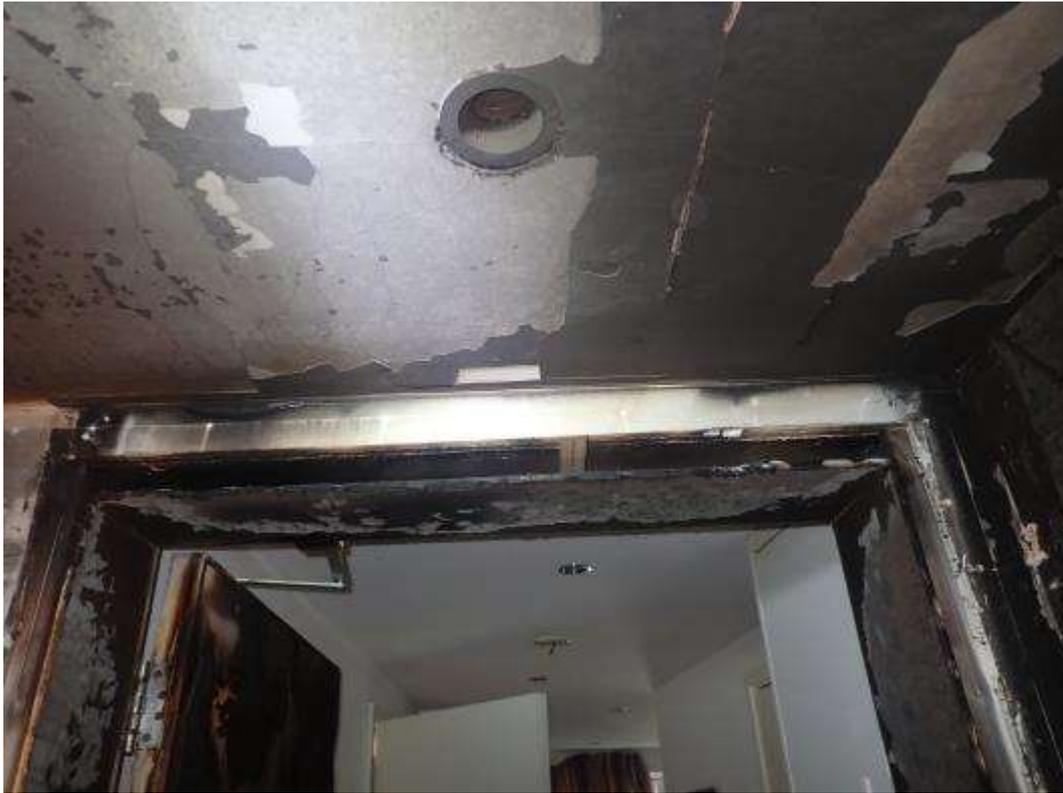
Image showing the void between the top of the door frame and the fabric of the building
