Condition Survey & Report
for the
**Mechanical & Electrical
Services Installation**
at
St Georges Swimming Pool
221 The Highway
London, E1W 3BP

Report produced for
**London Borough of Tower
Hamlets**
Technical Services Team
2nd Floor (Annexe)
Mulberry Place
5 Clove Crescent
London, E14 2BG

Reference	21012-CSR-101a
Prepared by	S Godden
Date	November 2021

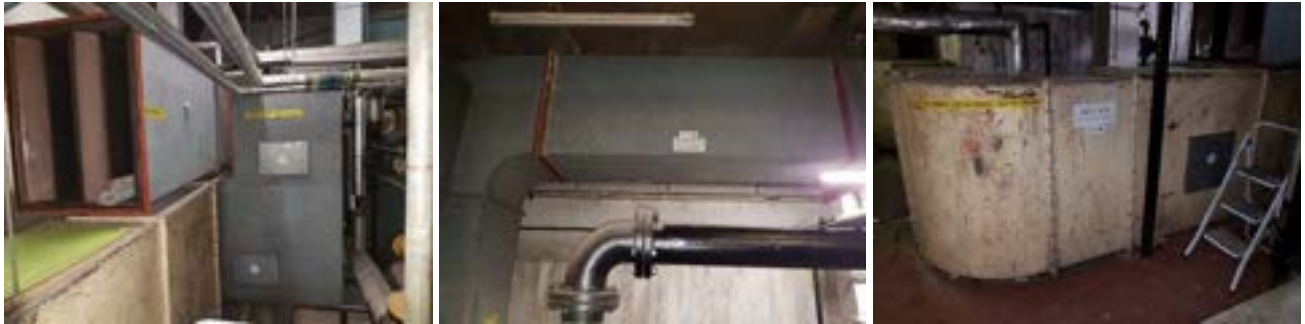
The return air fan exhausted used air to the roof via the vertical services duct

The original pool halls return air ductwork that connected to the belt driven centrifugal fan from both the north and south aspects of the building and discharged through the vertical services riser to the roof.

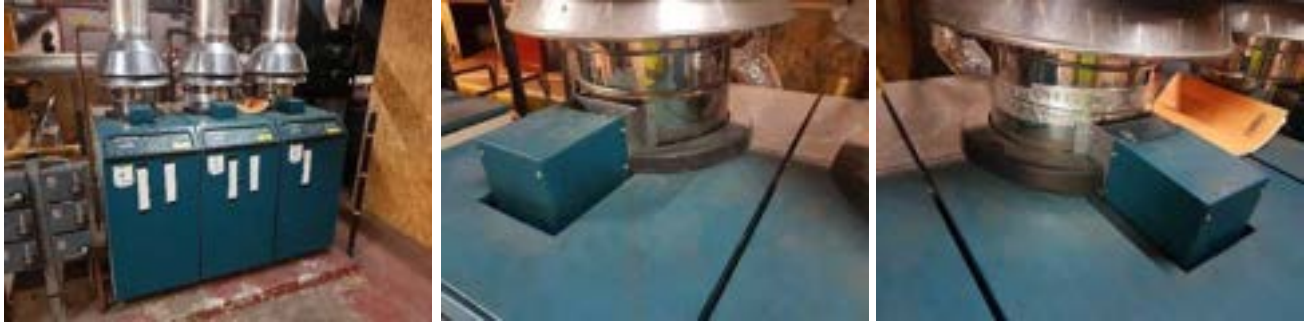
Boilers 4, 5 & 6. The known problem areas with these boilers is the failure, and often seizure, of the nylon bearings on the flue standing loss damper. On boilers 4, 5 & 6 these are intact and in a reasonable condition.

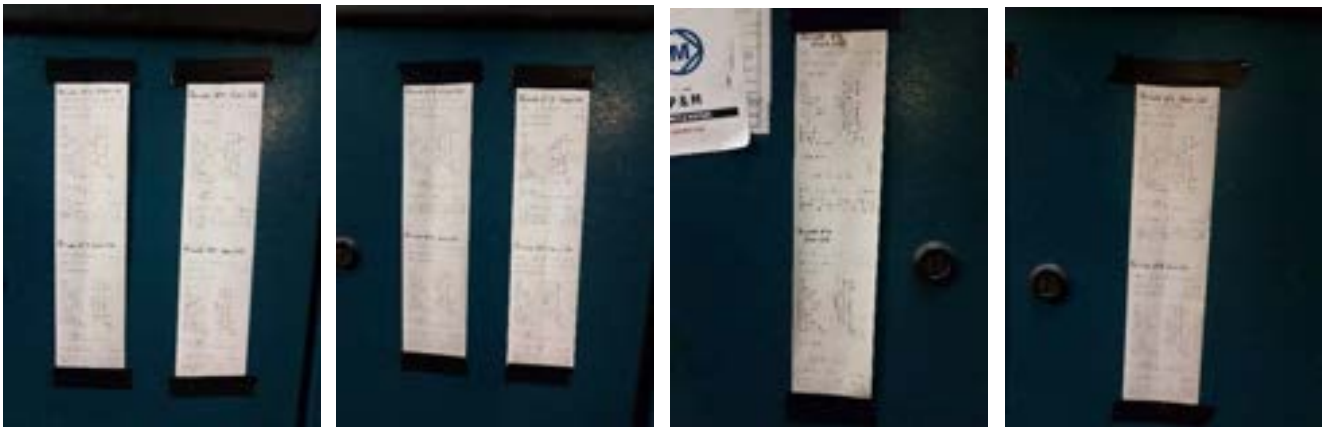
The last serviced dates including the previous last date and the current last date for information for boilers 4, 5 & 6

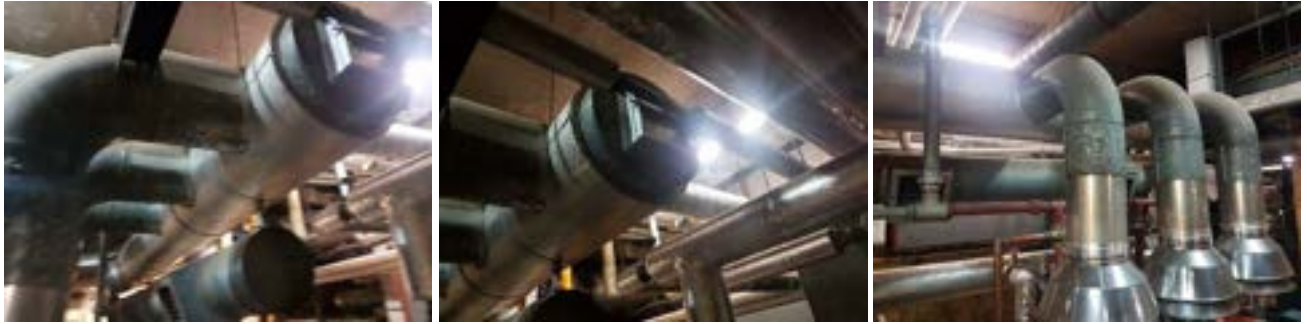
The three rising flues from boilers 6, 5 & 4 rise and connect into the 300 dia common flue.
The back draught damper in the common flue.
The three flues from boilers 1, 2 & 3 rise and connect into the 300 dia common flue.

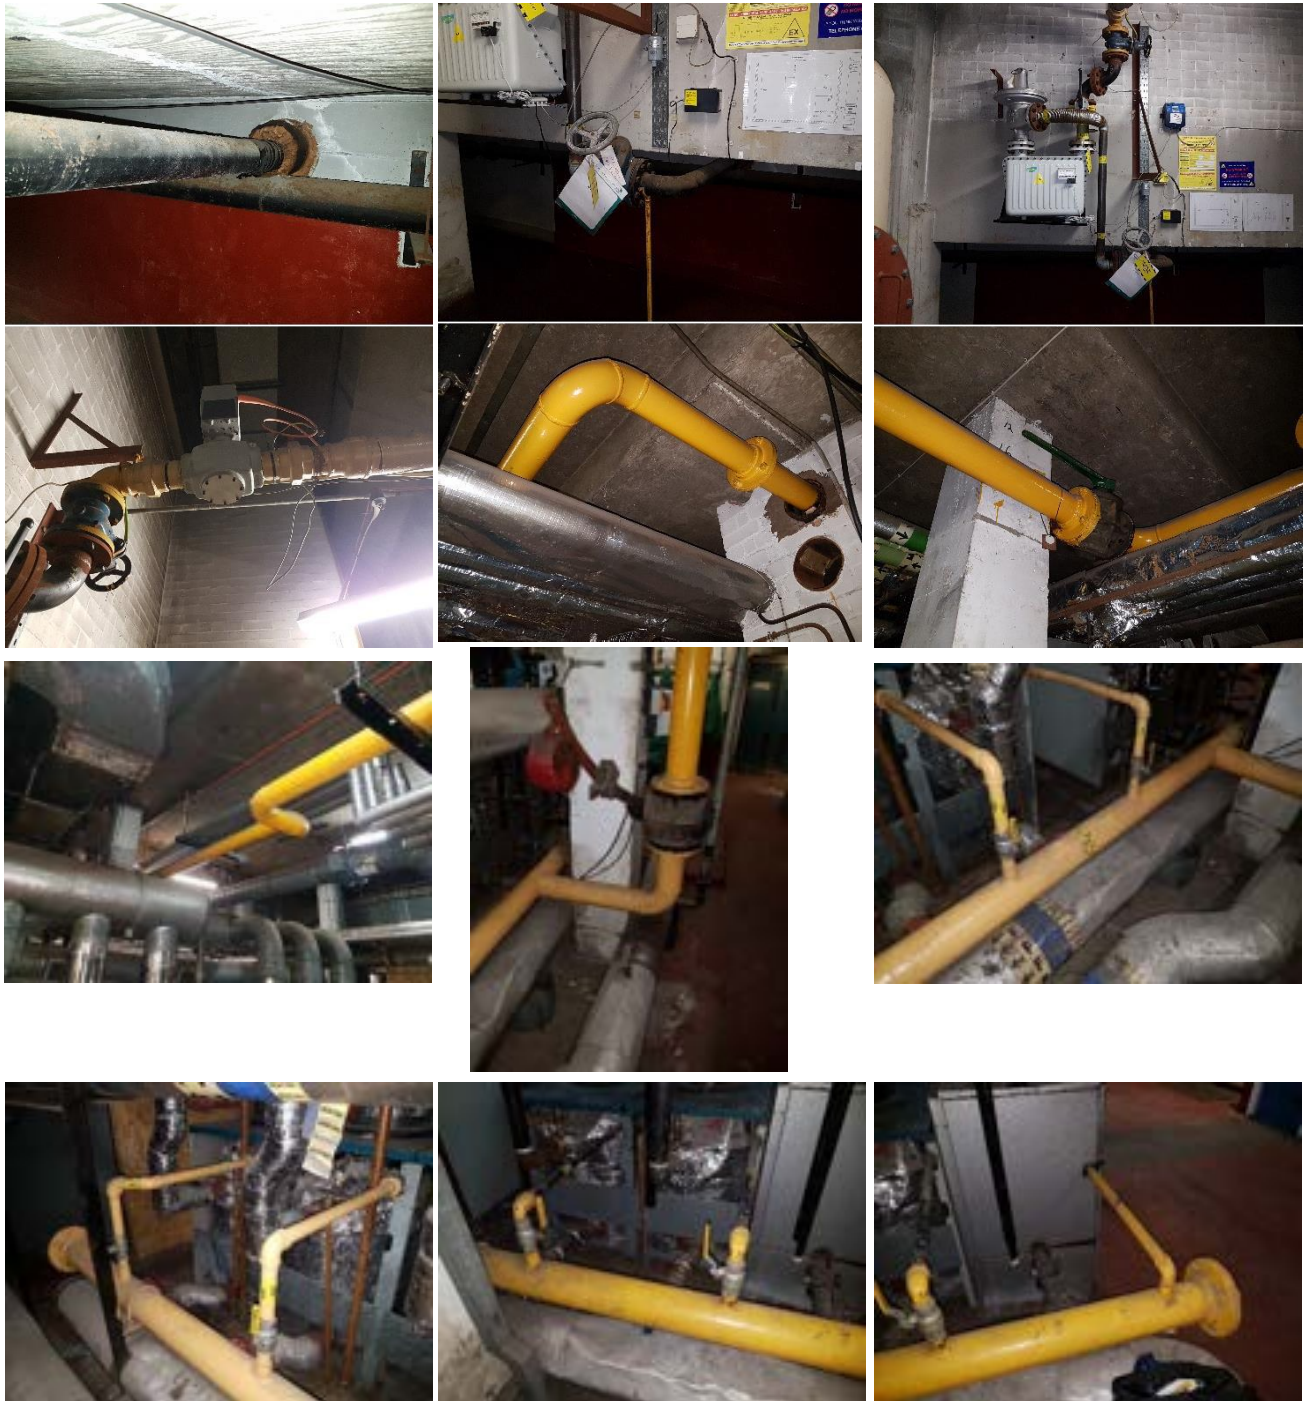
The gas service installation from incoming supply, gas meter, remote meter reader, gas safety solenoid valve, high level pipework, drop to boilers, mechanical gas safety valve and final connections to boilers.

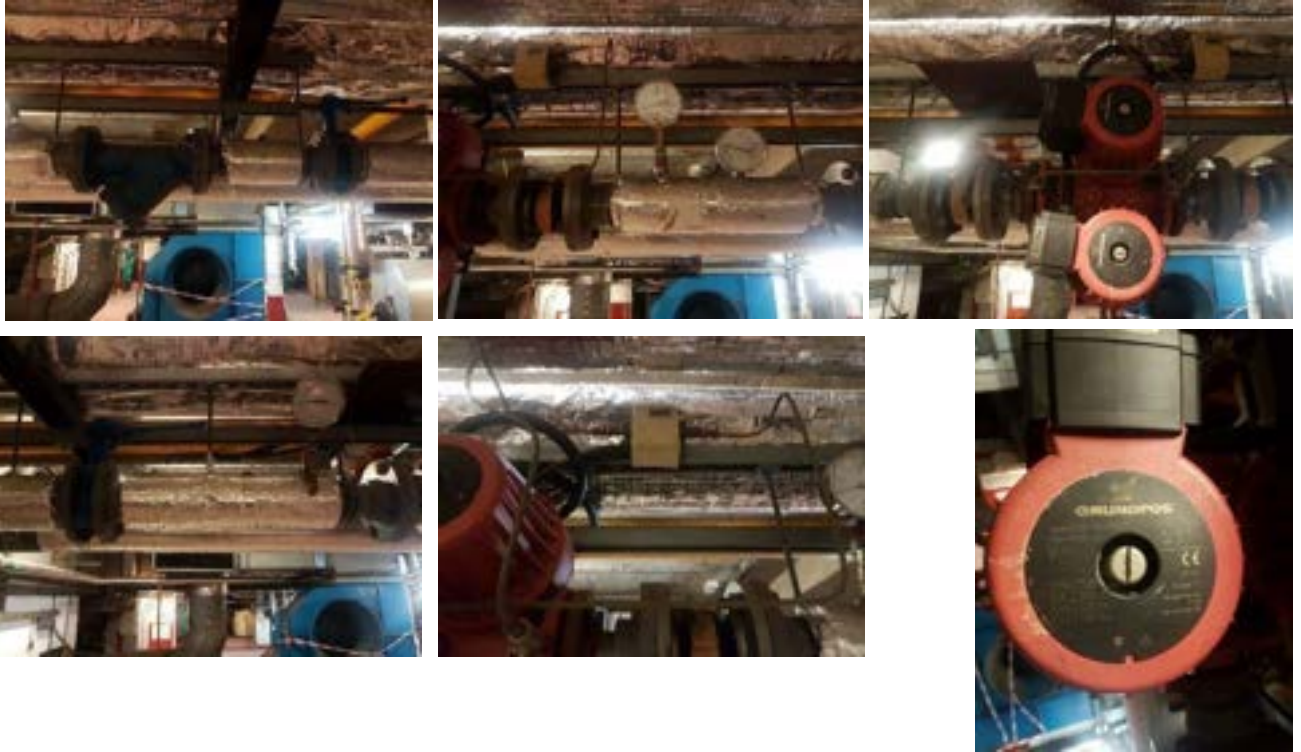
The main pool recovered heat pumps and associated fittings. The pumps appear to be operational with only minor leaks from the motor access screw. The pumps are fitted with inlet and outlet isolating valves, neoprene anti-vibration bellows and altitude gauges and there is a differential pressure switch to activate auto-changeover in the event of a pump failure.

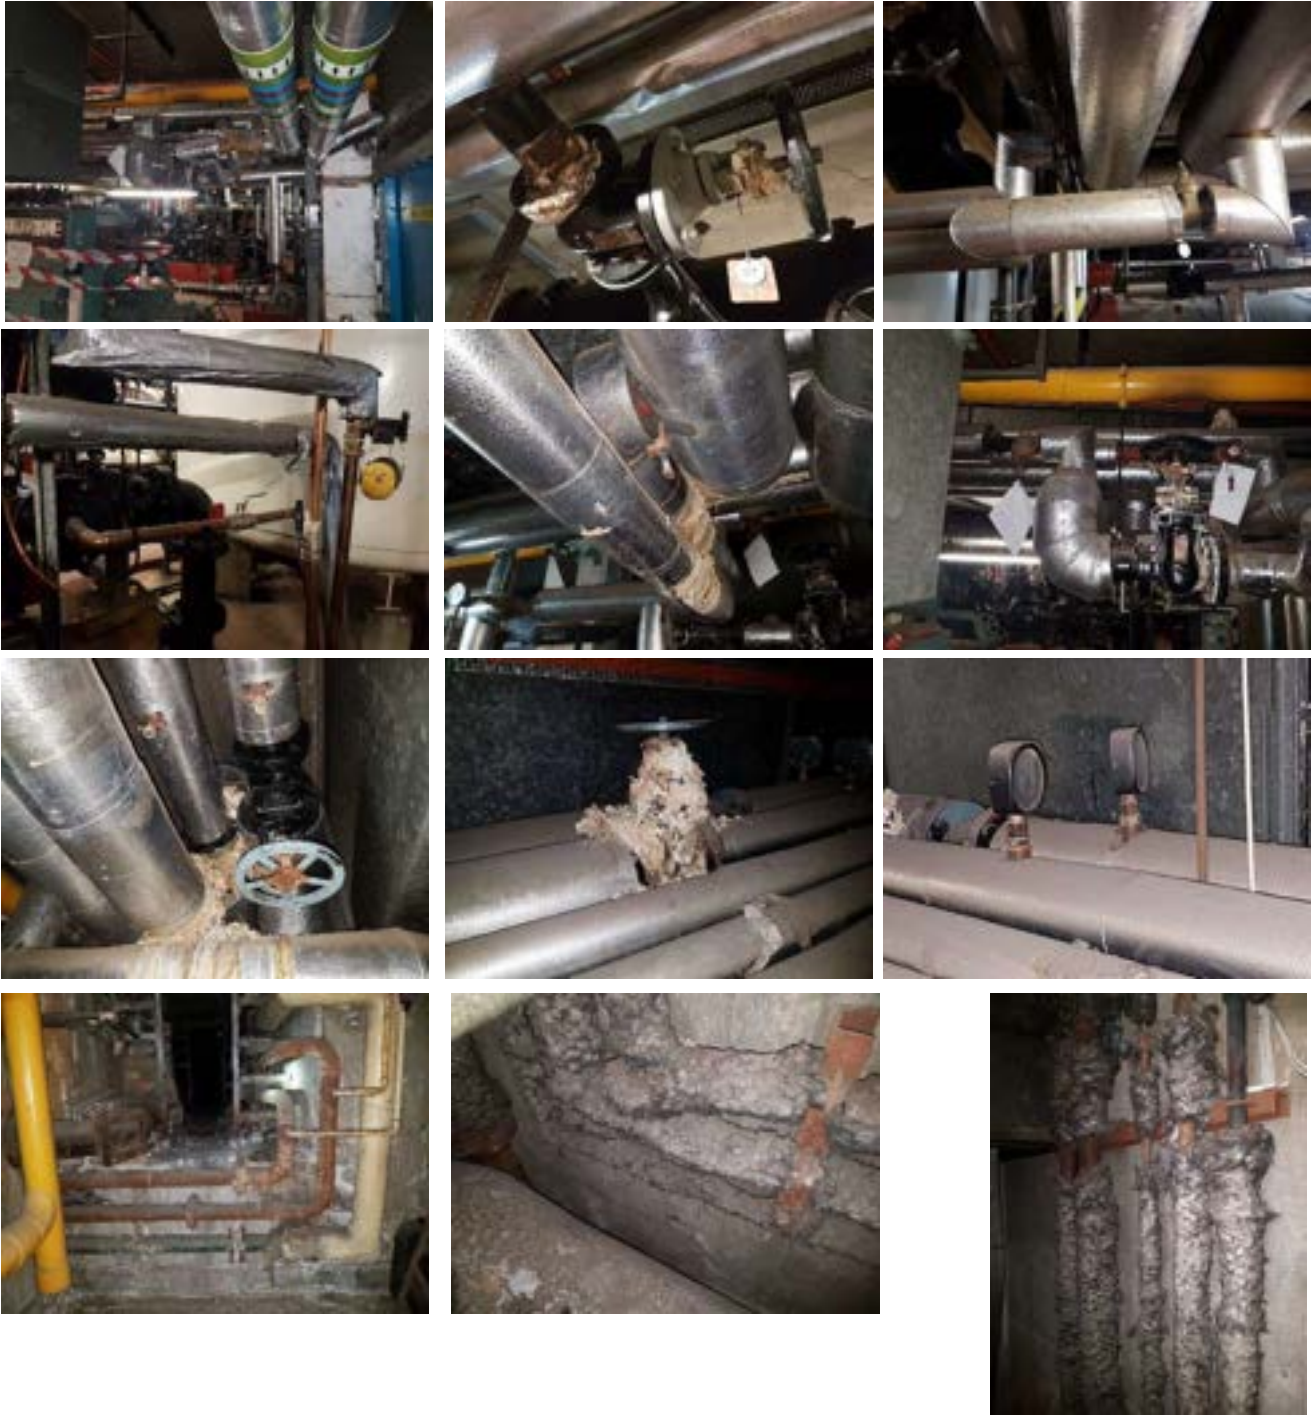
Various images of the heating pipework in the basement plantroom. The level of leaks on valve glands is enormous. The existing heating pipework into the undercroft is still in use, badly corroded and uninsulated. The existing heating pipework into the vertical services riser is again in very poor condition. The vertical services riser and the undercroft must be considered confined spaces and we did not enter them to undertake the survey.

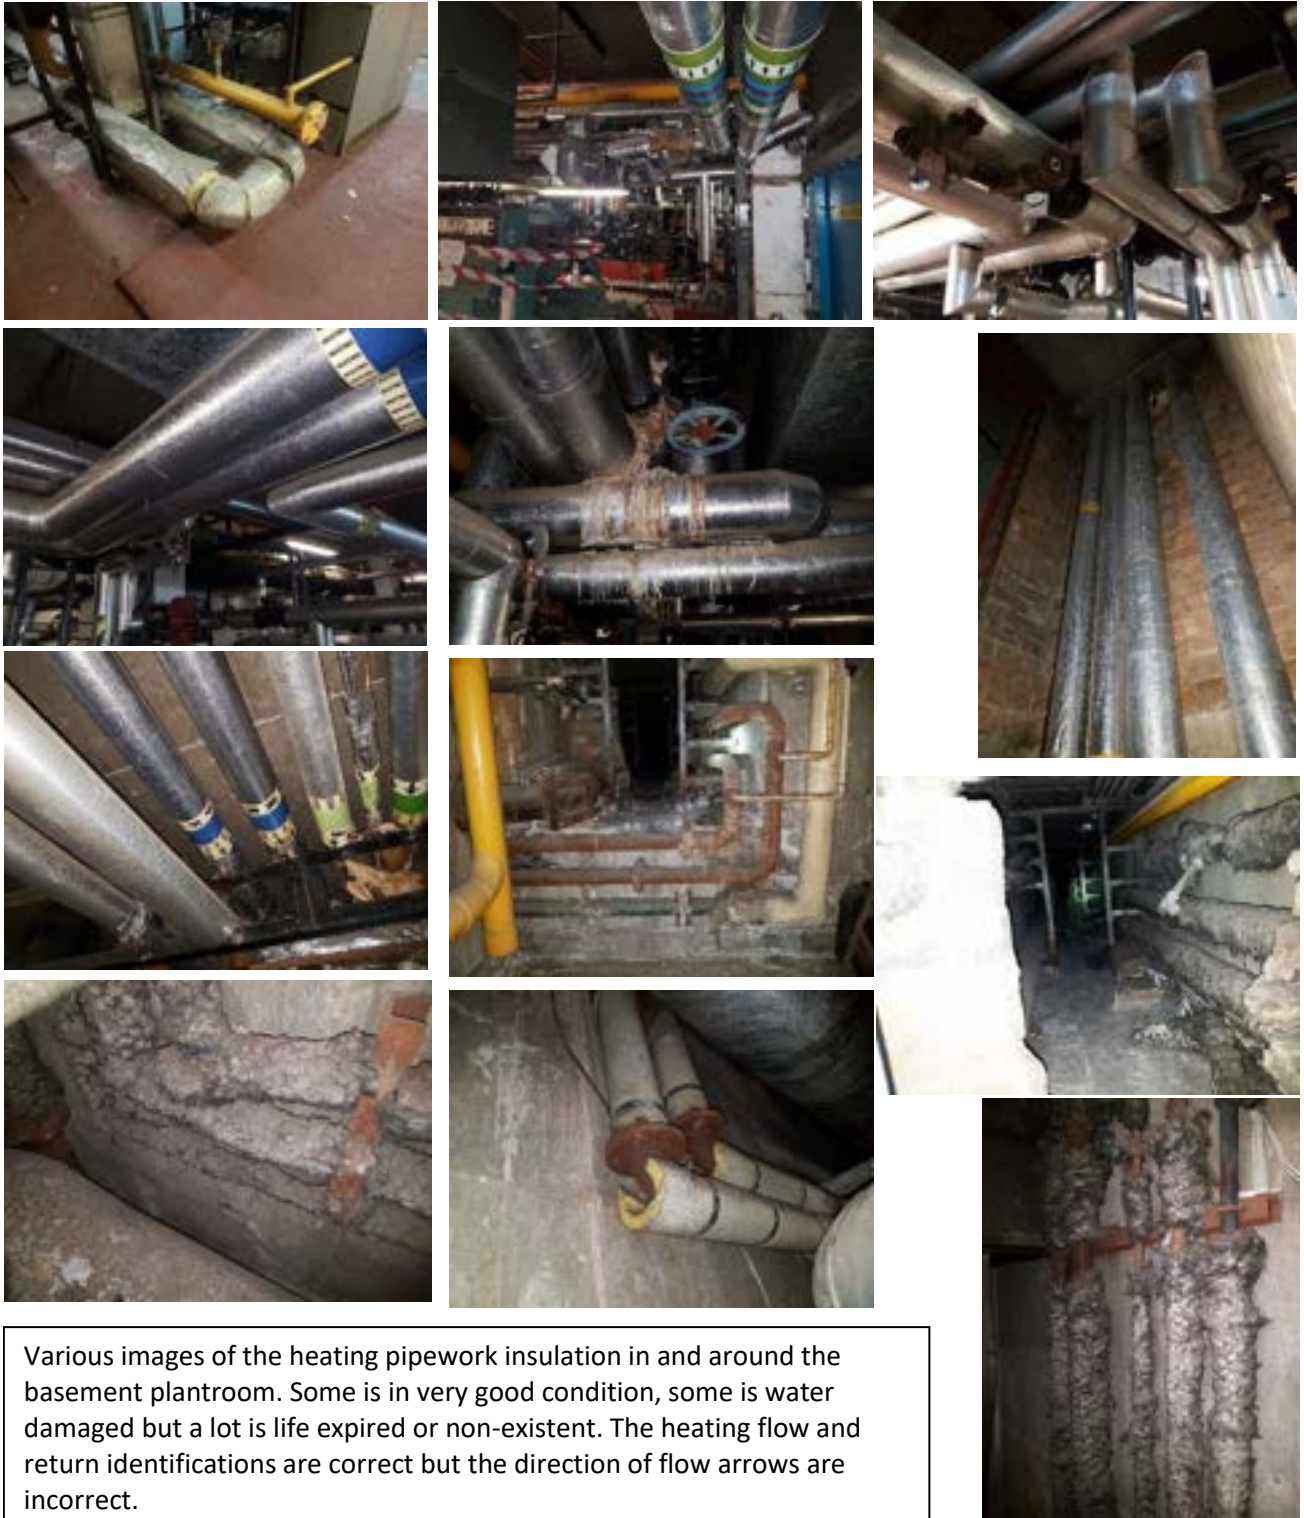
Various images of the heating pipework insulation in and around the basement plantroom. Some is in very good condition, some is water damaged but a lot is life expired or non-existent. The heating flow and return identifications are correct but the direction of flow arrows are incorrect.

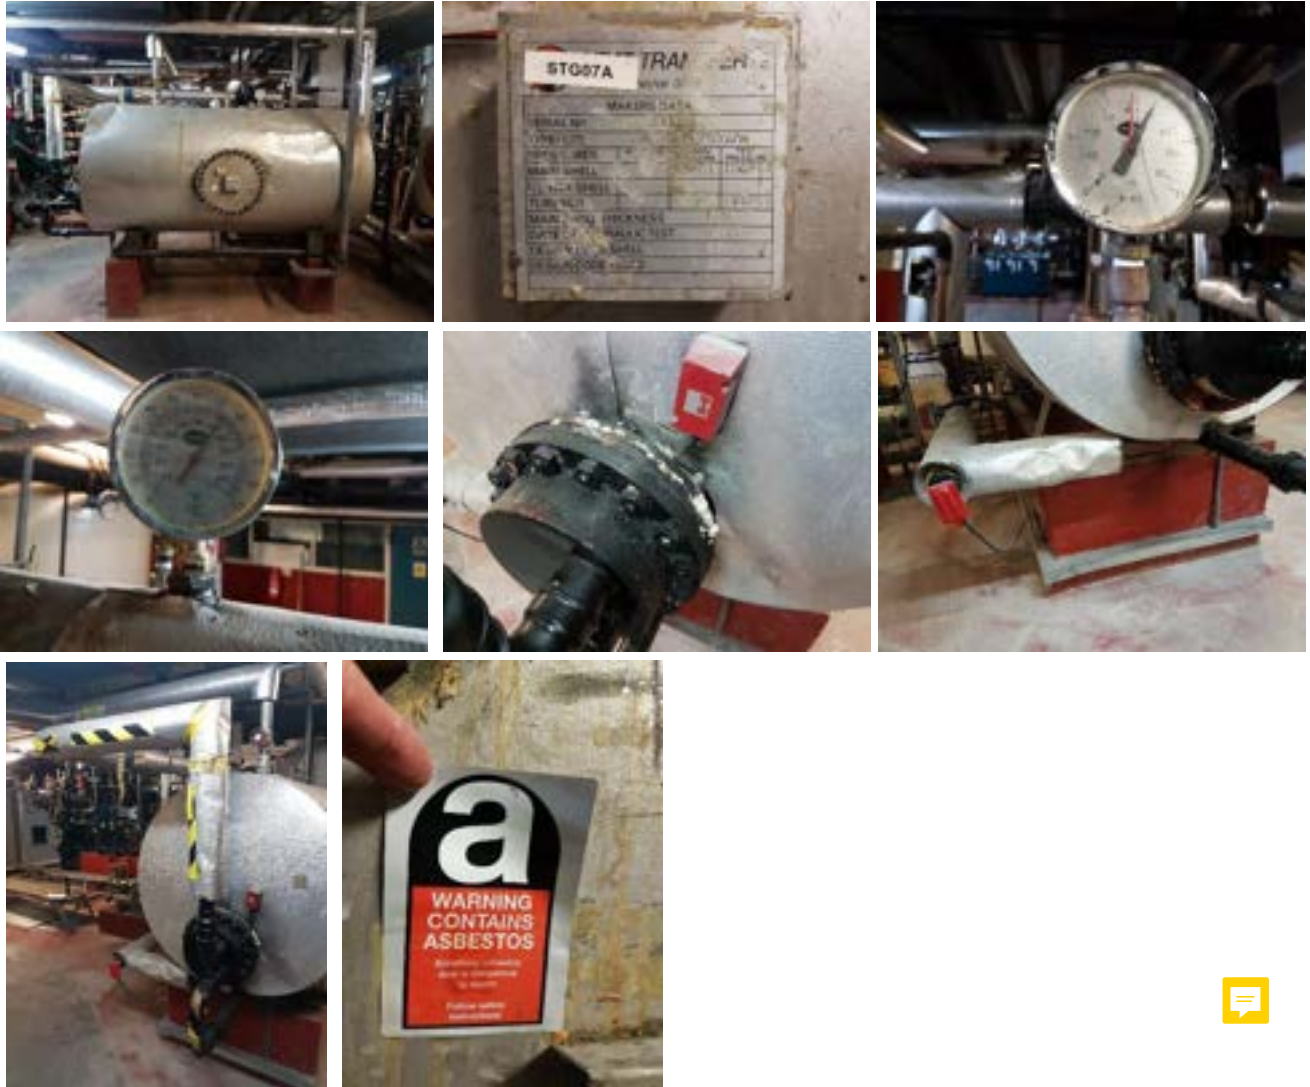
The general layout of the LPHW to HWS shell and tube calorifier showing the manufacturers data plate, the altitude and temperature gauge, the thermal insulation and the leak on the LPHW tube cluster flange. It is believed the asbestos warning notices is applicable to the gaskets.

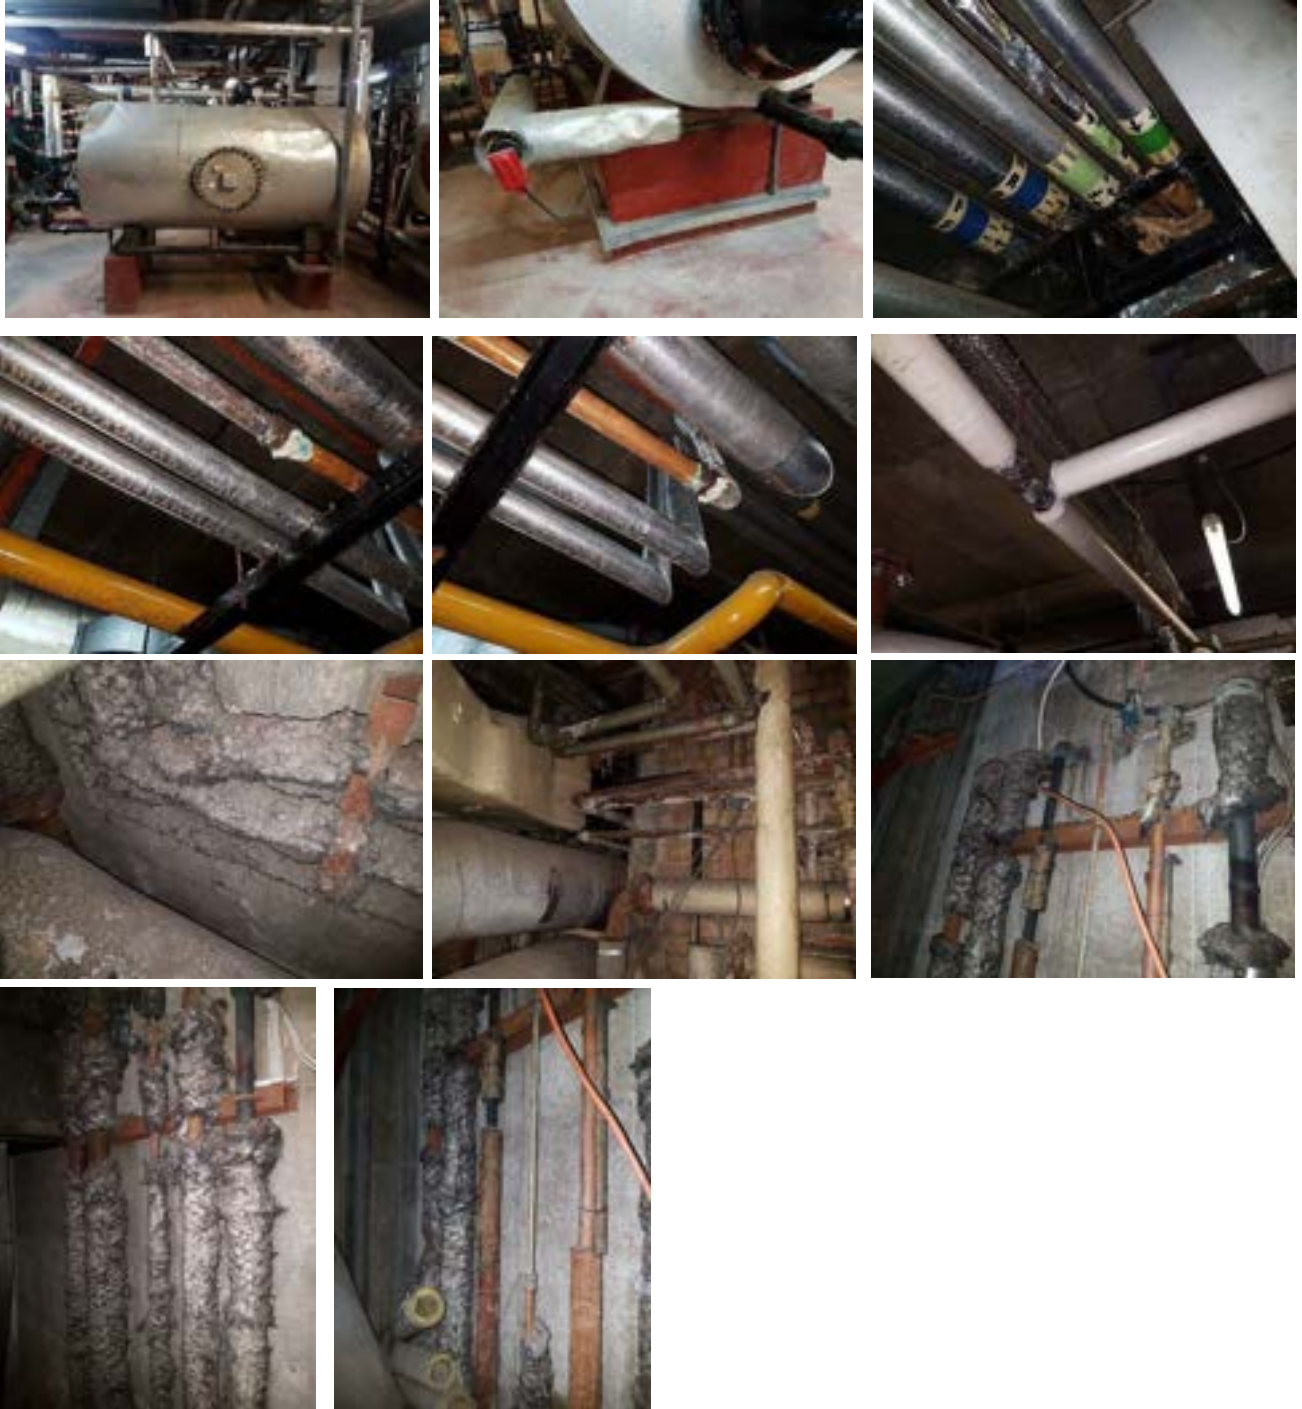
The hot and cold water service insulation around the pumps and at high level is in a reasonable condition and correctly identified. Going into the vertical services riser the thermal insulation is non-existent. Rising vertically, some existing pipework has been re-used and the insulation consists of loose rockwool with a chicken wire covering until this finishes although un-installed glass fibre sections appear to have been planned for these pipes.

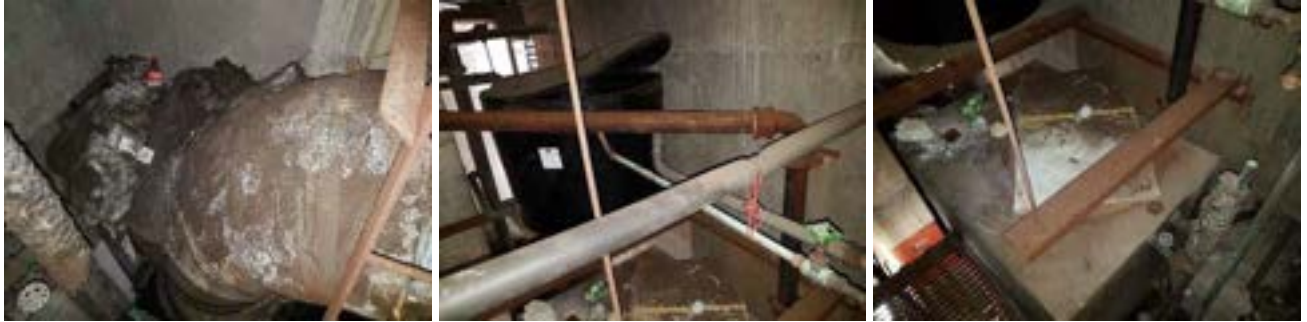
A large circular duct at the top of the vertical services riser has become a rubbish trap. The previously discussed heating feed and expansion tank, note the mains cold water supply to this supported by a piece of red wire and the old galvanised steel feed and expansion tank.

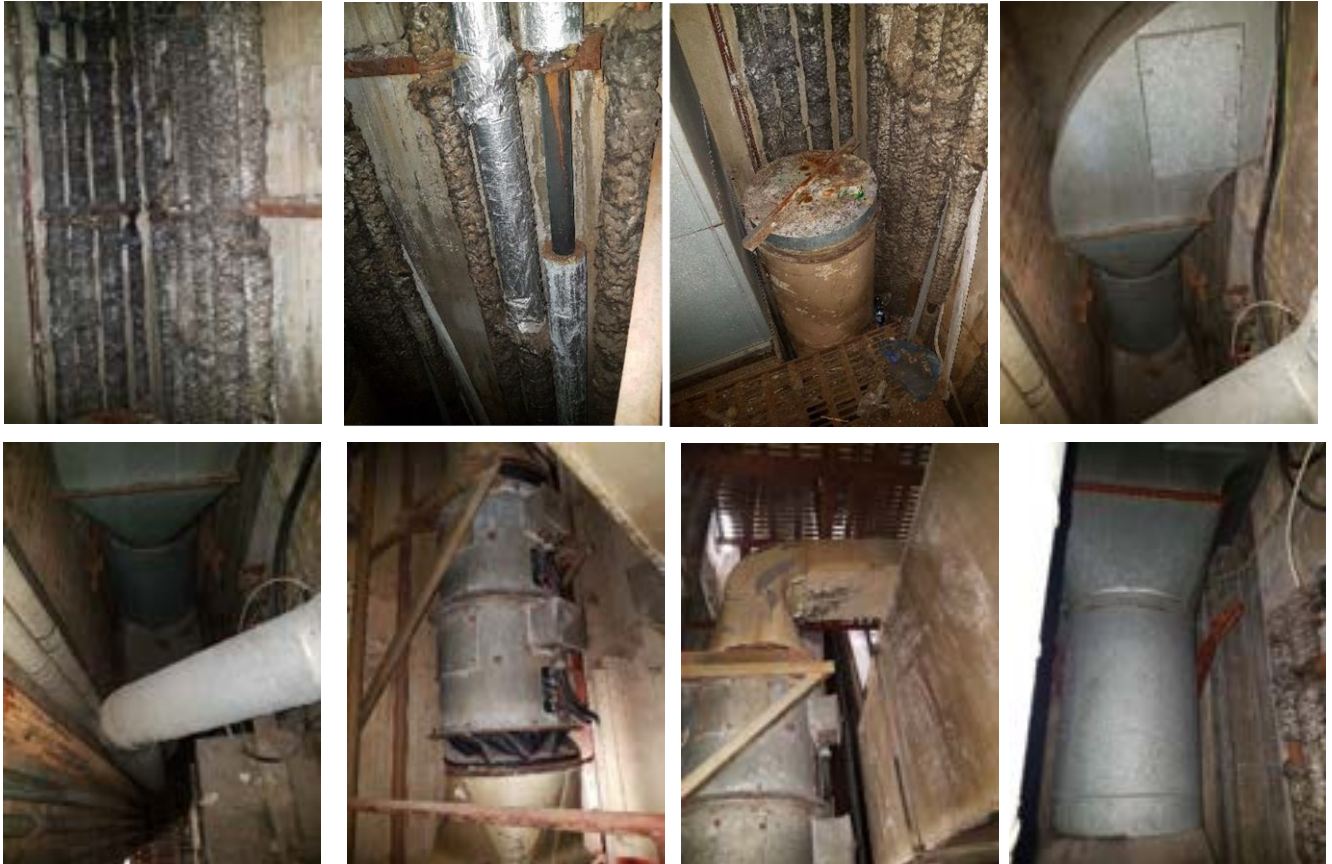
Within the vertical services riser are a lot of life expired and redundant pipework and ductwork services as well as a few live ones. Trying to differentiate between these is almost impossible due to lack of identification.

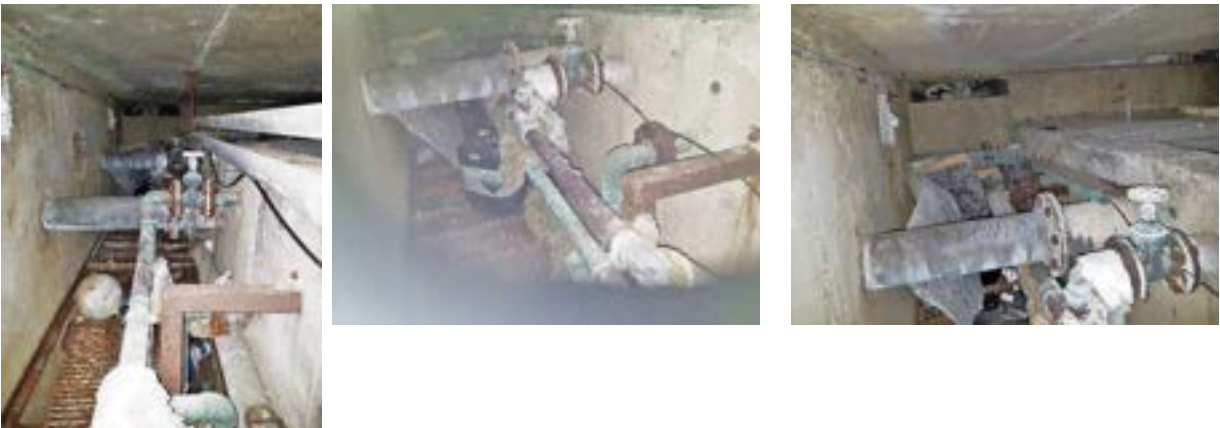
The two mains cold water supplies where they connect to the ball valves in the tanks.
The rotten walkway, the abandoned and rubbish materials including chemicals. The level of dust and dirt presents a serious health hazard and the area must be considered a confined space.

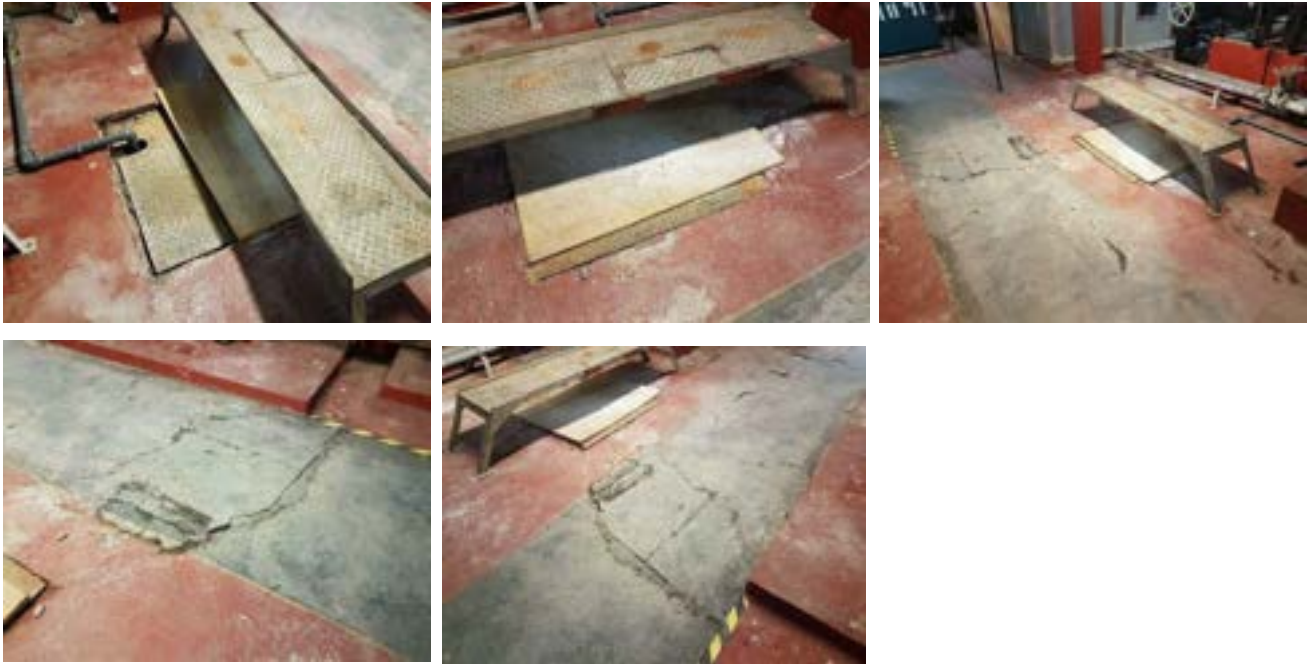
There is a pumped sump in front of the pool heat transfer equipment. The fitted cover plate is loose and has been over covered with a thin sheet of plywood which itself is protected with a step-over block.

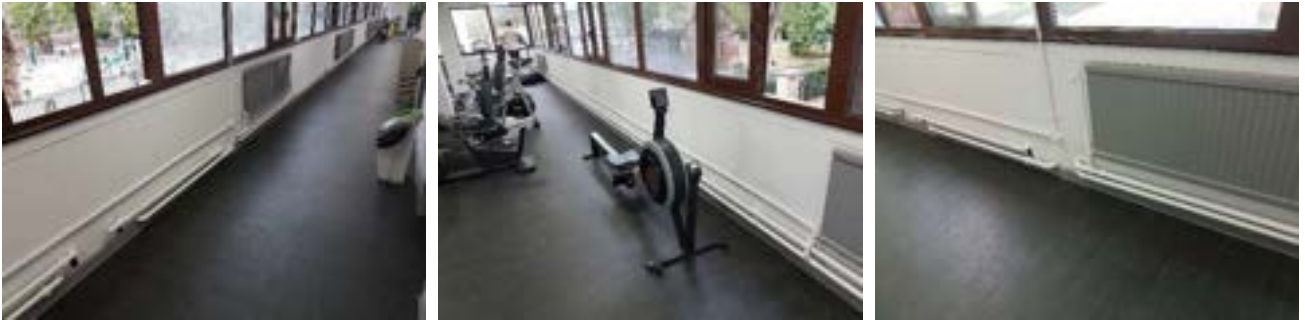
The tubular heating coil at the east end of the teaching pool and the leg that sits at high level on the east wall. The corrosion of this heating coil is very bad.

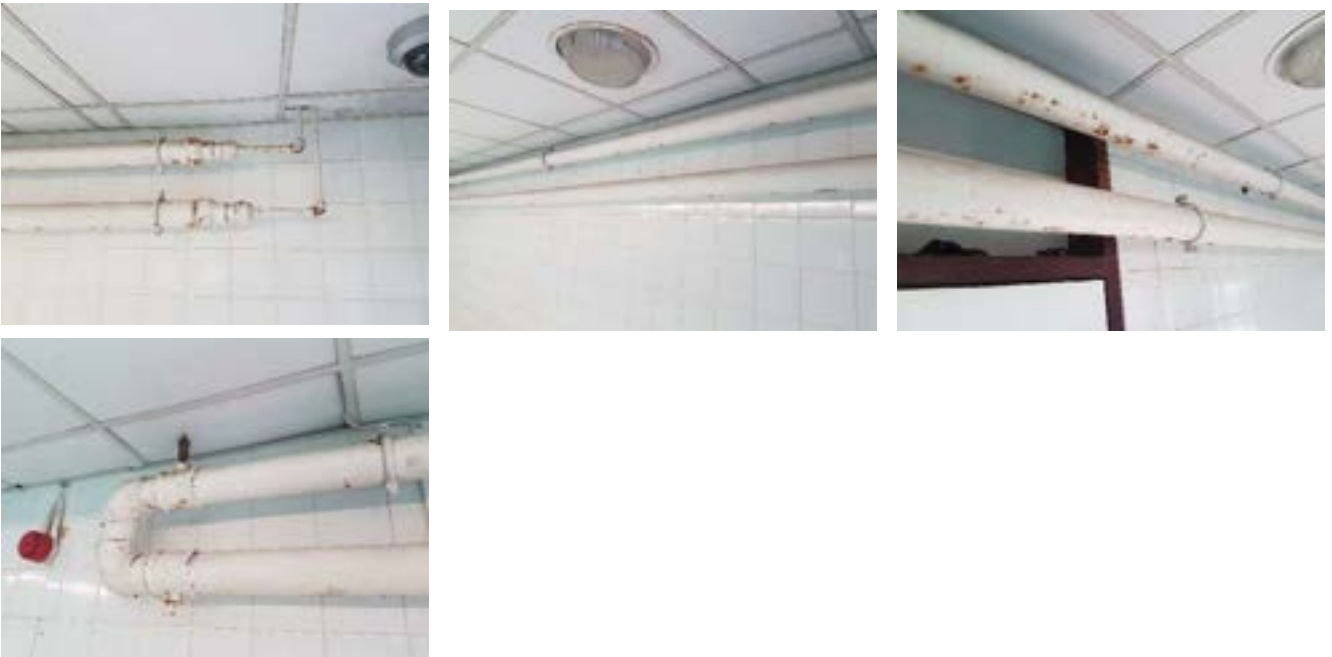
The tubular heating coil at the east end of the teaching pool and the leg that sits at high level on the north wall. The corrosion of this heating coil is starting to appear.

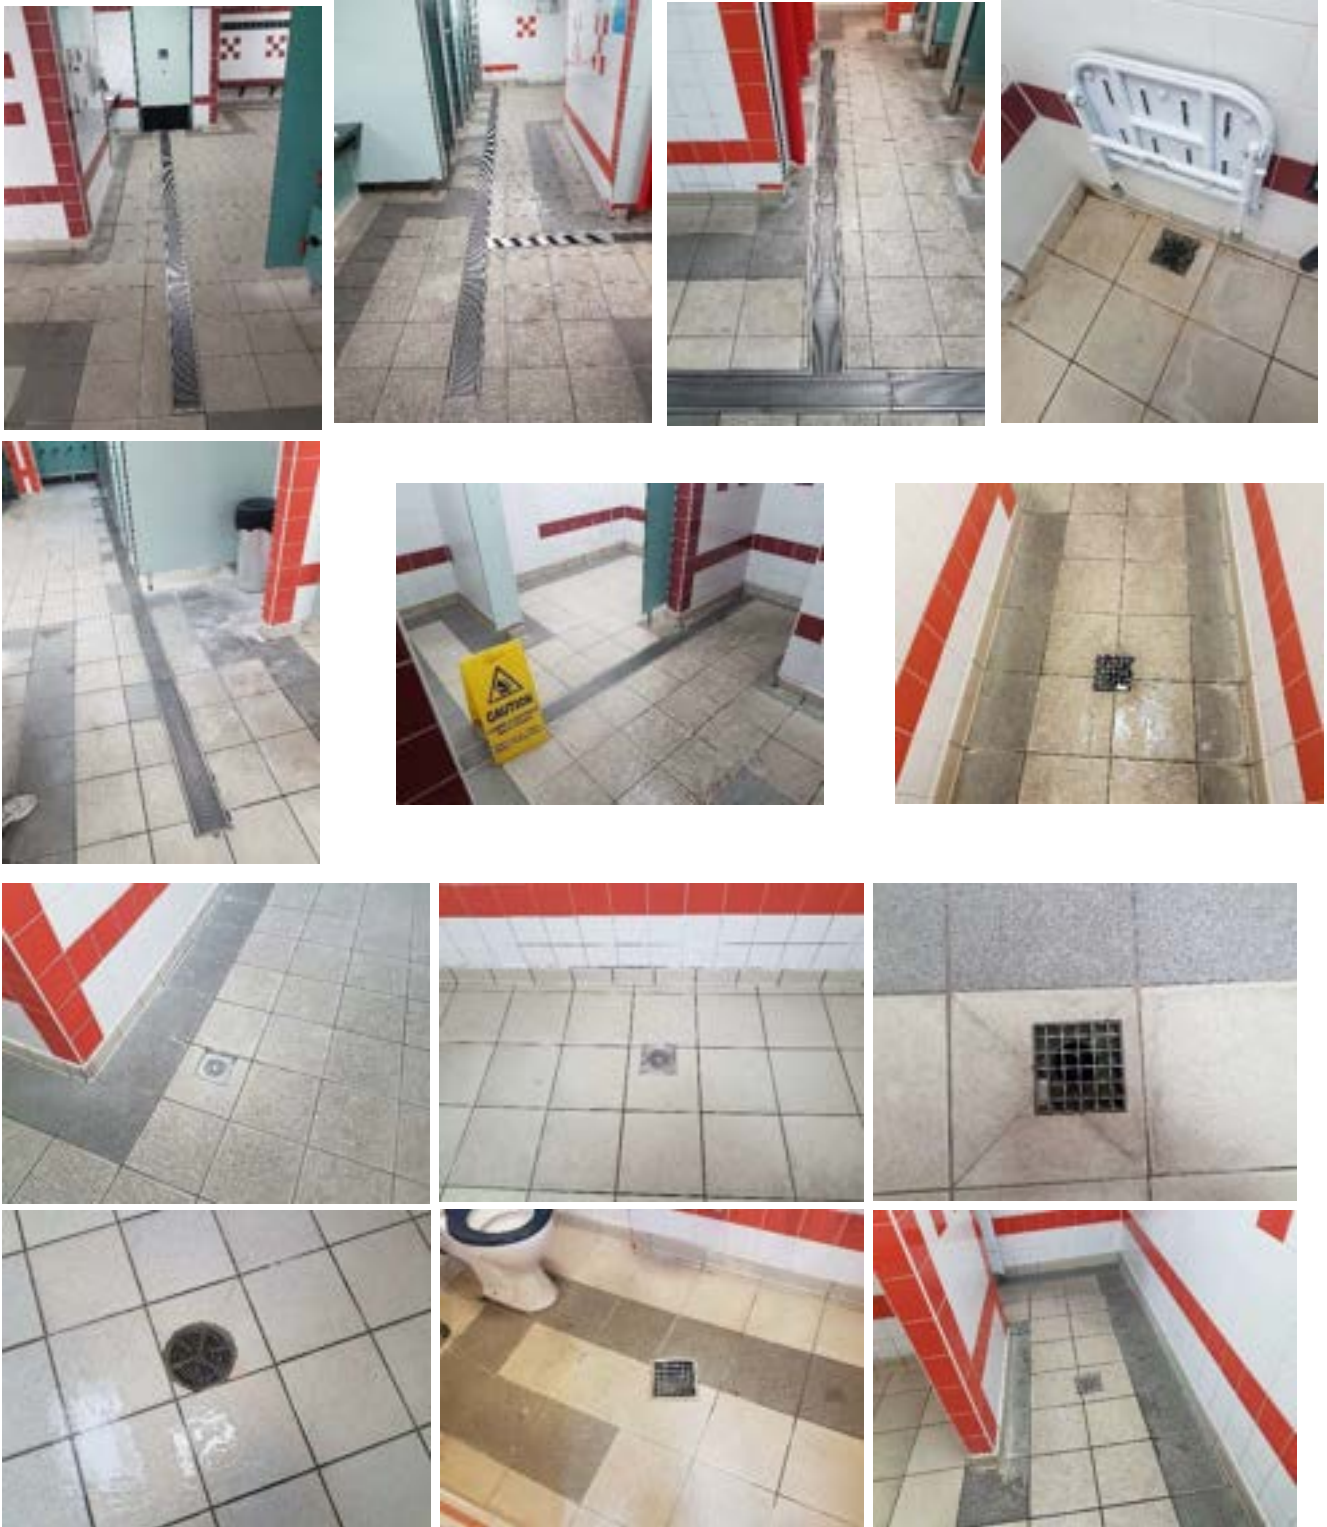
A selection of the floor channel's and gullies around the various changing rooms and toilets. None of these show any sign of having been opened for cleaning and looking inside them (too difficult to photograph) the build-up of debris and dirt is significant.

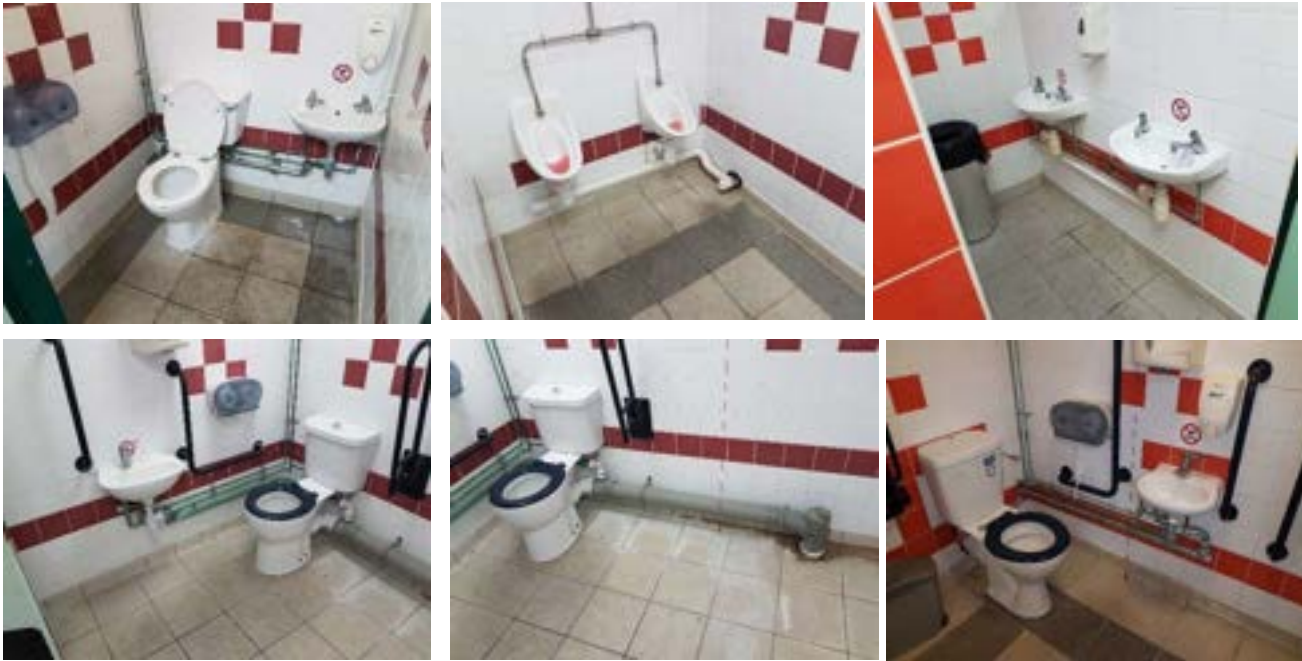
A selection of wc pans and wash hand basins drain connections showing a few leaks and generally tired.

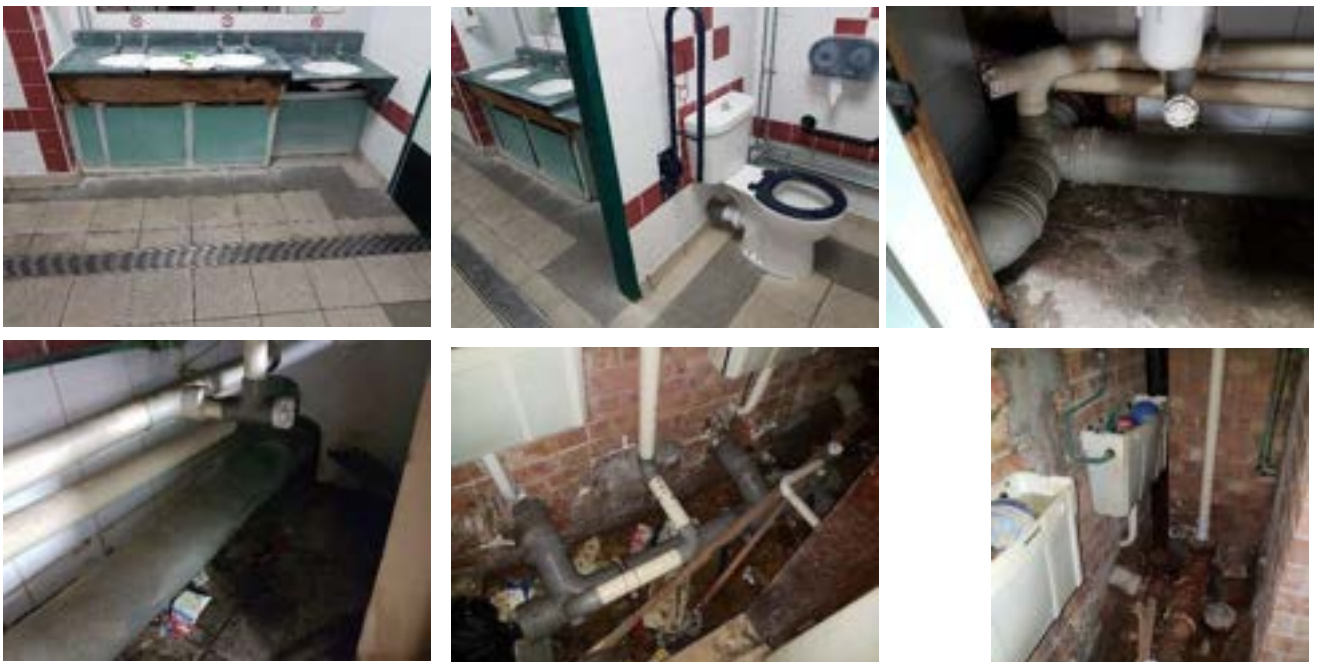
There are a number of locations where we fear the 4" soil and vent pipe has been overloaded. The wash hand basins and the wc pan along with three more wc pans and wash hand basins connect into the same stack. It is also of note that the stack appears to be fitted with undersized vents and there is a disused stack with an old, smaller branch connection still installed but not sealed.

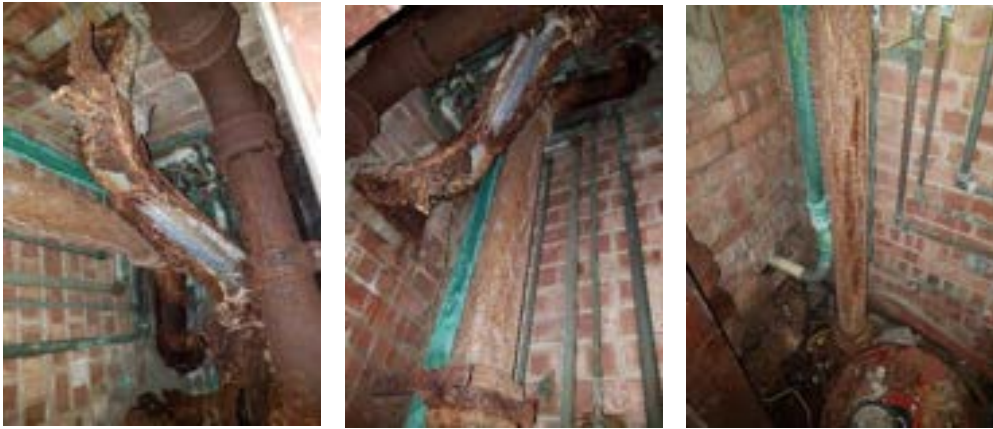
Within the riser there is another drain that enters from above and drops to low level. The pipe is in an atrocious conditioning and de-laminating and it is our considered opinion it is near the point of complete failure.

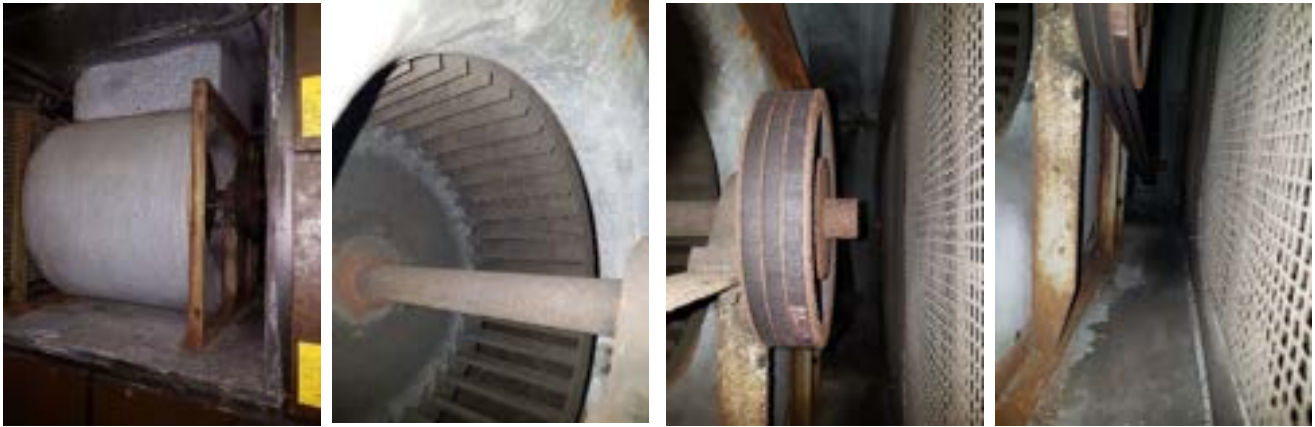
The return air/exhaust fan. There is a high level of surface corrosion and the fan impeller is very dirty and appears never to have been cleaned. The fan belts appear to be relatively new and are in a sound condition.
