Condition Survey & Report
for the
**Mechanical & Electrical
Services Installation**
at
St Georges Swimming Pool
221 The Highway
London, E1W 3BP

Report produced for
**London Borough of Tower
Hamlets**
Technical Services Team
2nd Floor (Annexe)
Mulberry Place
5 Clove Crescent
London, E14 2BG

Reference	21012-CSR-101a
Prepared by	S Godden
Date	November 2021

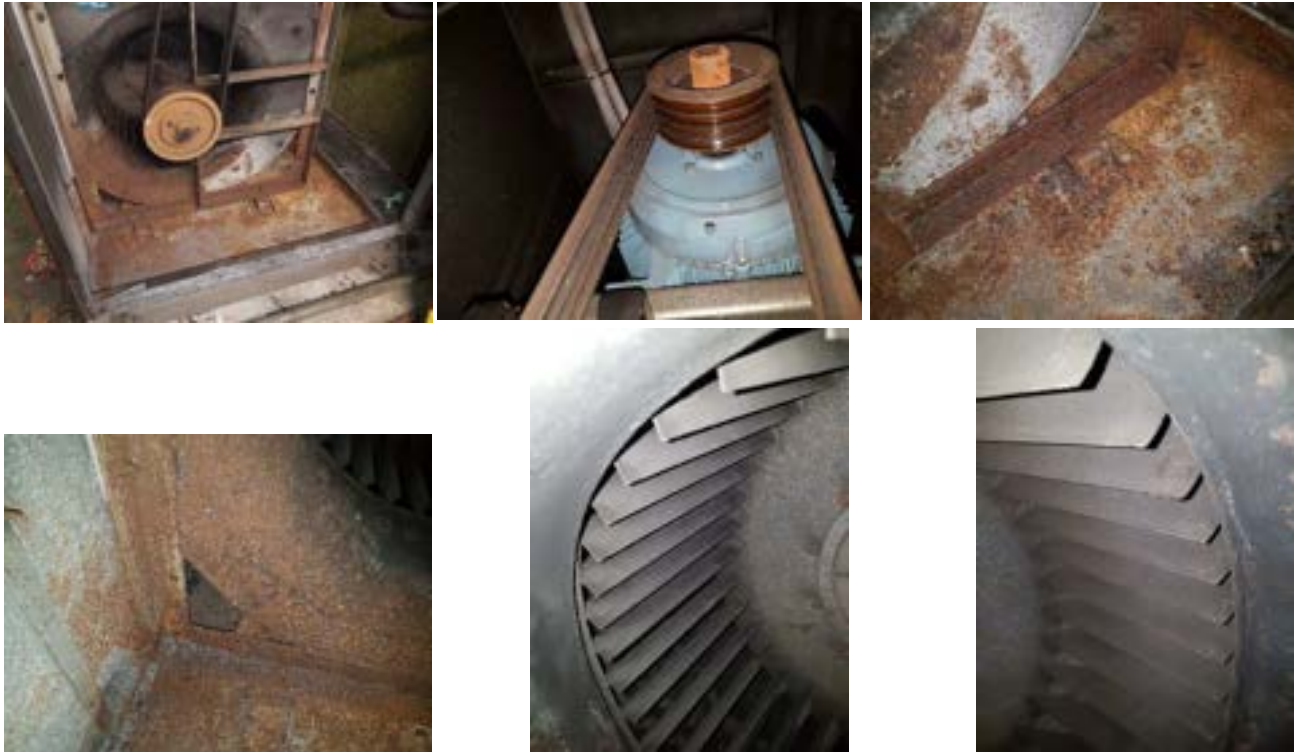
The supply air/fresh air fan illustrating the corrosion around the fan and casing and the general casing of the air handling unit. The fan impeller is very dirty and appears never to have been cleaned.

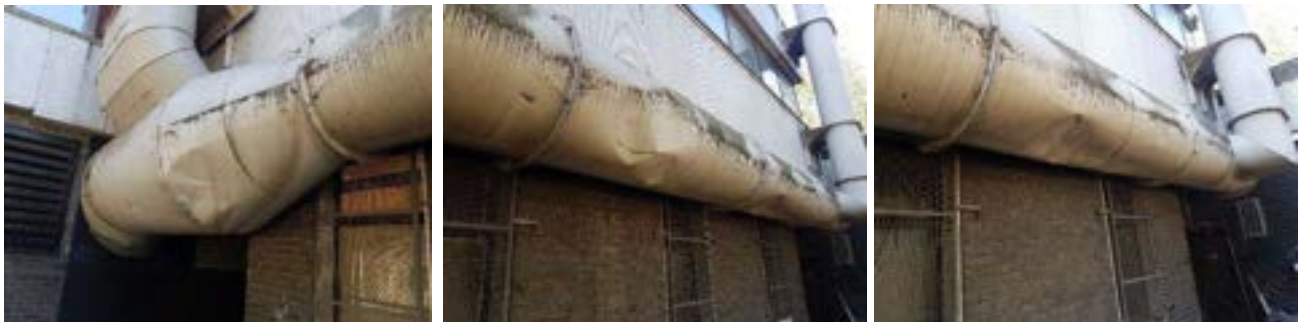
The main pool supply air ductwork as viewed from the car park to the north of the building. The duct has been impacted by a number of high vehicles in the past. It is not possible to establish if this has damaged to ductwork beyond the thermal insulation but it has certainly damaged the integrity of the insulation protection and let in water which will have compromised the quality of the thermal insulation.

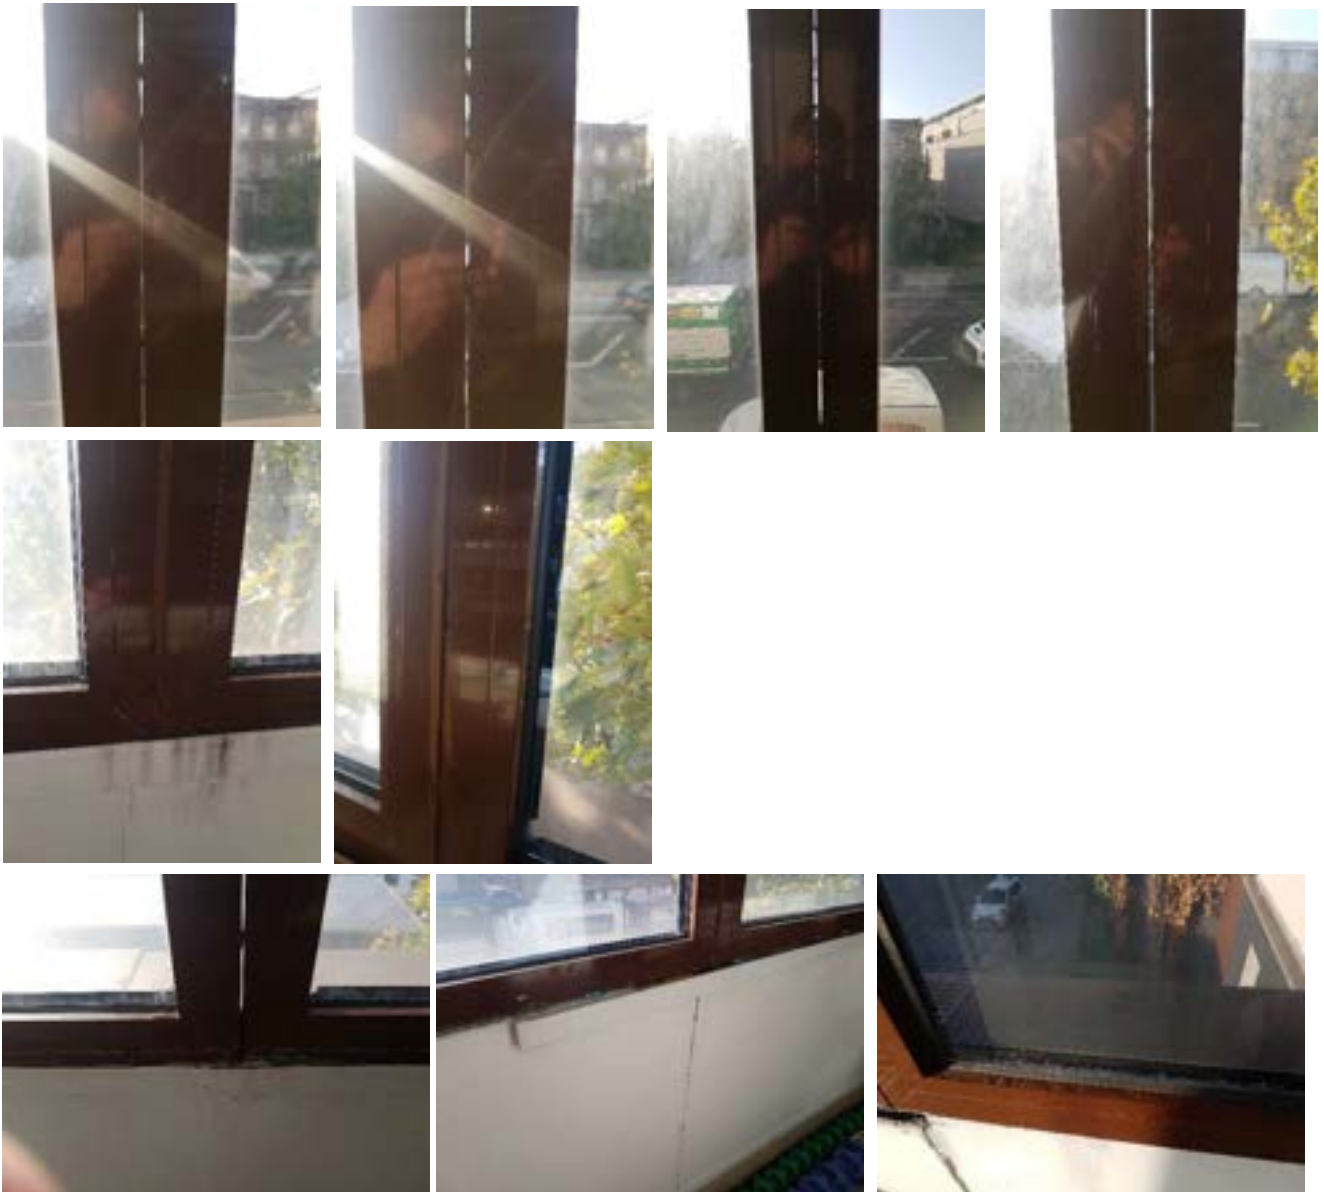
Our attention was drawn to the windows on the south face of the building at first floor main pool hall level. The windows are double glazed sealed units most probably installed as a part of the 2008 refurbishment. The windows are aluminium frames supporting the sealed units. The gap between the aluminium frames have been filled with a mastic sealant that we presume should expand or shrink to accommodate the expansion or contraction of the metal window frames.

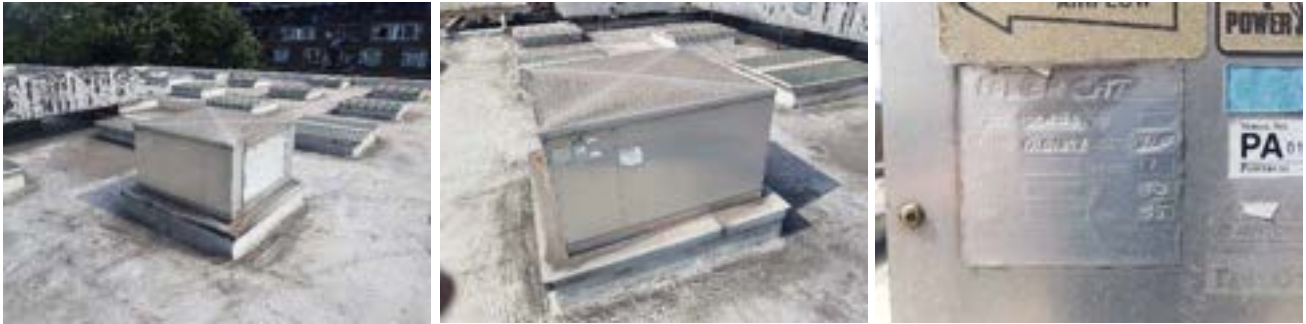
The curb mounted twin extract fan believed to be the extract from the first floor changing rooms.
The fan is non-operational and requires replacement.

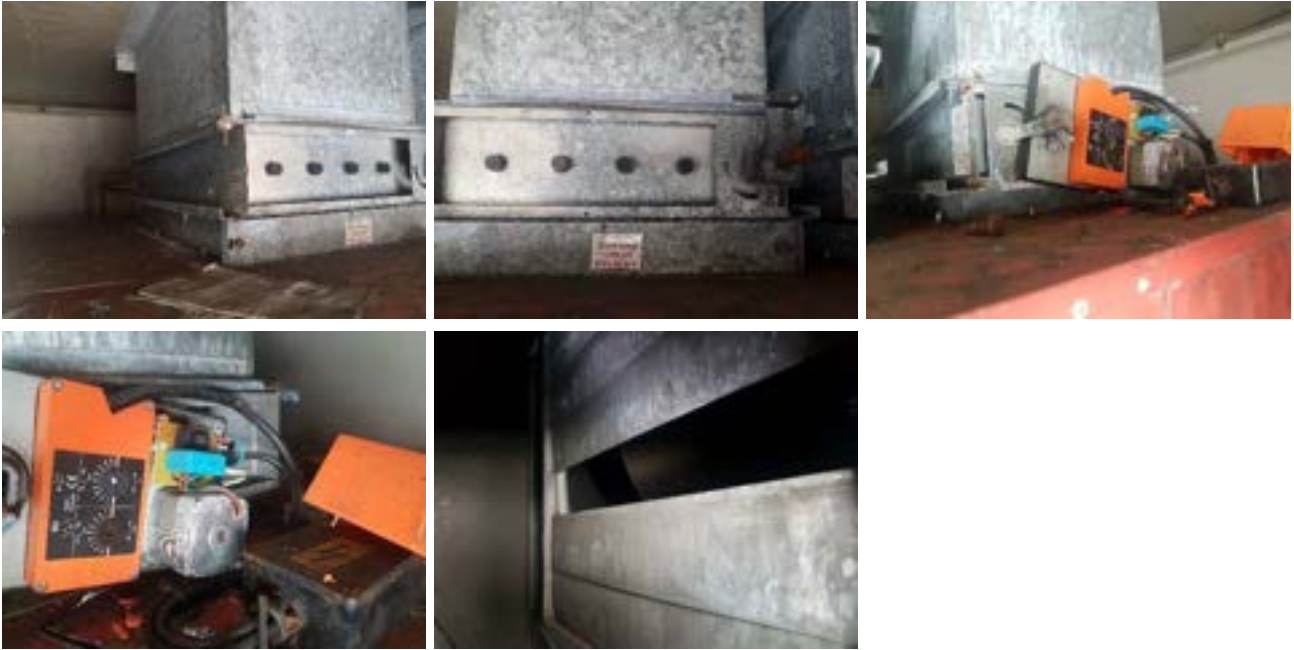
The fresh air intake damper and the extract air exhaust damper. These dampers are designed to work in unison in order to match the level of fresh air against the level of exhausted air. The dampers are both seized fully open and the damper actuator disconnected. The recovered heat by-pass is a simple mechanical flap damper but one of the flaps is missing.

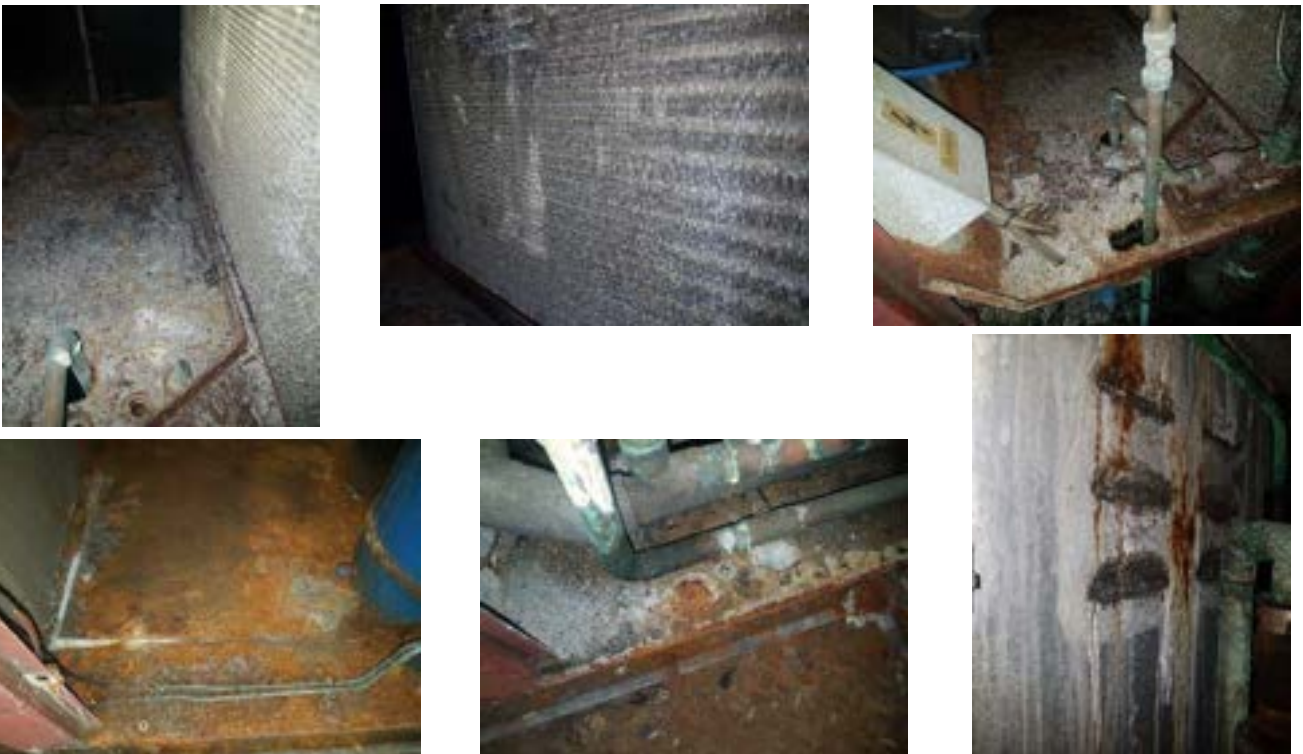
The general level of corrosion inside the heat recovery air handling unit is some of the worst we have ever seen and is mainly the result of warm, wet return air meeting the cold GRP plantroom housing.

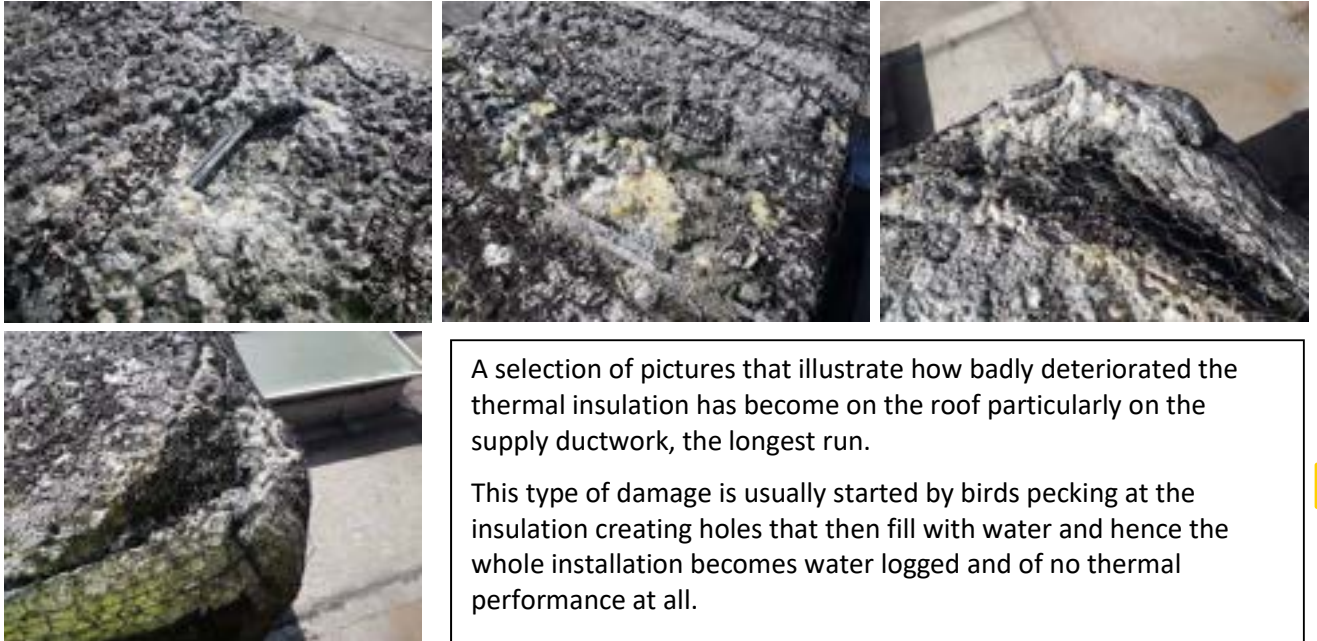
A selection of pictures that illustrate how badly deteriorated the thermal insulation has become on the roof particularly on the supply ductwork, the longest run.

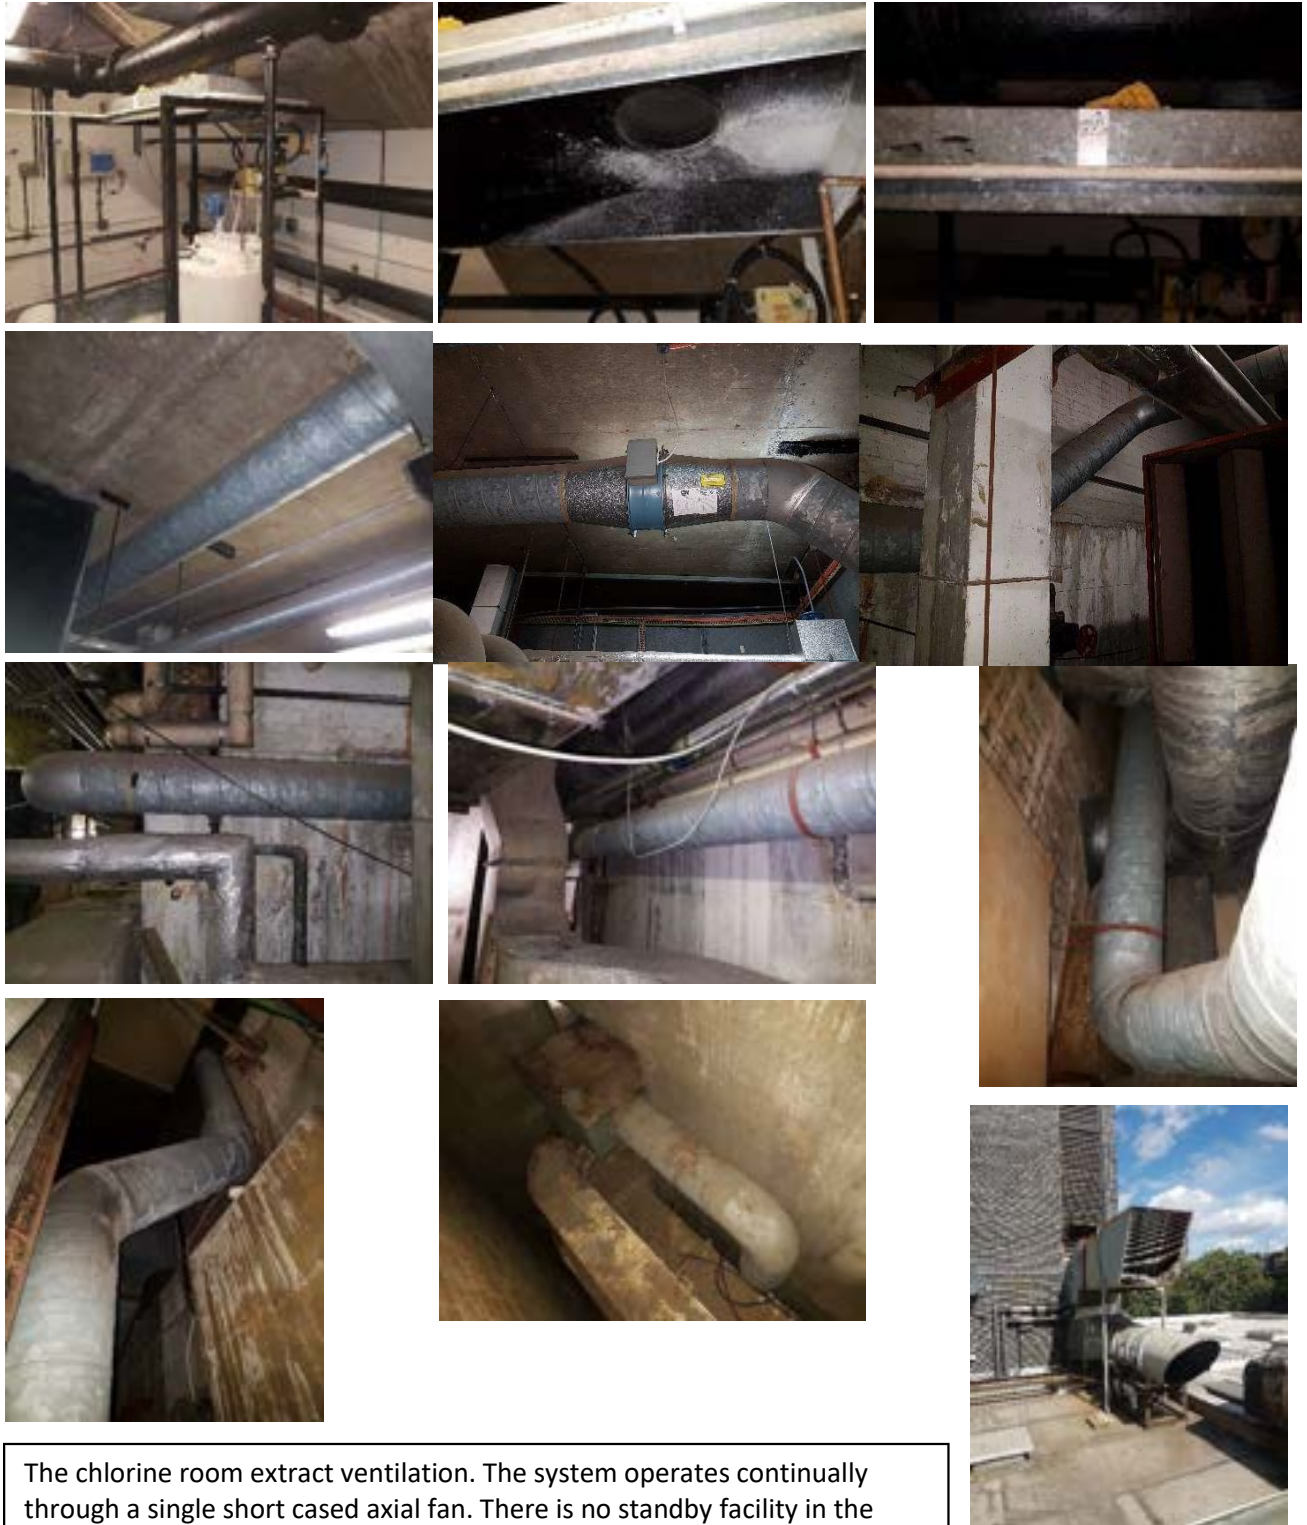
The chlorine room extract ventilation. The system operates continually through a single short cased axial fan. There is no standby facility in the event of fan failure. The LEV (Local Exhaust Ventilation) certification appears to be up to date. The chlorine room ventilation terminates out of the vertical services riser just visible above the original pool hall extract ventilation outlet.

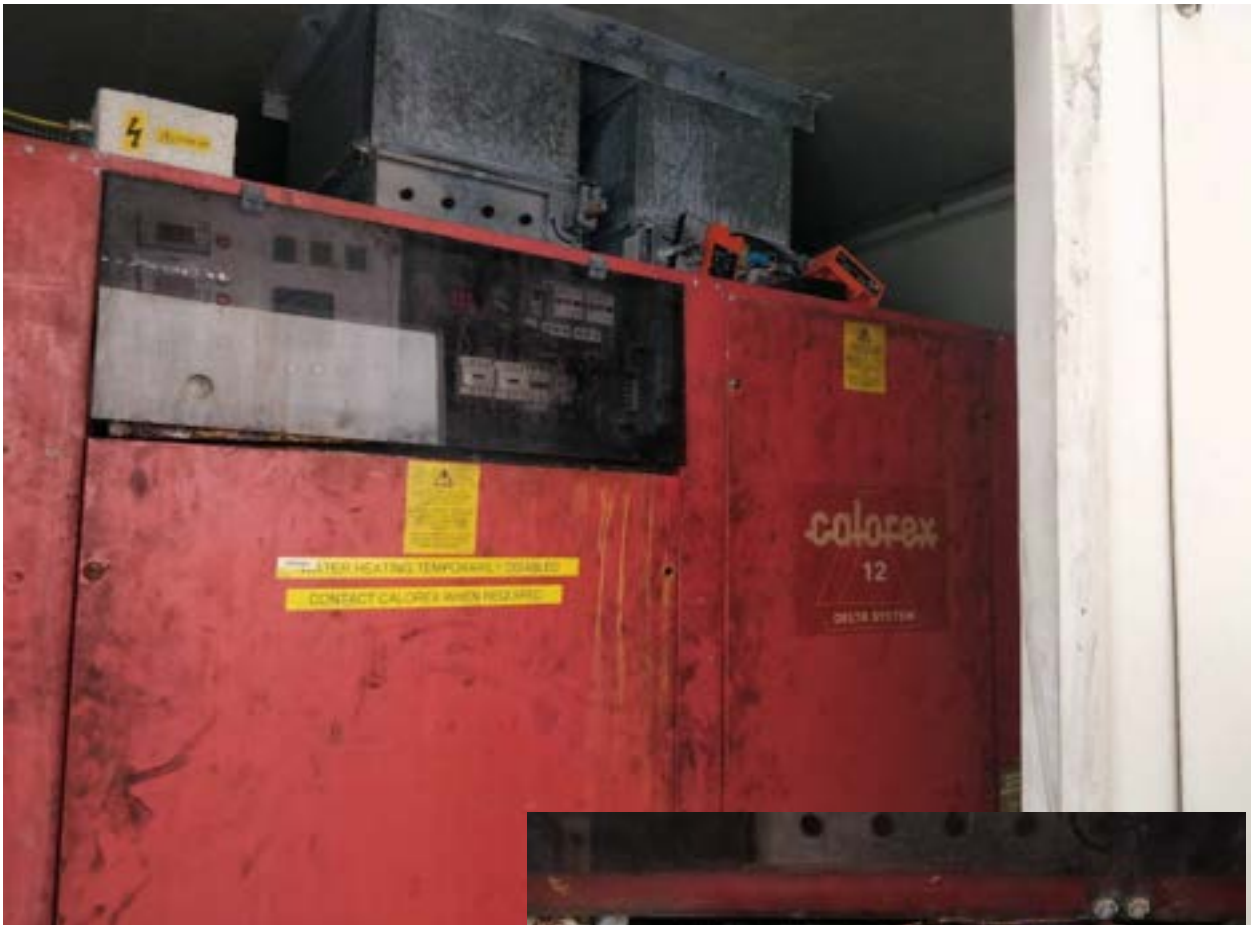
The small Pool Calorex unit located on the first floor roof has independent controls which are in terrible condition - these have been corroded also the heating actuator has been broken off allowing no control

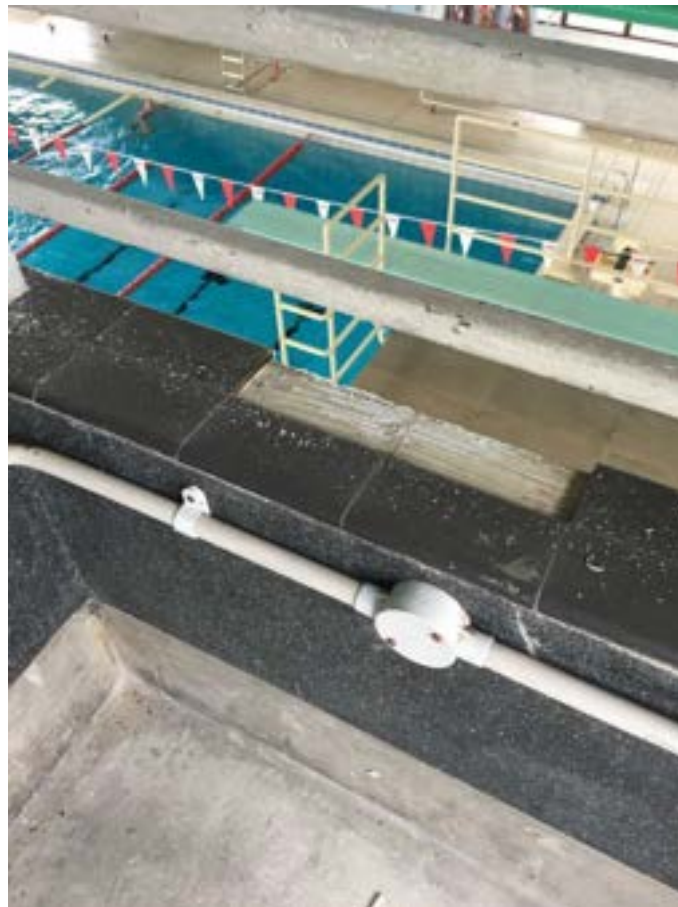
Fig 4.4.7 – The photo above was taken within the main pool area on the second-floor galleries showing a close-up view on the existing broken / missing tiles on the gallery parapets.

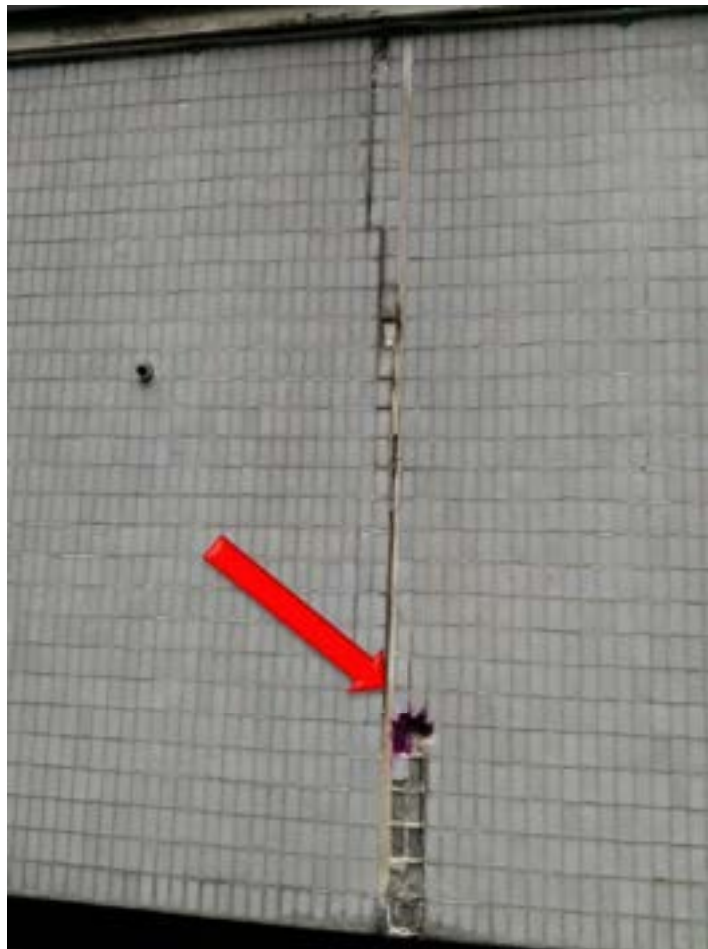
Fig 5.1 – The photo above shows a typical example of potential tile shelling at movement joint in the facade.

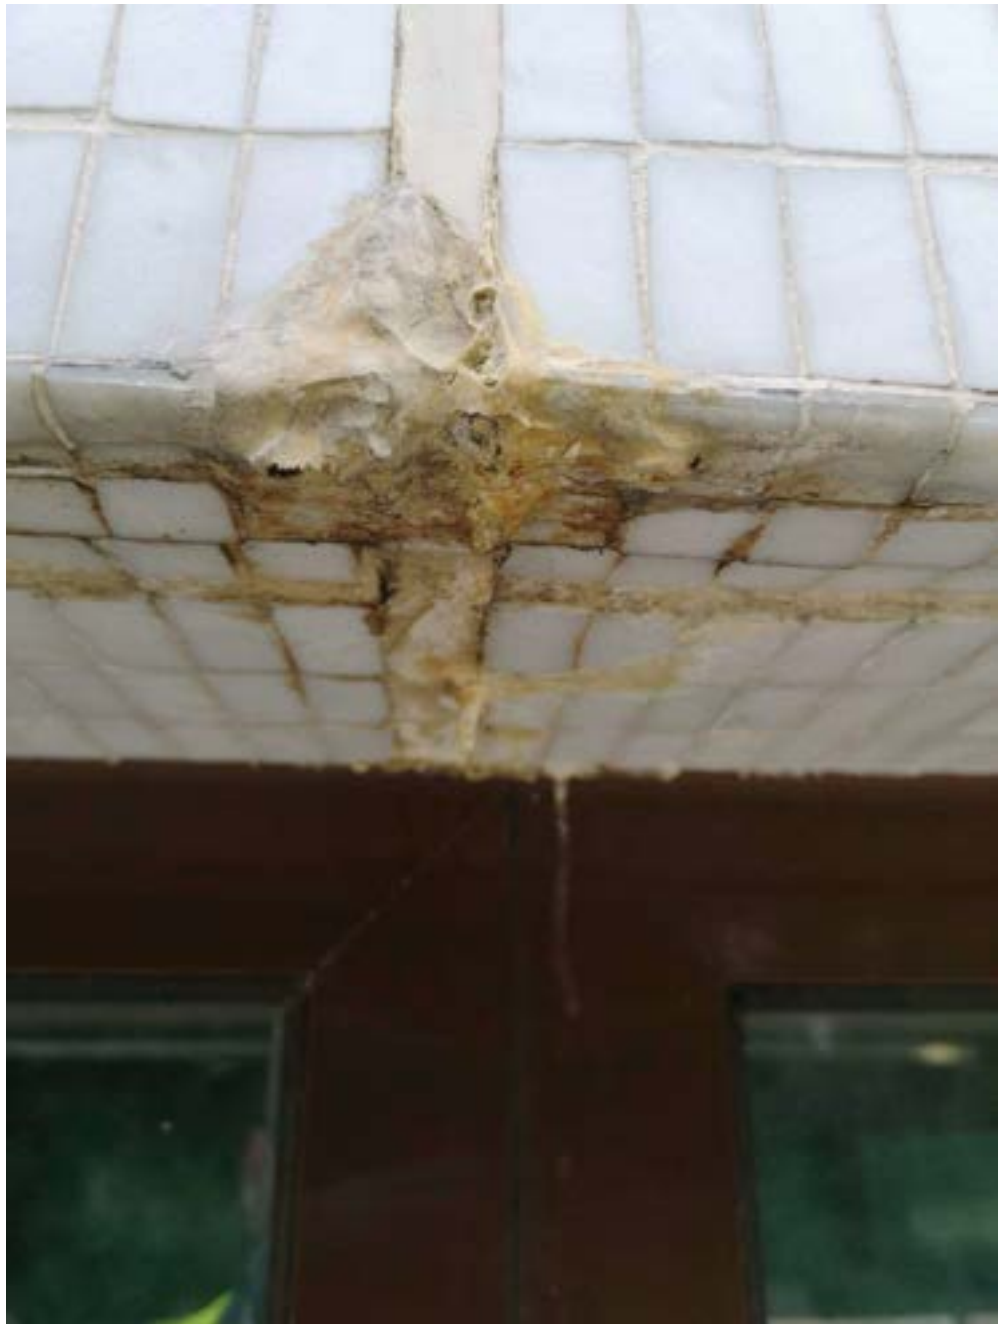
Fig 5.2 – The photo above shows a typical example of potential tile shelling at movement joint in the façade and an historic repair.
