Condition Survey & Report
for the
**Mechanical & Electrical
Services Installation**
at
St Georges Swimming Pool
221 The Highway
London, E1W 3BP

Report produced for
**London Borough of Tower
Hamlets**
Technical Services Team
2nd Floor (Annexe)
Mulberry Place
5 Clove Crescent
London, E14 2BG

Reference	21012-CSR-101a
Prepared by	S Godden
Date	November 2021

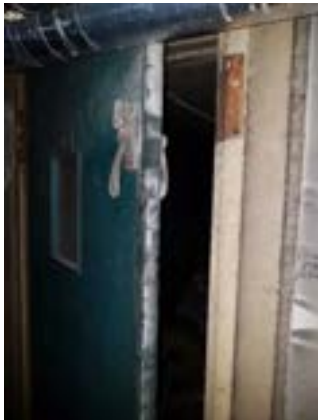
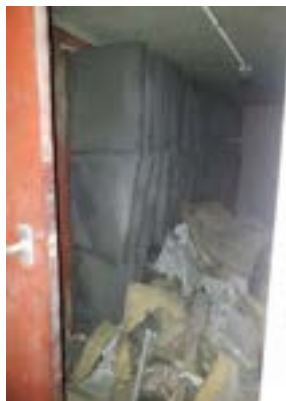
It appears that fresh air was originally drawn from a room sealed plenum located on the north wall of the basement plantroom. Although it is inaccessible a view through the doors indicate there are still some bag filters in a frame in there along with a lot of general rubbish.

A view of the pressure sealed door to the original fresh air intake plenum along with a view of the remaining bag filters and the accumulated general rubbish.

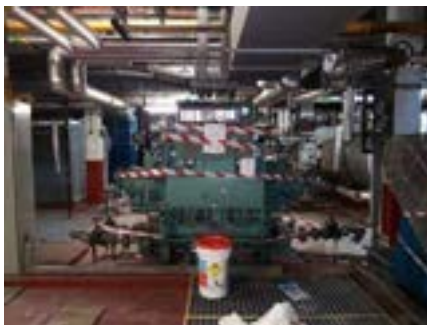
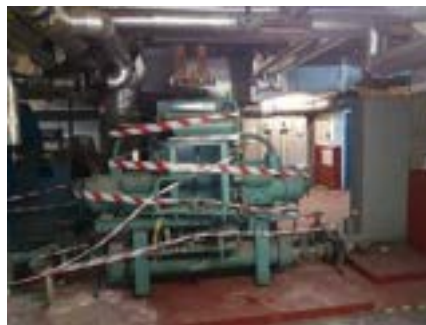
The old York air cooled liquid chiller in the basement plantroom where it has been left disconnected and abandoned. The evaporator shell and tube and flow and return valved pipework connections are clearly visible.

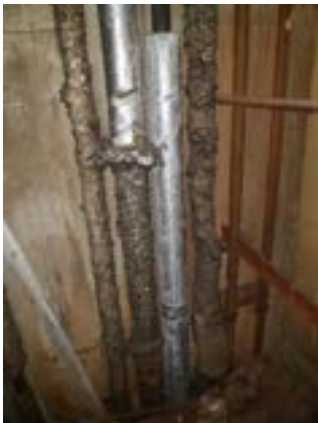
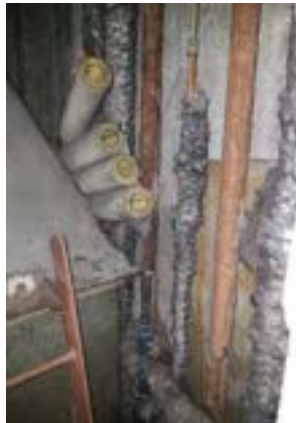
Evidence of where the original mains cold water, cold water down and hot water service pipework is still in use.

It is interesting to note the mixture of pre and post 2008 insulation on the pipework and the post 2008 insulation that was never fitted to re-used hot water service pipework.

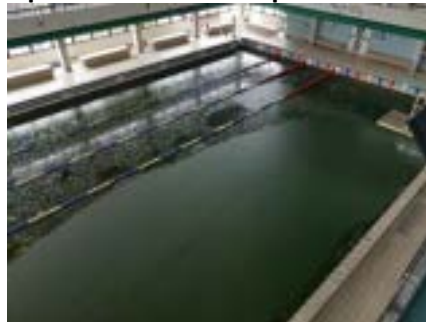
The result of this action is that the main swimming pool has experienced serious damage from a very heavy algae growth across the complete surface of the pool.

The main swimming pool as observed from the 3rd Floor Viewing Gallery.

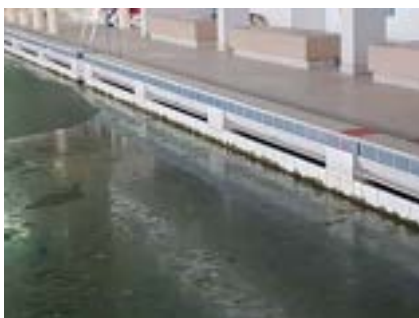
The densely growing algae growing up the wall on the north side of the pool where it is in the sunshine from the south facing windows on The Highway side of the pool. There is very little growth on the south wall of the pool where the wall is in shade from the sunlight.

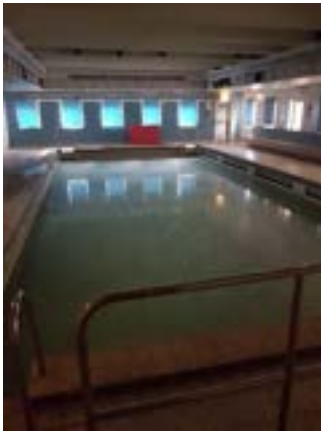
The water in the smaller Teaching Pool is discoloured but is showing no signs of the heavy algae growth seen in the main pool. This is most probably because the blinds have been left down and restricted the direct sunlight onto the pool water.

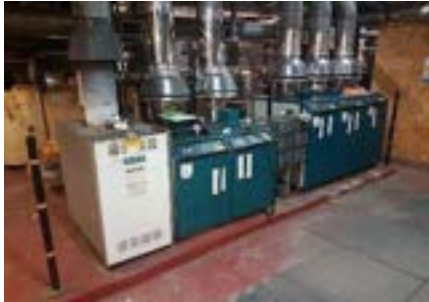
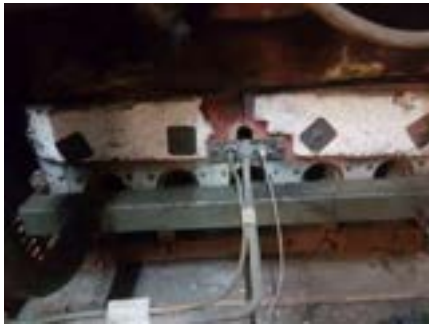
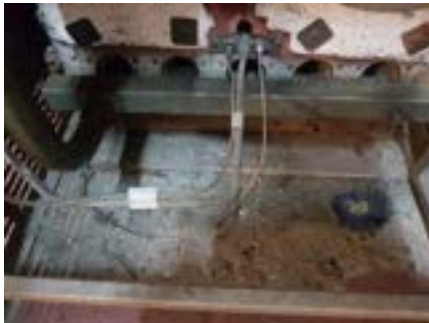
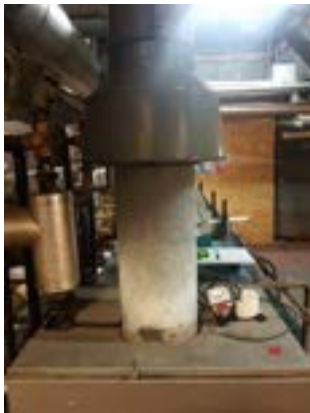
1	Building	Basement Plant Room	Condition
2	Description	Boiler No 1	
3	Manufacturer	Hamworthy	
4	Type	Atmospheric Gas	
5	Model	UR 365	
6	Serial No	Not Known	
7	Date	Not Known (circa 1980)	
8	Duty (input – kW)	101.40	
9	Duty (Output – Kw)	79.20	
10	Flow & Return - mm	50	
11	Min Flow Rate – l/s	Not known	
12	Gas - mm	20	
13	Gas Consumption – m ³ /hr	Not Known	
14	Flue - mm	200	
15	Dimension – H x W x D	1010 x 535 x 1008	
16	Weight – kG (dry)		
17	Power Supply – V/Ph/Hz	240/1/50	
18	Power Rating - A	5.00	
19			
20	Operational Condition	Boiler non-operational – Life expired	O - X
21	Lifecycle Assessment A		E
22	Lifecycle Assessment B		E
23	Notes		
<p>Dangerous – Do Not Use label attached dated 25 October 2012</p> <p>Last maintenance – 24 August 2011</p> <p>Part of casing missing</p> <p>Burners badly corroded</p> <p>Lower casing badly corroded</p> <p>Parts missing</p> <p>Flue overheated (galvanised finish burnt)</p> <p>LPHW pipework still connected – losing heat</p>

Missing casing
Dangerous – Do No Use label
Last Maintenance
Damaged Burner
Corroded lower casing
Damaged flue

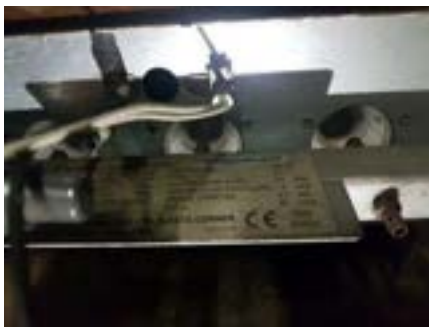
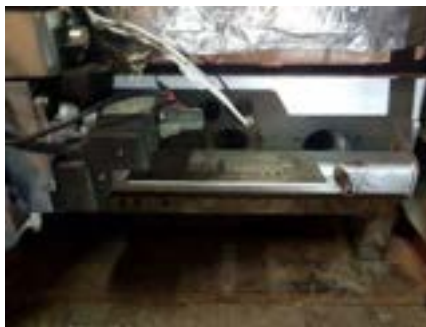
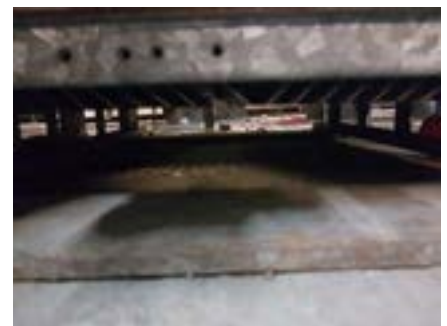
Boilers 2 & 3 have very clean burners and are clear of any major debris beneath.

The known problem areas with these boilers is the failure, and often seizure, of the nylon bearings on the flue standing loss damper. On boilers 2 & 3 these are intact and in a reasonable condition.

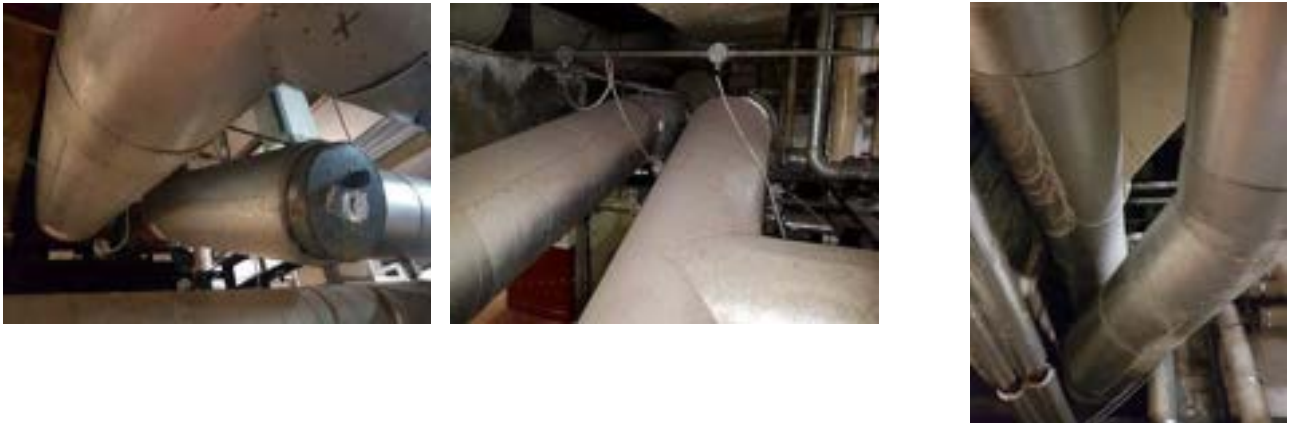
1	Building	Basement Plantroom	Condition
2	Description	Boiler Flue System	
3	Manufacturer	Not known	
4	Type	Galvanised Sheet Steel into Stainless Steel twin wall vapour sealed	
5	Serial No	N/A	
6			
7			
8			
9			
10			
11			
12			
13			
14			
15			
16			
17			
18			
19			
20	Operational Condition		B
21	Lifecycle Assessment A		C
22	Lifecycle Assessment B		F
23	Notes		
Galvanised sheet steel not best suited to use as boiler flue Flue system showing minor water stains from leaks Flue system generally sound

The two common header flues turning towards the vertical services riser
The two common flues rise slightly into the vertical services riser
The vertical flues within the vertical services riser

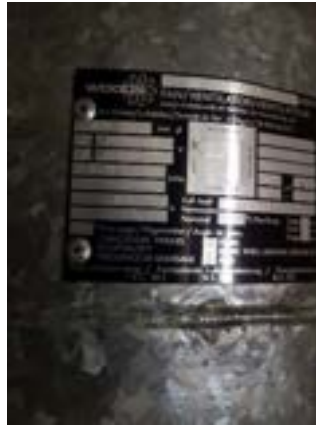
1	Building	Basement Plantroom	Condition
2	Description	Flue Dilution Fan 1	
3	Manufacturer	Woods of Colchester	
4	Type	Direct Drive	
5	Serial No	JN 0257/1	
6	Filters (No. x size)	N/A	
7	Fans (Model)	Woods J Type Long Case Axial	
8	Fans (Type)	Galvanised Steel Case 320°C Bifurcated Axial	
9	Motor (Model)	Not Known	
10	Motor (Type)	Out of Airstream	
11	Motor (Voltage x Phase x Hz)	415/3/50	
12	Motor (Current Amp)	1.0	
13	Belts (No. x Type)	N/A	
14	Fan Controller	D.O.L.	
15	Fan Changeover	From Control Panel	
16	Fan Casing (Internal)	Galvanised Mild Steel	
17	Fan Casing (External)	Galvanised Mild Steel	
18	Duct Connections (mm dia)	300	
19	Duct Connections (Integrity)	Direct flange	
20	Operational Condition	Fan operational	B
21	Lifecycle Assessment A		C
22	Lifecycle Assessment B		E
23	Notes		
Signs of gaseous leaks on dried out flange gaskets Fan noisier than expected

The two Woods of Colchester galvanised steel cased bifurcated flue dilution axial fans at high level
The motor plates on the bifurcated axial fans

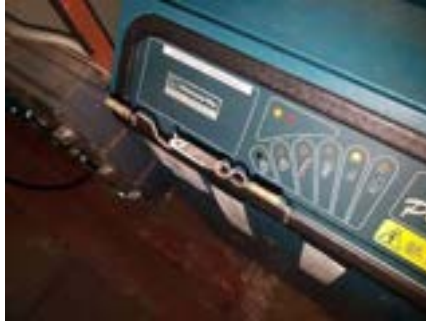
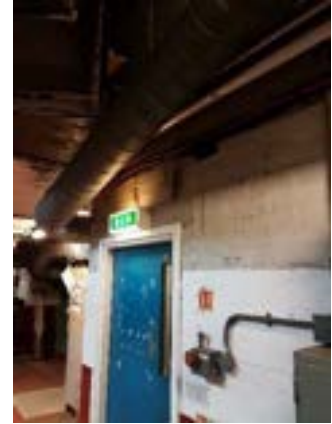
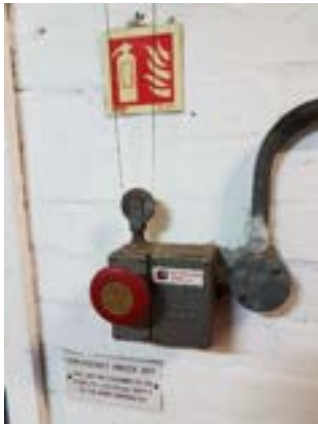
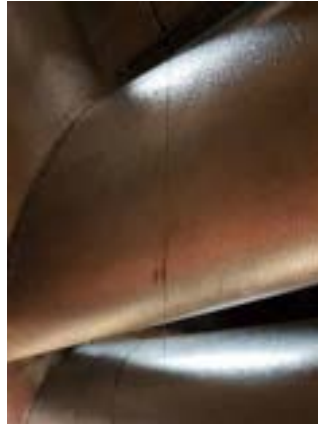
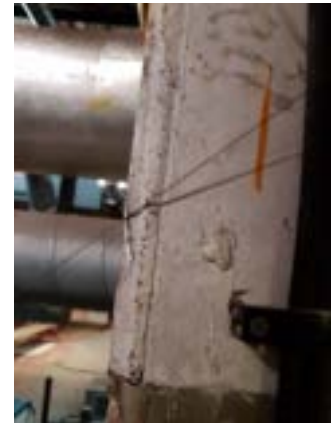
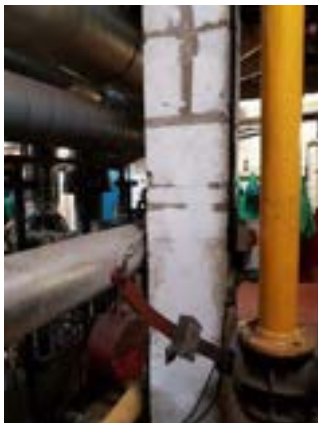
1	Building	Basement Boiler Room	Condition
2	Description	Gas Safety System - Mechanical	
3	Manufacturer	Landon Kingsway	
4	Type	Electromec Mk II	
5	Serial No	Not Known	
6	Valve Size - mm	100	
7			
8			
9			
10			
11			
12			
13			
14			
15			
16			
17			
18			
19			
20	Operational Condition		
21	Lifecycle Assessment A		D
22	Lifecycle Assessment B		C
23	Notes		
<p>No record of last test</p> <p>No written test procedure</p> <p>Mechanical cable rubs on structural concrete</p> <p>Mechanical cable rubs on flue casing</p> <p>No proof of electric gas safety interlock</p>

The Landon Kingsway mechanical gas safety system. The system has a drop weight on the end of the cable run next to boiler 6. There are bi-metallic thermal links in front of each boiler.

The cable rises to high level and then drops and connects to an emergency knock-off button adjacent to the main plantroom entrance door.

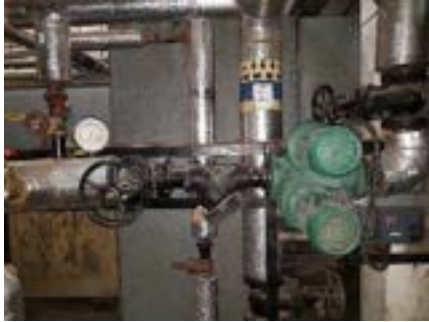
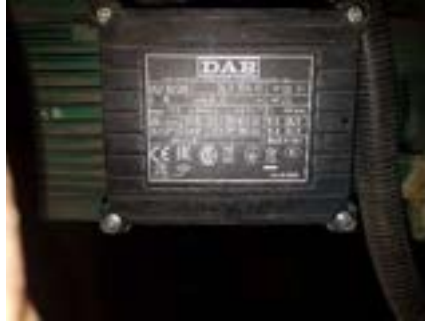
1	Building	Basement Plant Room	Condition
2	Description	Primary Heating Circulation Pump	
3	Manufacturer	DAB Pumps Ltd	
4	Type	Canned Rotor Twin Head Pump	
5	Model	DKLP 80/1200 T	
6	Serial No	6.2014.41	
7	Date	Not Known (2014 ?)	
8	Speed - RPM	2840	
9	Duty – m ³ /hr (design)	45.00	
10	Duty - m head (design)	10.00	
11	Duty – m head (min)	2.00	
12	Duty – m head (max)	11.80	
13	Connections - mm	80	
14	Connection - Type	Solid Flange	
15	Weight – kG (dry)	76	
16	Power Supply – V/Ph/Hz	415/3/50	
17	Power Rating - kW	1.84	
18	Power Consumption - A	6.80	
19			
20	Operational Condition		B
21	Lifecycle Assessment A		B
22	Lifecycle Assessment B		E
23	Notes		
No anti-vibration flexible connections A lot of dust in motor housing (fire hazard) There are no inlet and outlet pressure gauges

The primary twin head circulation pump installed on the common flow pipework and the manufacturers plate

Note the pump has no anti-vibration flexible connections but is protected by an in-line strainer

The pump has no inlet or outlet pressure gauges

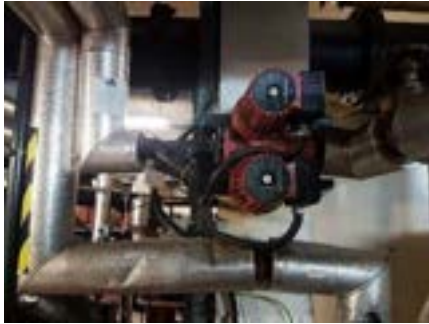
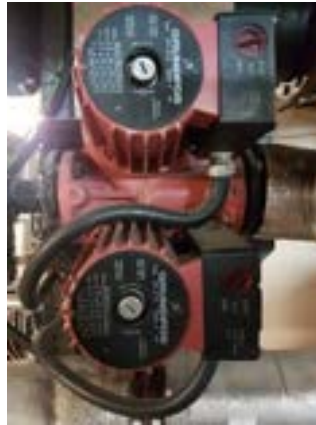
1	Building	Basement Plant Room	Condition
2	Description	HWS Primary Circulation Pumps	
3	Manufacturer	Grundfos Pumps Ltd	
4	Type	Canned Rotor Twin Head Pump	
5	Model	UPCD 40-60-Type A	
6	Serial No	Not known	
7	Date	Not Known	
8	Speed - RPM	2790	
9	Duty – m ³ /hr (design)	Not Known	
10	Duty - m head (design)	Not Known	
11	Duty – m head (min)	Not Known	
12	Duty – m head (max)	Not Known	
13	Connections - mm	40	
14	Connection - Type	Solid Flange	
15	Weight – kG (dry)	Not Known	
16	Power Supply – V/Ph/Hz	415/3/50	
17	Power Rating - kW	0.29	
18	Power Consumption - A	0.64	
19			
20	Operational Condition		B
21	Lifecycle Assessment A		C
22	Lifecycle Assessment B		F
23	Notes		
No anti-vibration flexible connections There are no inlet and outlet altitude gauges

The hws primary twin head circulation pump installed on the flow pipework to the hws calorifier and the pump details

Note the pump has no anti-vibration flexible connections but is protected by an in-line strainer

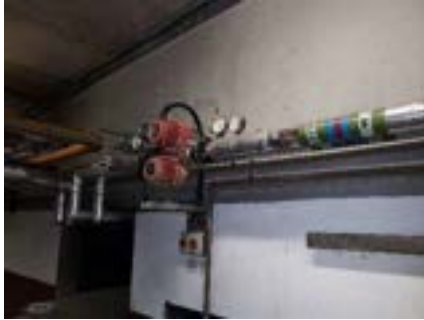
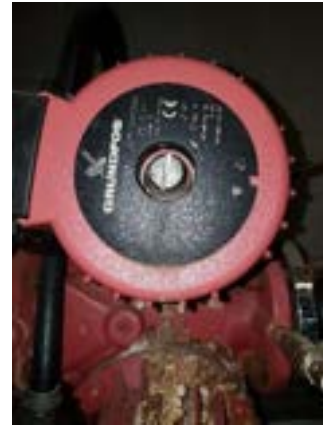
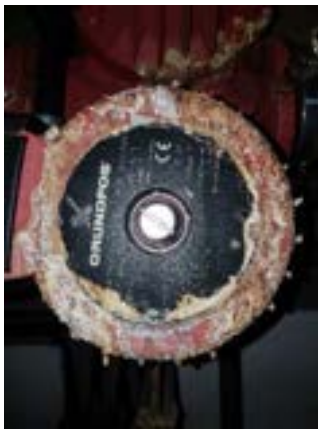
The twin head heating pumps serving the heating coil in the main pool air handling unit itself located in the new plantroom.

There is a minor leak on the upper head no. 1 and a very bad leak on the lower head no. 2.

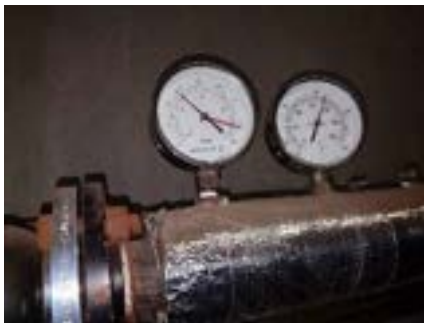
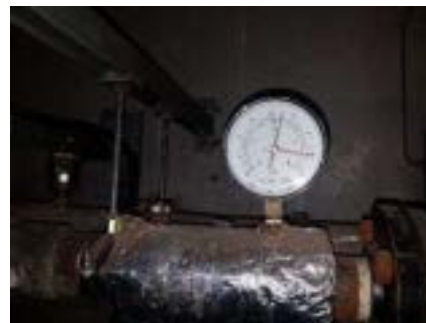
Both the inlet and outlet altitude gauges are working

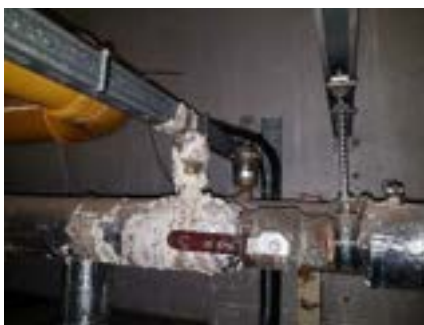
There is a very bad leak on automatic air vent associated with these pumps

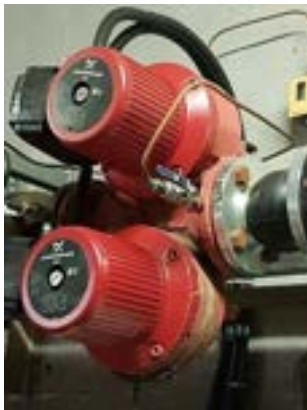
The corroded pump housing has been left in-situ where the staining of the previously leaks are in evidence.

The twin head heating pumps serving the heating coil in the main pool air handling unit itself located in the new plantroom have been replaced for new heads onto the existing body.

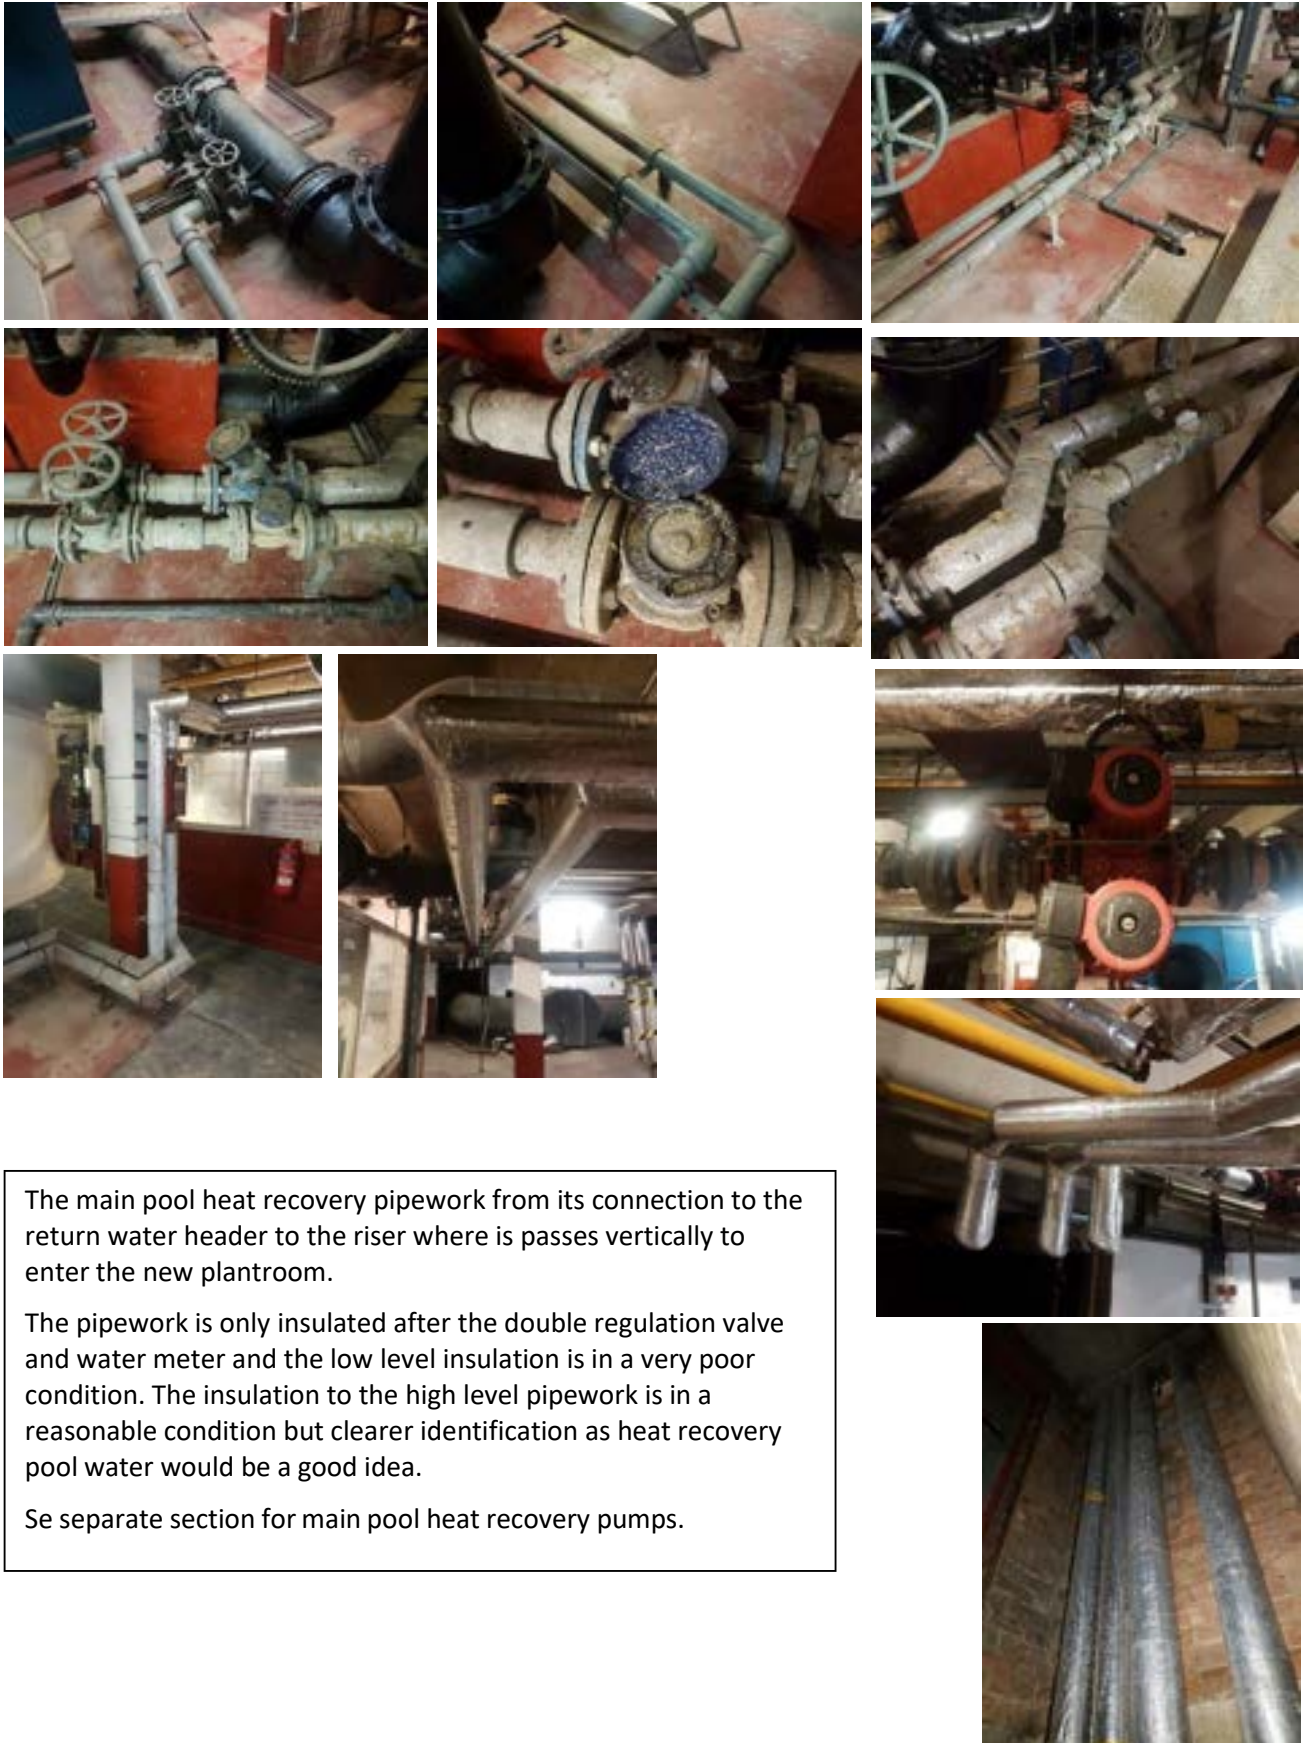
The main pool heat recovery pipework from its connection to the return water header to the riser where it passes vertically to enter the new plantroom.

The pipework is only insulated after the double regulation valve and water meter and the low level insulation is in a very poor condition. The insulation to the high level pipework is in a reasonable condition but clearer identification as heat recovery pool water would be a good idea.

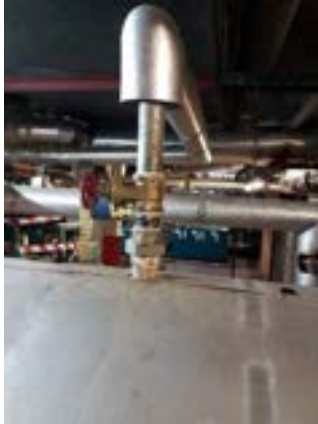
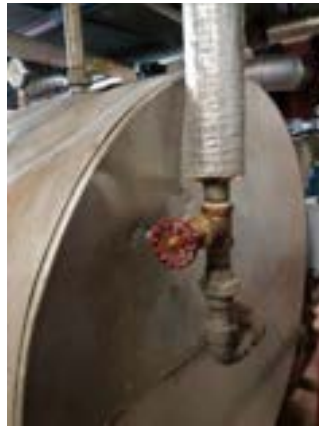
The secondary HWS flow and return connections to the HWS calorifier.

Both appear to be relatively new in comparison with the age of the calorifier and most probably date from the 2008 refurbishment.

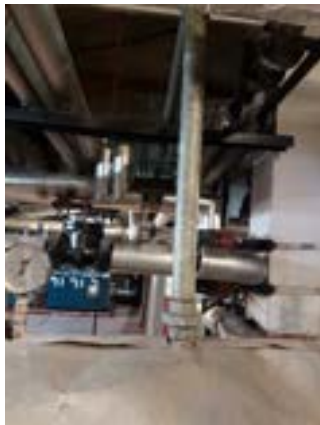
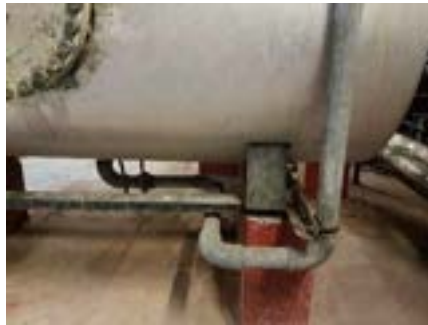
The open vent and cold feed connection to the HWS Calorifier.

Both appear to be relatively new in comparison with the age of the calorifier and most probably date from the 2008 refurbishment.

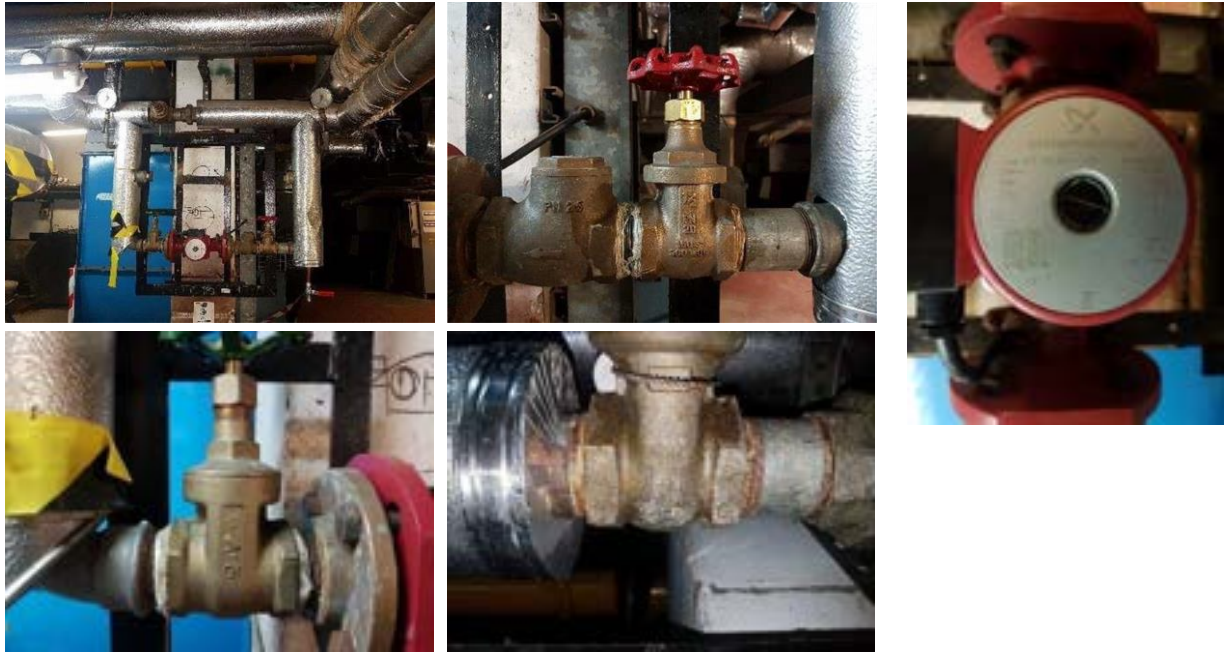
The HWS secondary circulation pump showing where the second pump was once installed and the by-pass valve.

The pump plate, the inlet and non-return valve, the outlet and by-pass valves all showing signs of minor leaks on the threaded connections.

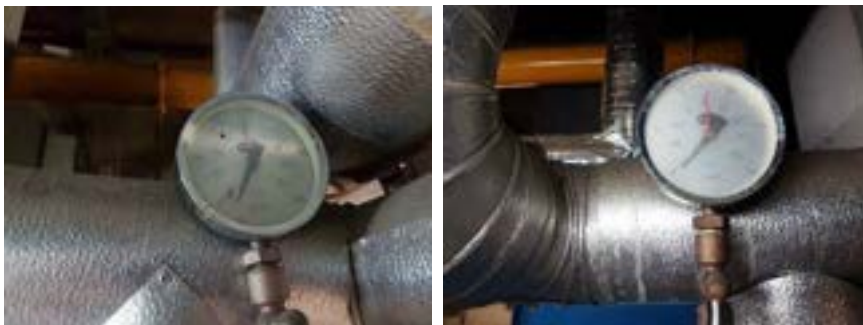
The non-operational inlet and outlet pump gauges

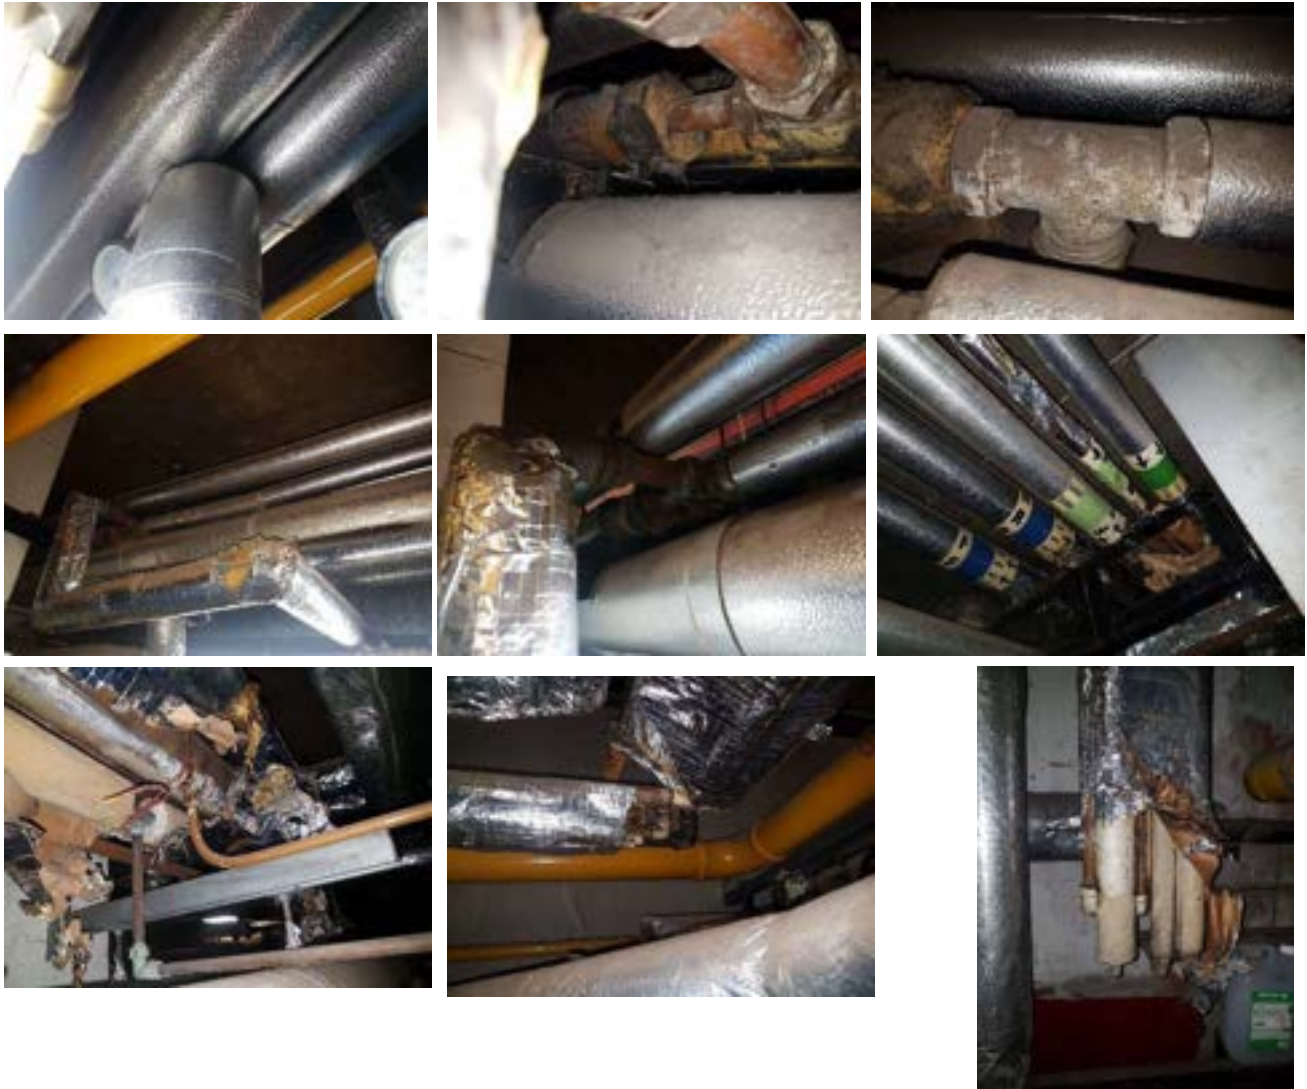
The secondary hot water service pipework that changes from galvanised mild steel to copper and rises to high level before splitting in two directions.

The thermal insulation is in poor condition in the majority of areas and the services are lagged together with the cold water down services making tracing difficult.

Where it exists the identification banding and direction of flow arrows are correct.

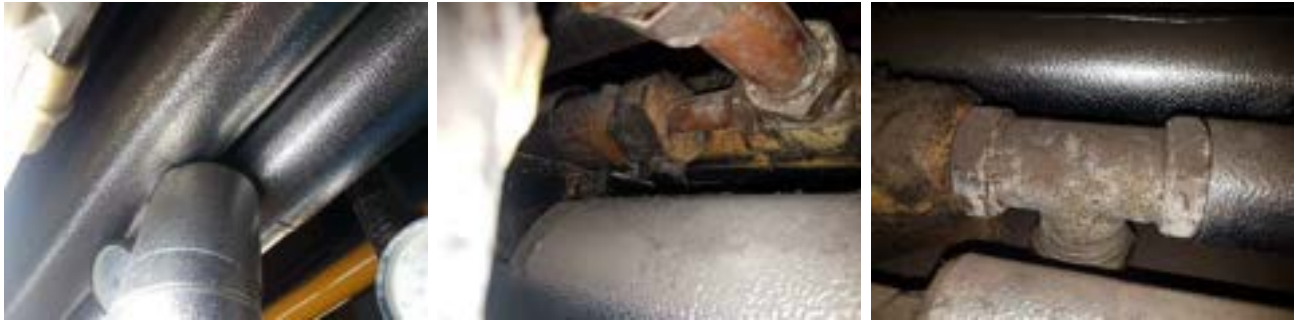
The secondary hws flow and return and the cold water down service where they enter the undercroft at the west end of the plantroom.

The undercroft must be considered a confined space and with the high level of dust and dirt must also be considered a health hazard.

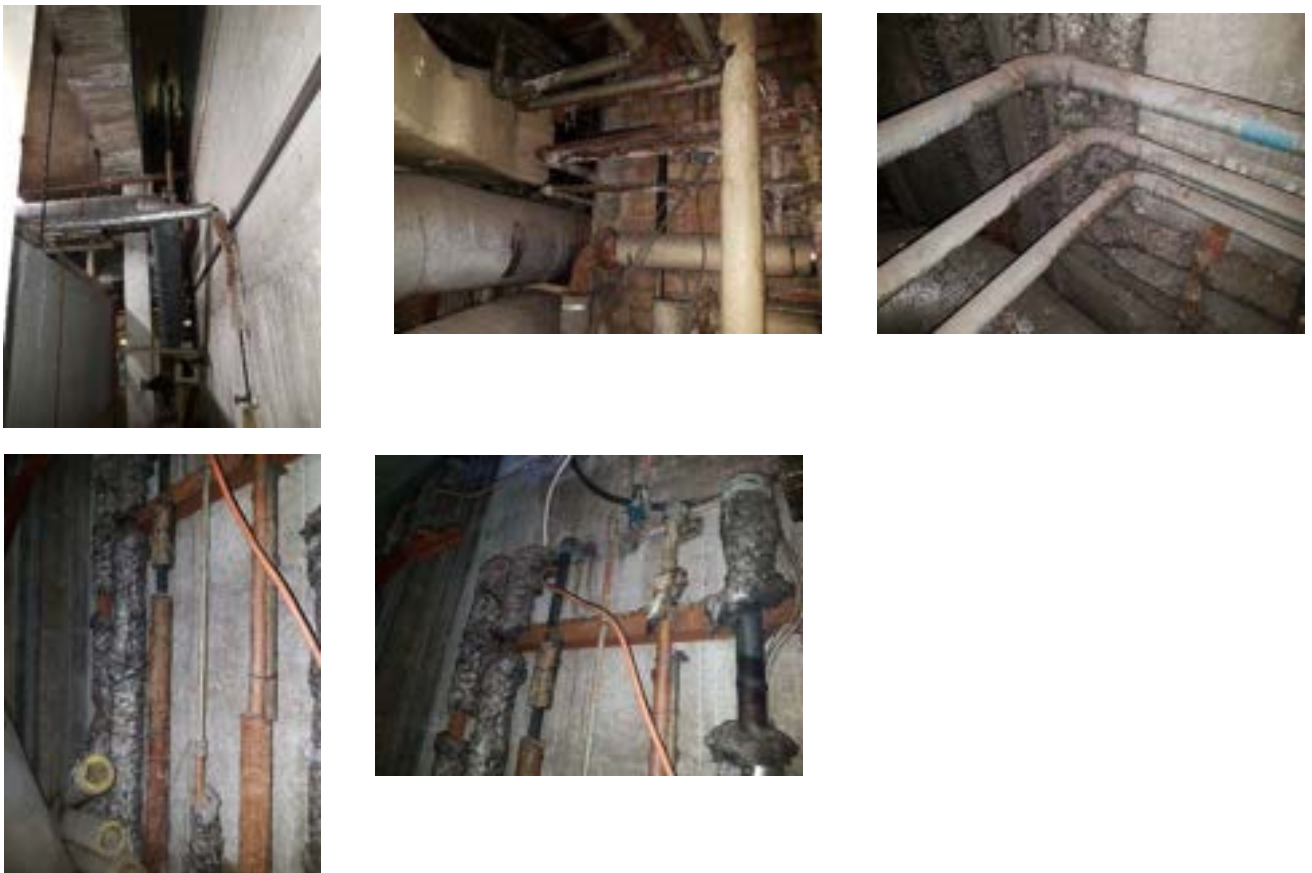
The hot flow and return pipework and the domestic cold water service at the eastern end of the plantroom where they pass into vertical services riser and pass up to high level ground floor before passing through the wall and into the changing rooms ceiling void.

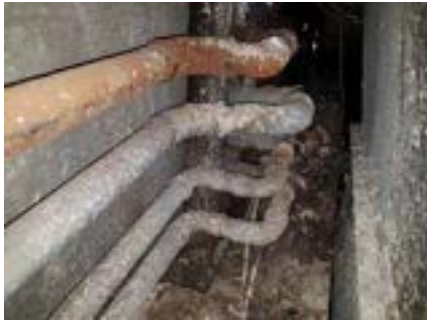
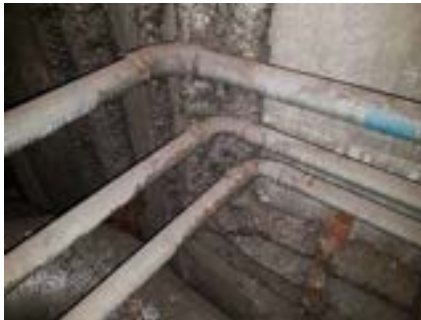
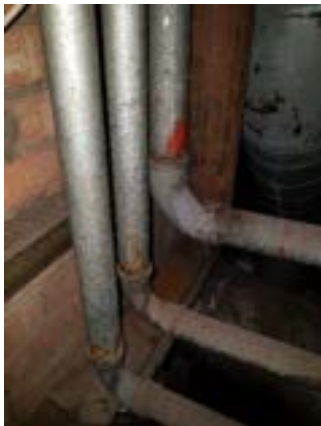
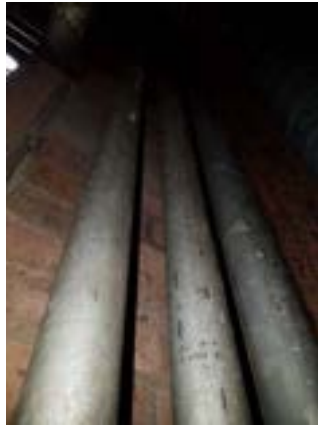
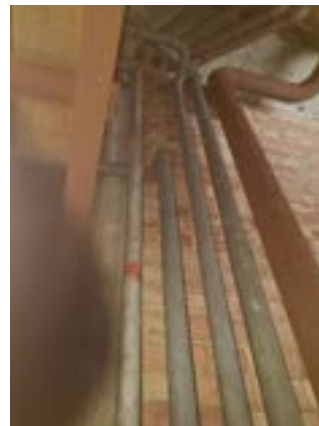
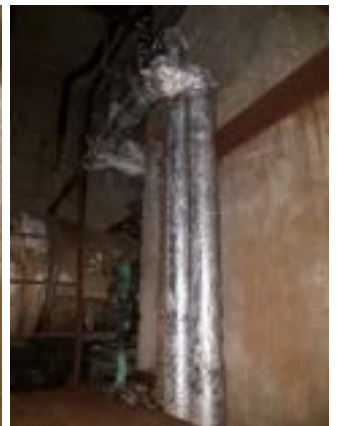
The hws open vent and cold feed along with the LPHW heating open vent and cold feed enter the vertical services riser together and rise to high level. All these vertical services are uninsulated until the open vent immediately adjacent to the tank room.

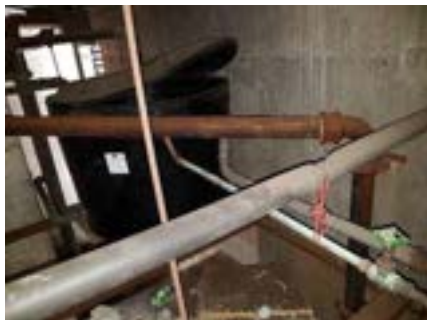
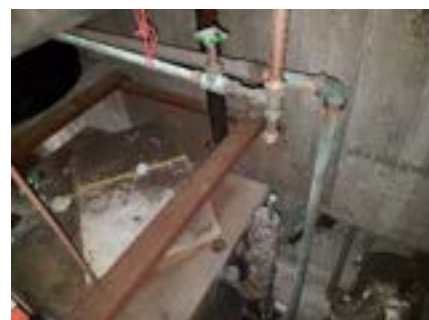
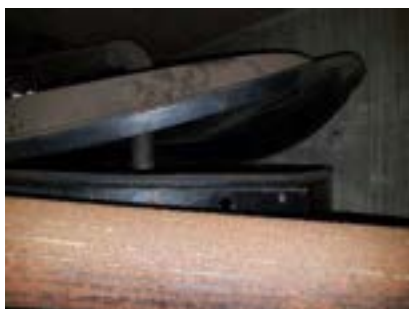
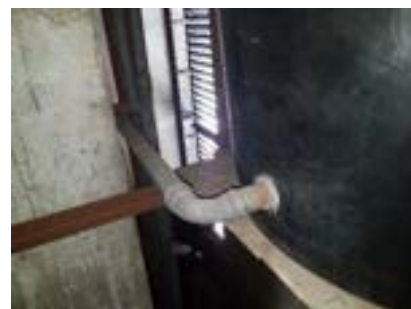
The 100 gallon plastic heating feed and expansion tank installed on a crude timber platform above what appears to be a life expired galvanised feed and expansion tank.

The tank has been distorted at some point and the lid does not fit correctly.

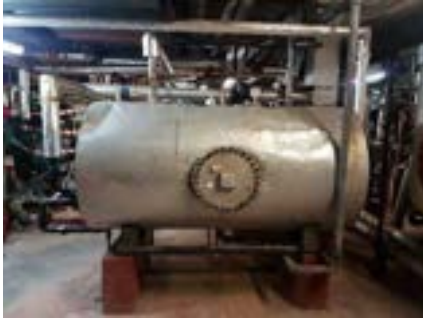
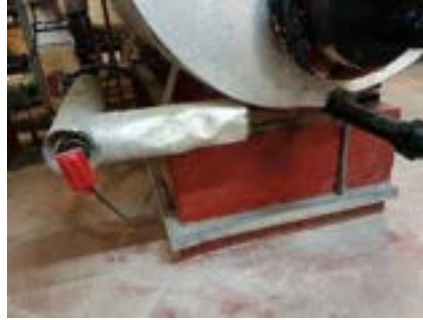
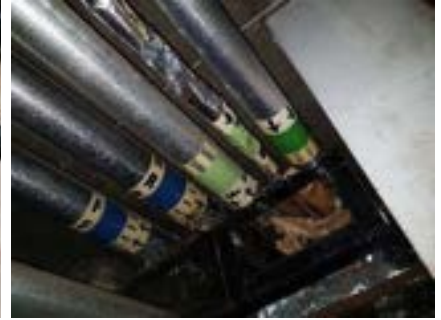
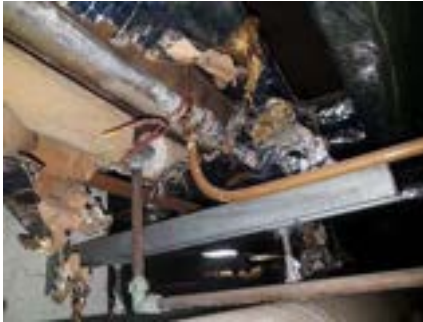
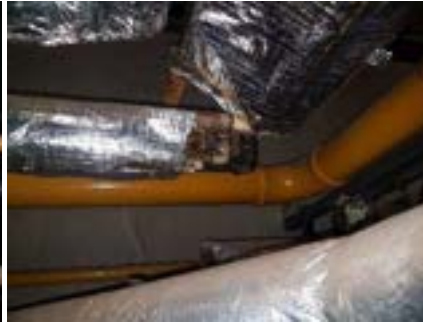
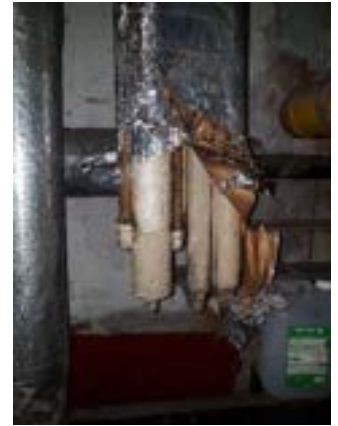
The thermal insulation to the hws calorifier and local pipework is damaged. In numerous location the high level insulation has been opened up and not resealed.

At the western end of the plantroom the hot water flow and return pipework has been crudely insulated together with the associated cold water down service and mains cold water service with some pipework just covered with the foil finish and not actually insulated.

The secondary hot water service flow and return along with the associated cold water down service and mains cold water service enter the undercroft initially uninsulated but within the undercroft have a loose covering of rockwool with a chicken wire finish.

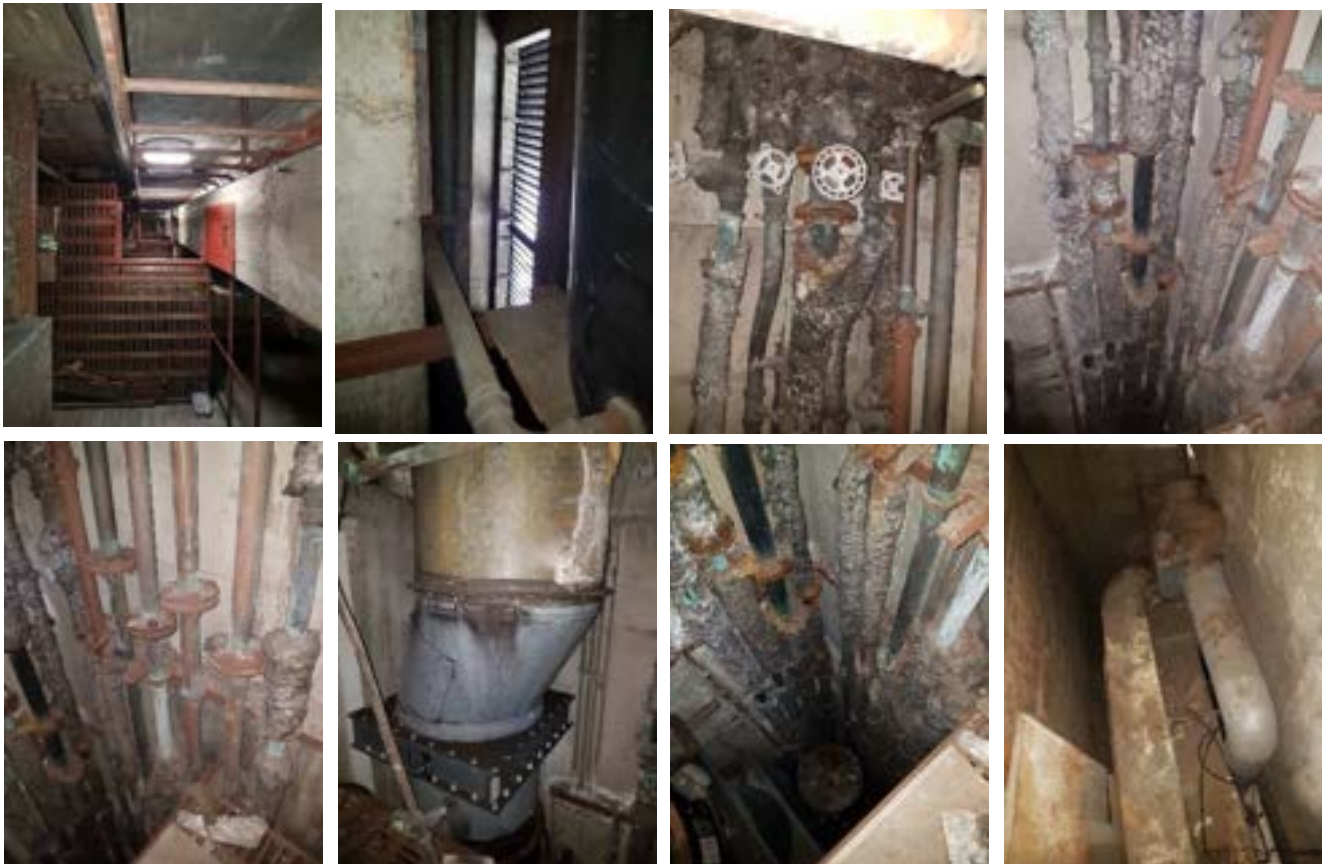
A view down the complete 16.50 metre tall access ladder within the vertical services riser.

There is a large external louvre at the top of the vertical services riser.

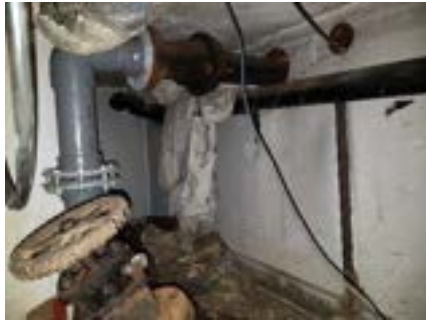
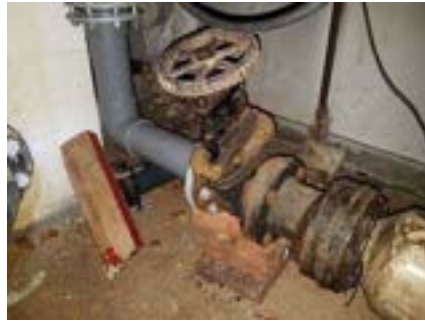
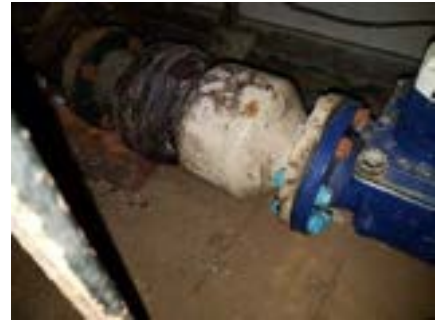
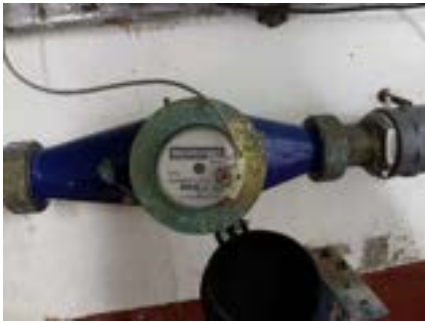
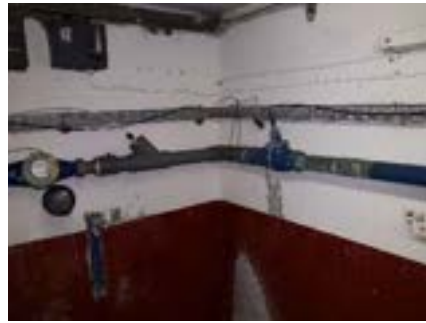
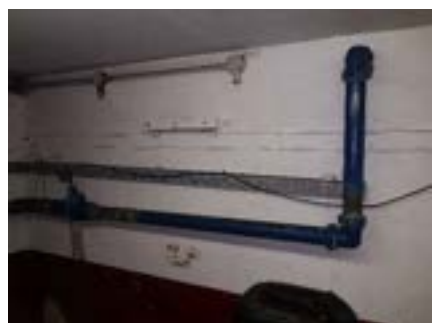
The incoming mains cold water service in cast iron, ABS, cast iron and mild steel. Note the inlet and outlet valves supported on bricks and timber. The mass of Denso tape appears to be to mask a leak. The inaccessible double check valve, an old non-return valve that should have been removed and an original isolating valve. The mains cold water service pipework on the eastern wall of the plantroom and rising to serve the plantroom sink.

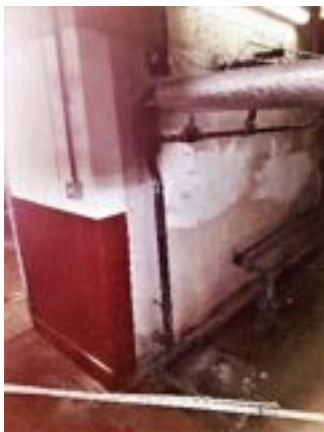
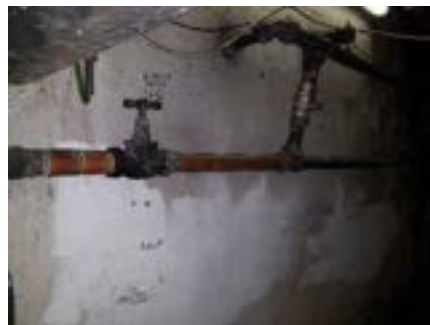
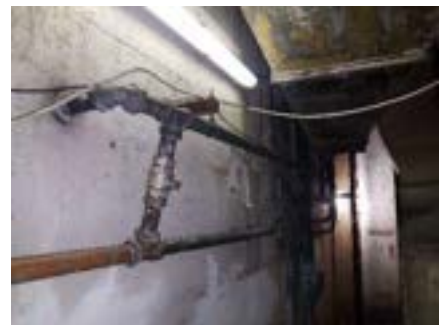
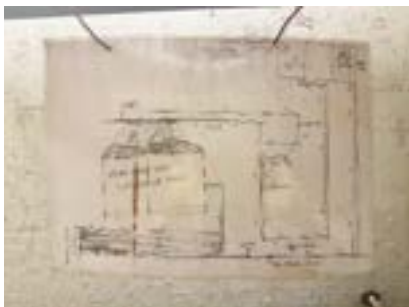
The mains cold water services enters the bio-sulphate room (for water softening) before passing back into the plantroom

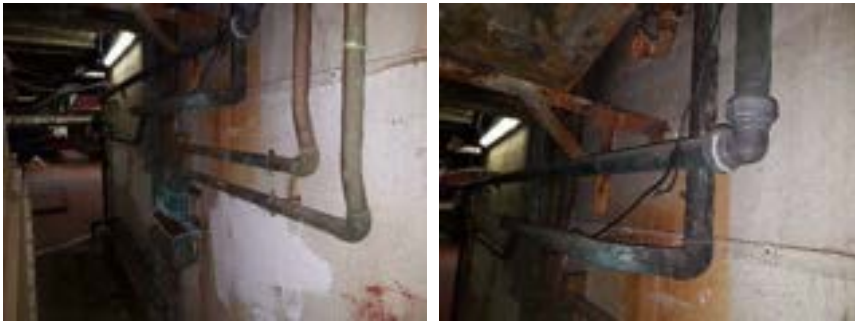
The mains cold water into and out of the bio-sulphate room showing the rather crude by-pass arrangement and the simple hand drawn sketch explaining the pipework, valve and tank arrangements. The two mains cold water supplies, one raw water and one softened water, pass along the wall before rising to the tank room.

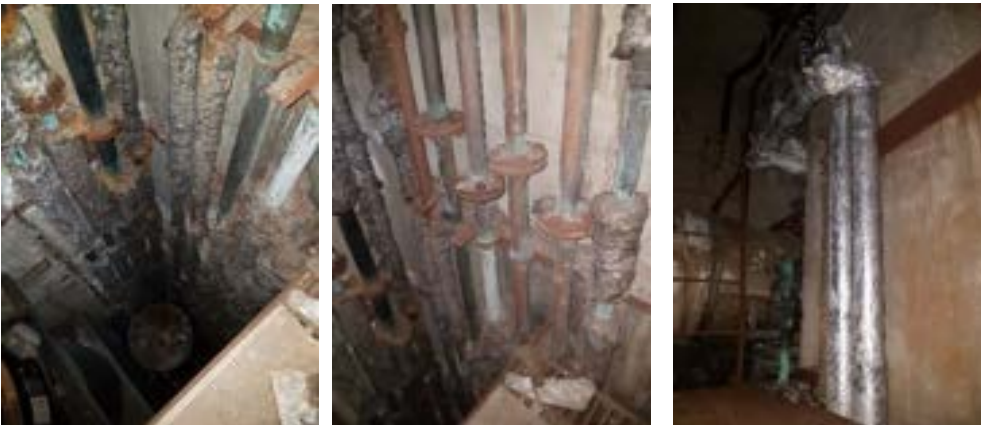
The two mains cold water supplies, one raw water and one softened water, pass along the wall before rising to the tank room.

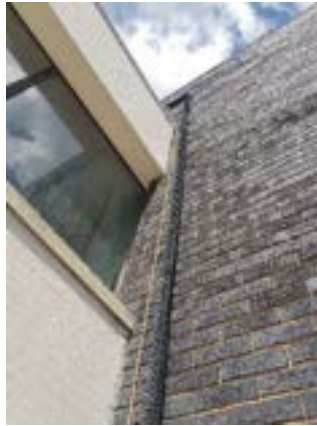
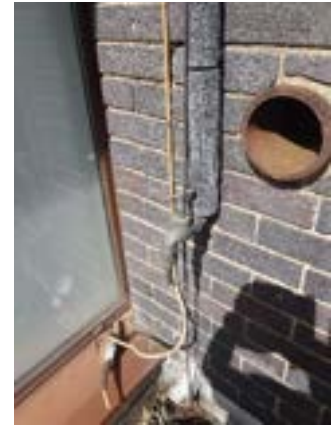
Within the vertical services riser is a 22mm copper supply taken from the raw water rising main cold water supply. This is insulated with a nitrile rubber type material seen supporting a red cable itself supporting another service.

The service is seen exiting to outside where it can be traced dropping externally from high to low level to connect to a $\frac{3}{4}$ " hose union tap.

The external thermal insulation has suffered very badly from UV degradation and it totally non-effective as insulation.

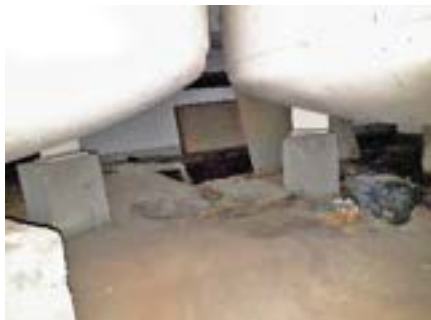
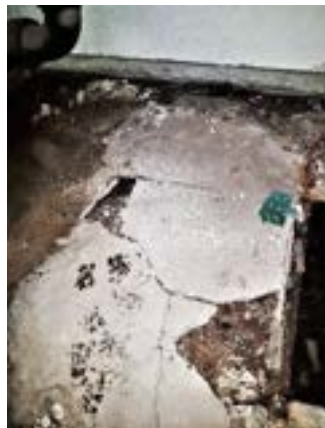
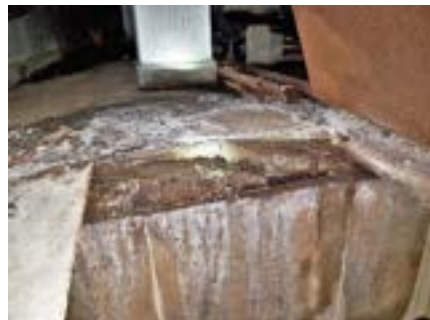
The main drainage inspection chamber located beneath swimming pool filter units 4 and 5 against the south wall of the basement plantroom. The air-tight lid and support frame to the inspection chamber has been removed most probably because of the flood damage to the screed and concrete floor and are seen stood against the far wall. Also visible is the 1/4" plate now used to cover the opening but which is too heavy and is never replaced.

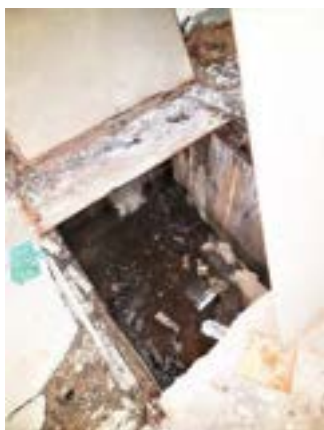
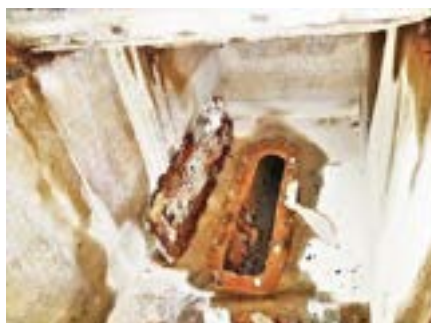
Closer inspection reveals the bottom of the inspection chamber is covered with bits of loose concrete and screed and was awash with water and faeces. When viewed from the other direction the cast iron inspection chamber can be seen with its bolted down air-tight cover removed. There was no sign of the nuts for the bolts which themselves appeared heavily corroded.
Soil waste and paper were observed passing through the inspection chamber.
This inspection chamber is a serious hazard to health and requires immediate, remedial attention.

The deplorable state of this manhole and access chamber remains exactly the same as in September 2019. This is a public health hazard requiring immediate attention.
