Condition Survey & Report
for the
**Mechanical & Electrical
Services Installation**
at
St Georges Swimming Pool
221 The Highway
London, E1W 3BP

Report produced for
**London Borough of Tower
Hamlets**
Technical Services Team
2nd Floor (Annexe)
Mulberry Place
5 Clove Crescent
London, E14 2BG

Reference	21012-CSR-101a
Prepared by	S Godden
Date	November 2021

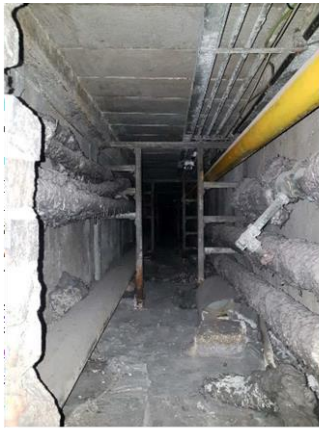
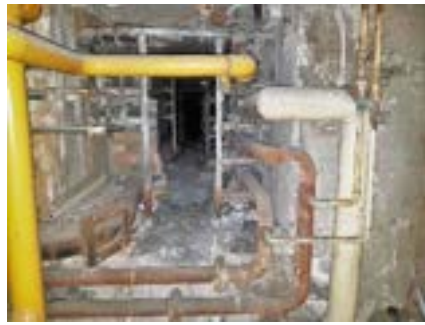
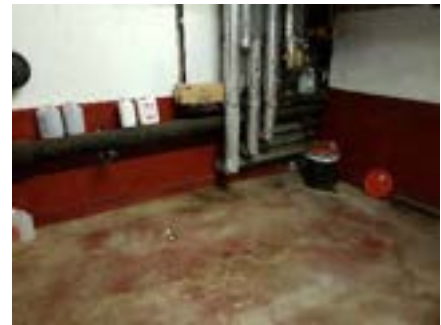
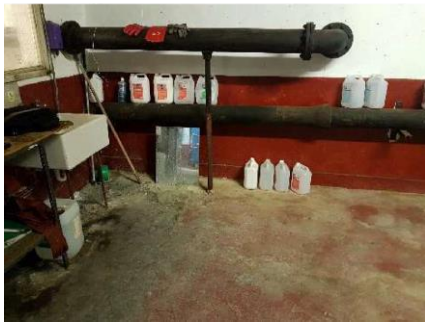
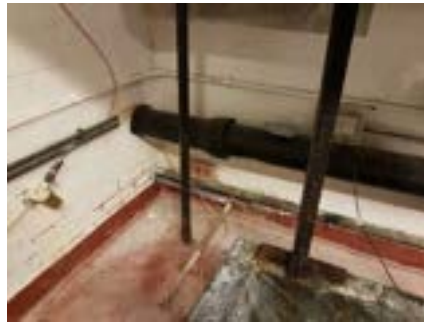
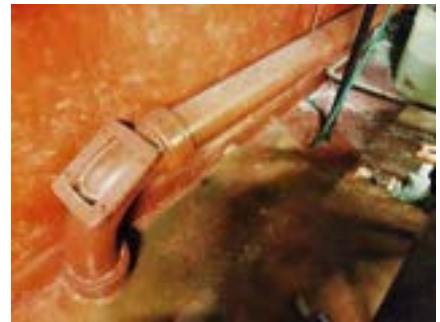
At the western end of the basement plantroom a 6" cast iron pipe passes through the on the left hand side before emerging into the actual plantroom. There is an cleaning access door on the bend as the pipe turns and falls behind the sink unit before passing through the chlorine room and then passes behind the main swimming pool pumps before dropping into the concrete slab.

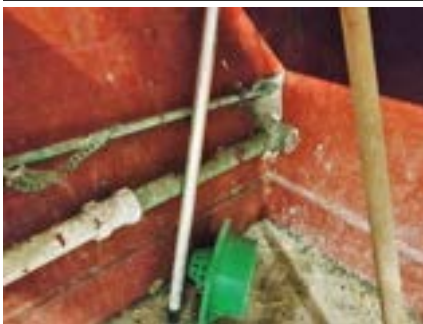
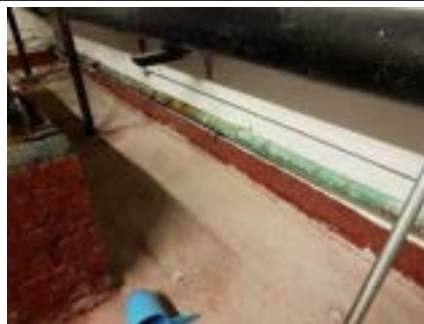
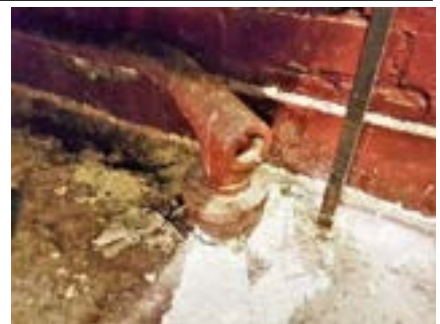
The 40mm copper drain from the sink in the basement plantroom passes through the chlorine room before turning adjacent to the main pool pumps and connecting into a 3" cast iron spigot at floor level.

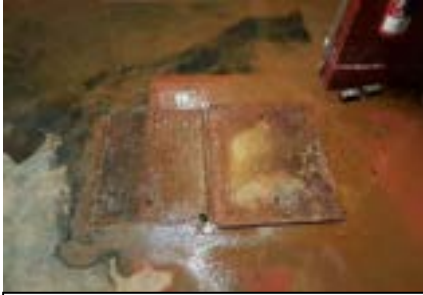
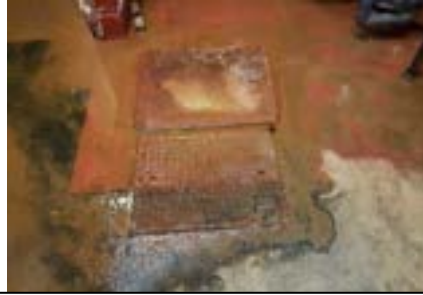
There are two inspection chambers at the foot of the fire escape stairs and adjacent to the main pool pump. Both chambers appear to be in flood and it was not possible to raise the covers for further investigation.

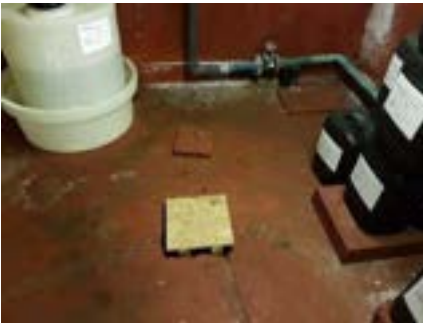
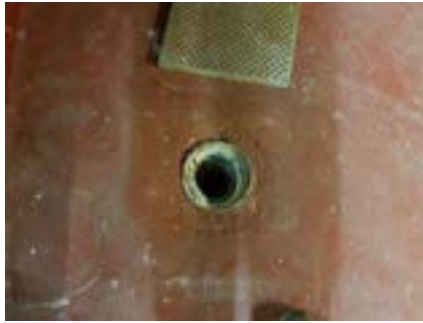
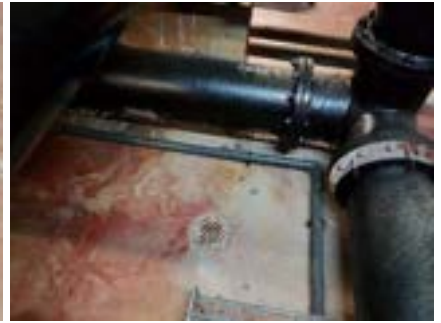
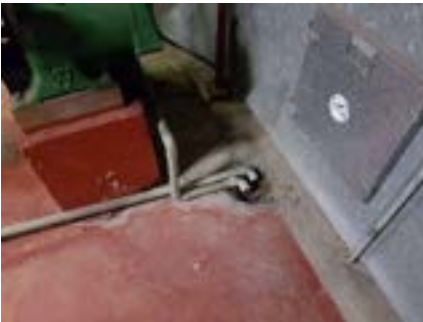
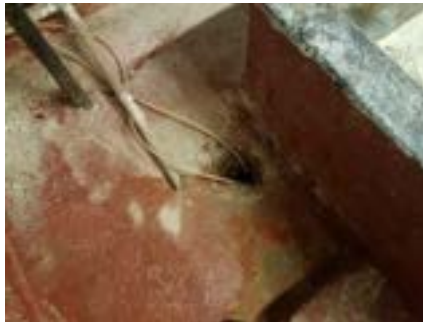
There are a number of other 3" cast iron sockets in the floor of the basement plantroom. These are in the bio-sulphate room (with poor fitting timber cover), in front of the old chiller (perforated stainless steel cover moved aside), near the main pool heat exchangers, adjacent to the teaching pool pumps and in the chlorine room where the overflow pipes from the dosing pumps discharge.

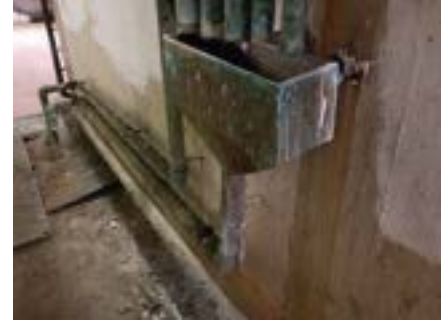
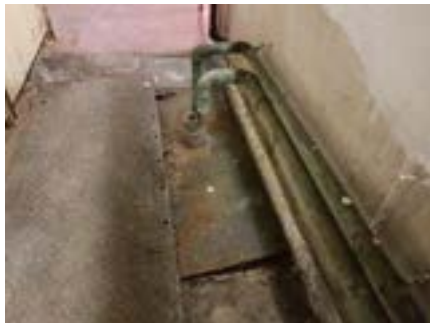
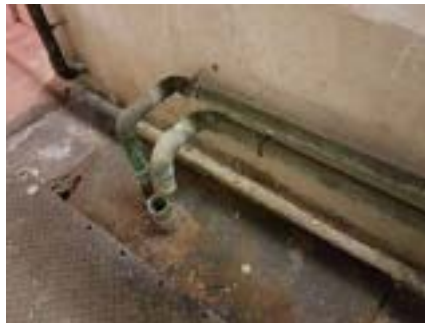
The warning pipes from the roof tanks all drop into a copper tundish at the base of the vertical services riser that itself discharges into the pumped sump. Note the corroded and lifted cover of the sump and the ¼" steel plate cover.

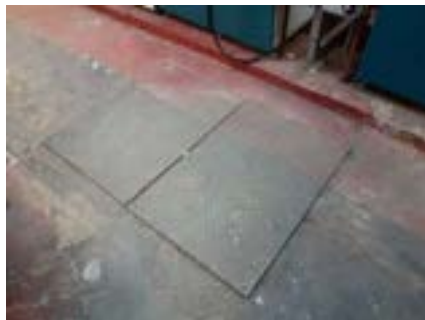
There are two steel chequer plate covers in front of the boilers believed to give access to an inspection chamber serving the east side of the building but it was not possible to lift these to prove that.

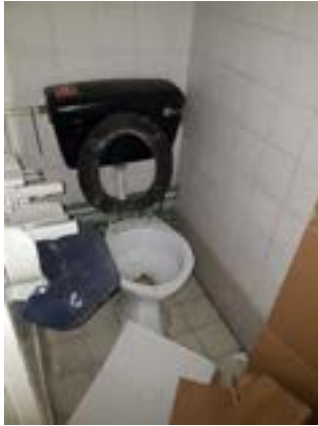
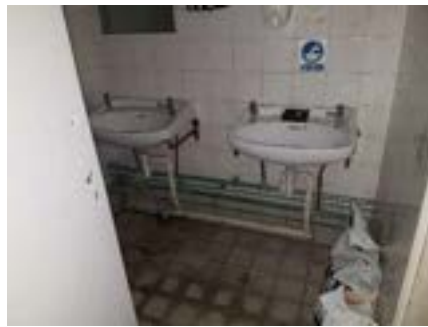
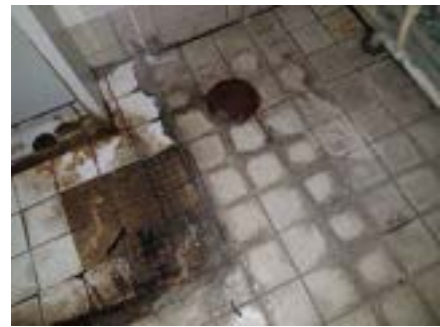
In a storage cupboard off the ground floor corridor to the western aspect of the building there is a cast iron soil and vent pipe that drops from above into the concrete slab. This has a connection from the wc's & wash hand basins in the old laundry area meeting rooms toilets.

This soil and vent pipe is believed to connect into the 6" cast iron pipe located within basement undercroft.

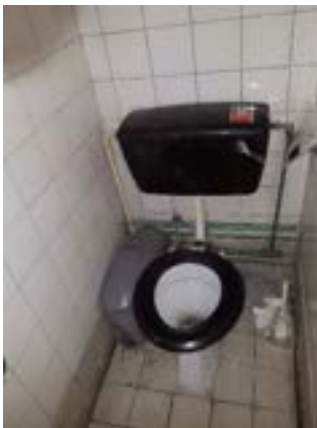
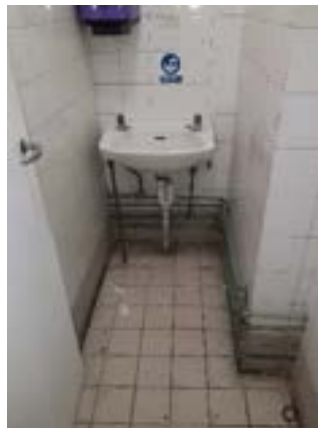
At the western end of the ground floor staff corridor are the semi-derelict male staff toilets. The wc pan, wash hand basin and urinal have drains that discharge into the concrete floor and there is an inspection port cover adjacent to the urinal.

These soil, vent and waste pipes are believed to connect into the 6" cast iron pipe located within basement undercroft.

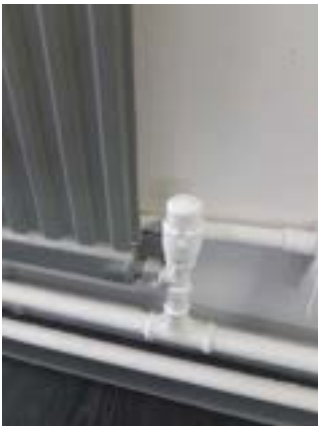
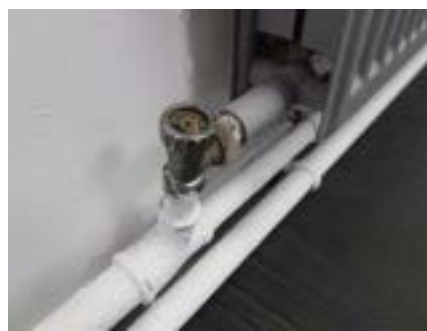
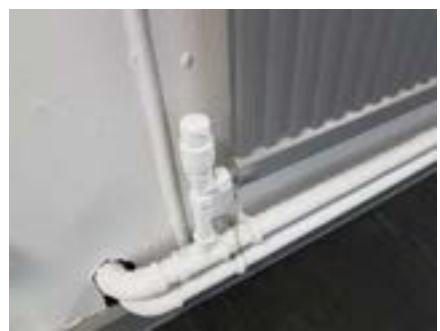
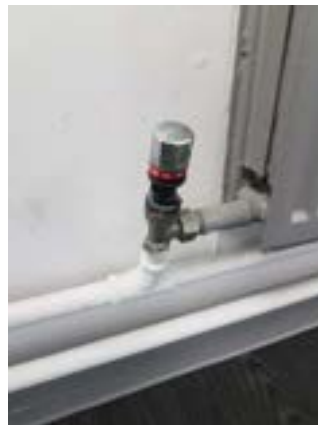
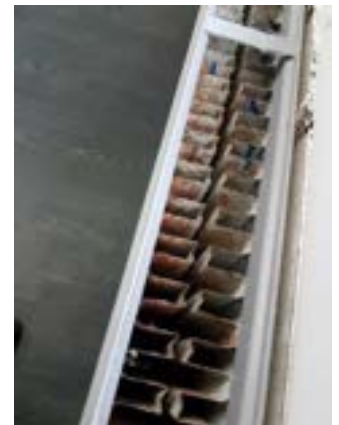
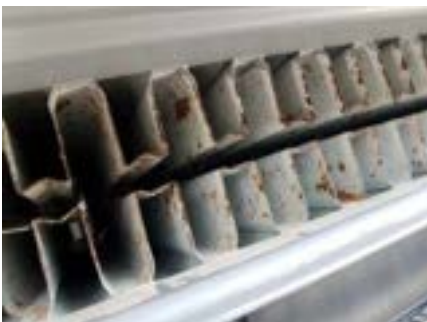
The pressed mild steel radiators in the first floor fitness suite. There are at least four removed radiators as evidence the large gap where plugged tees still exist at the actual radiator locations. The thermostatic radiator valves and the lock shield valves have been removed, damaged or painted over so as to be inoperable. Corrosion is evident on the convector fins to nearly all the radiators.

The source of the heating flow and return pipework is not obvious but is believed to originate from the uninsulated heating services at high level in the bio-sulphate room and across the top of the duty managers office.

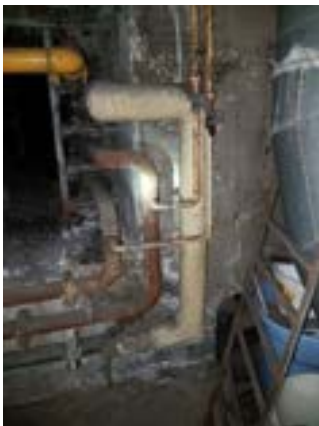
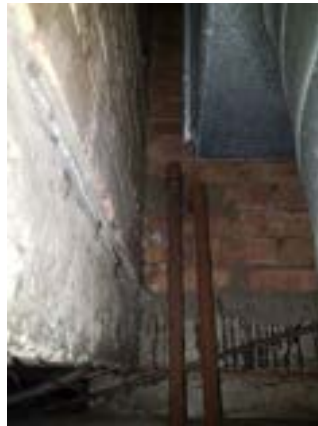
The natural convectors in the staff room and the adjacent store-room and the radiator in the general manager's office.

All these radiators are fed from a $\frac{3}{4}$ " bsp flow and return that rise from the 2" flow and return as they head into the undercroft. Without any thermal insulation and running a long distance with no obvious venting arrangements most probably account for the fact that these convectors and radiators are reported as "never getting hot".

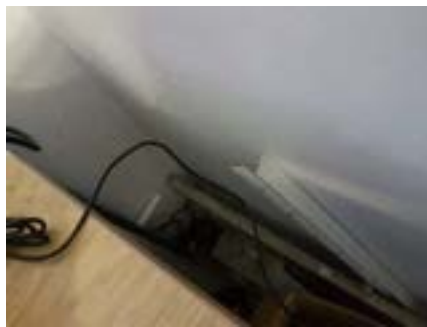
In what appears to have once been a staff toilet next to the duty managers office off the ground floor corridor a heating flow and return drop from the ceiling void to low level before passing through a wall and connecting to a steel panel radiator in the duty managers office.

The radiator is fitted with manual wheel head and lock shield valves.

The source of this heating flow and return is believed to be the uninsulated heating pipework observed at high level in the bio-sulphate room.

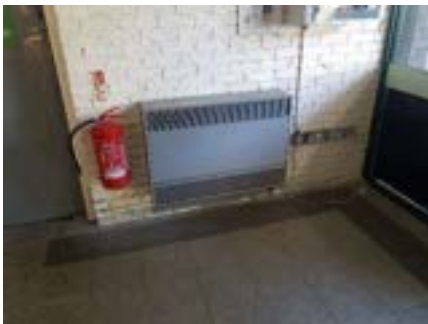
In the public entrance space is a wall mounted fan convector.

The source of the heating flow and return is not established but it is believed to be the uninsulated heating pipework observed at high level in the bio-sulphate room.

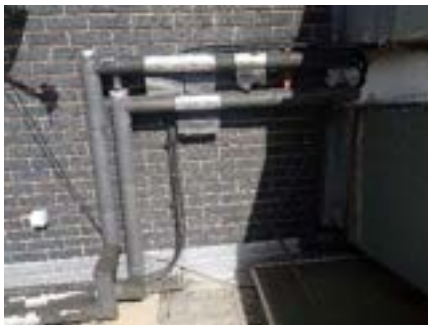
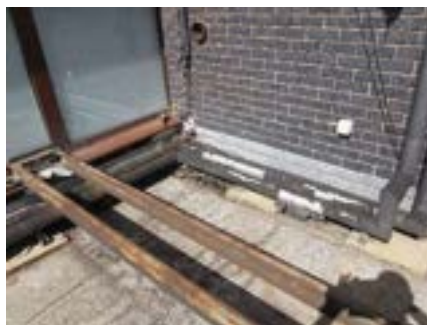
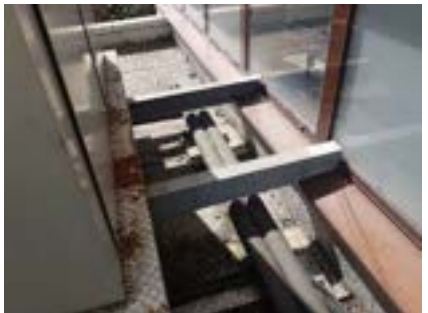
On the lower roof a 1½" bsp heating flow and return pass out from the vertical services riser and drop to low level to eventually pass up into the roof plantroom.

The thermal insulation is in poor condition having suffered from UV degradation.

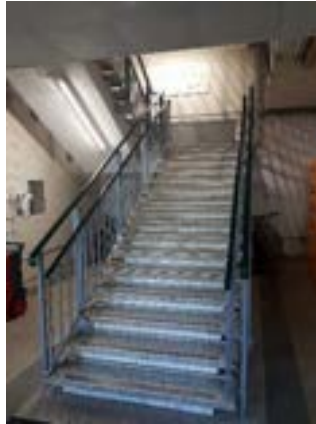
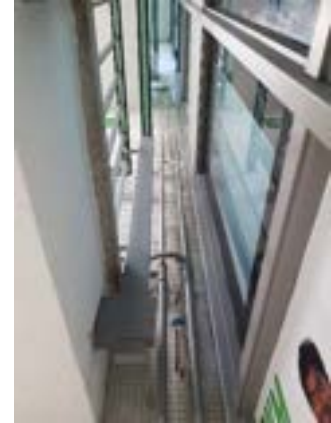
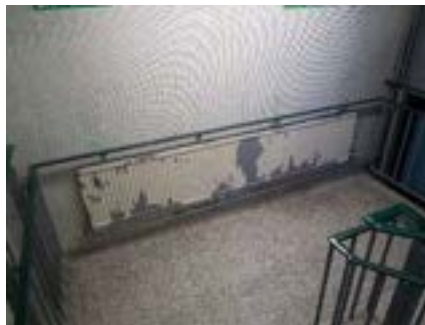
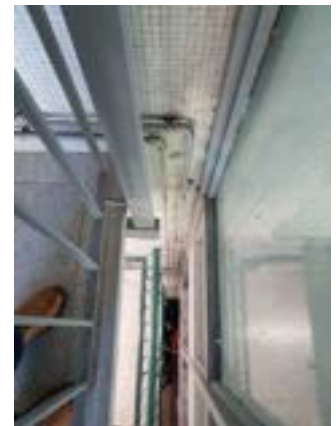
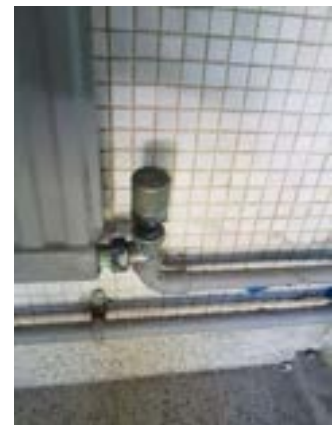
There are steel panel radiators on the public stairs at ground to first landing, first to second landing and second to third landing. The radiators are generally sound although at first to second the paint is peeling very badly. The radiators are fitted with thermostatic valves but these appear to be seized and are inoperable. The pipework starts from a connection in the basement plantroom near the bio-sulphate room and is exposed in the stairwell. The pipework appears sound and in a reasonable condition.

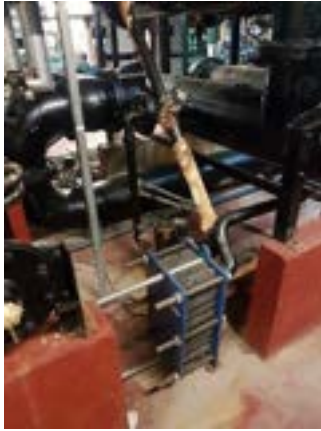
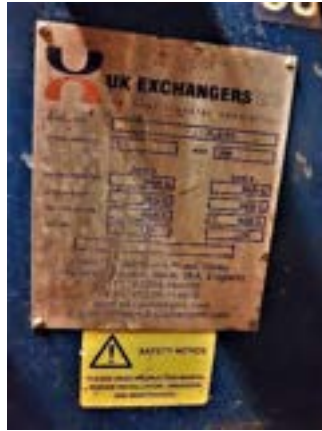
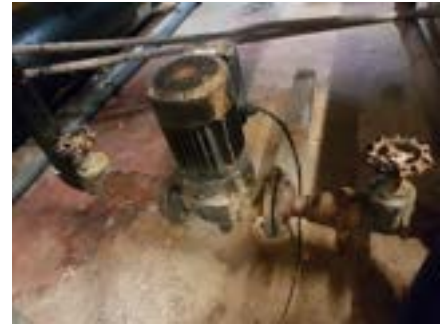
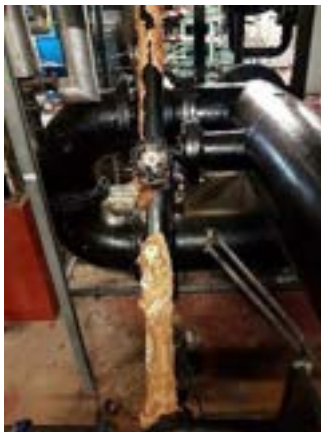
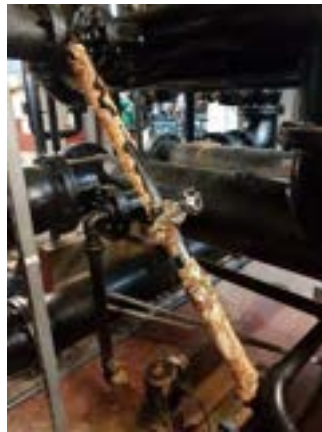
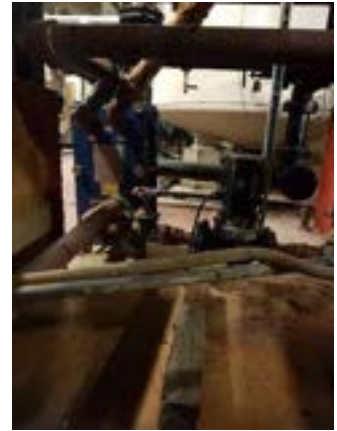
The plate heat exchanger installed as a replacement for the two large shell and tube heat exchangers for the main pool.

The pump installed on the primary LPHW circuit is 240 volt single phase installed on a trailing lead to a 13 amp socket adjacent to the main pool circulation pumps that is manually operated by staff; when the pool water is too cold the pump is turned on and when the pool water is too warm the pump is turned off – crude in the extreme and so wasteful of valuable energy.

It was not possible to gather information of the primary circuit pump because A) it is inaccessible beneath the old shell & tube heat exchanger and B) it is totally obscured by debris from a leak on the secondary pipework above it.

The leak is caused by breakdown of the mild steel pipe, that has been very crudely installed at an angle, carrying chlorinated water that is causing the pipework and valves to breakdown and leak. In our opinion this pipe is close to failure and requires immediate attention.

It is of note there is only a single plate heat exchanger, in comparison to two shell and tube heat exchangers, so, in the event of a failure there is no back-up heat source for the main pool water.

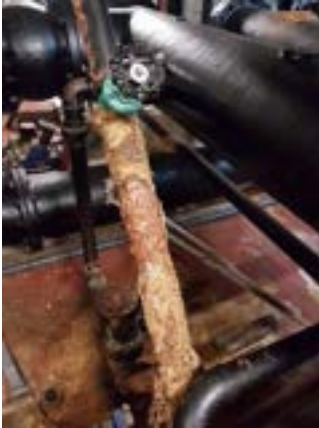
Despite the fact that all plant is now turned off and isolated, the corrosion to the 2" secondary pipework has deteriorated further to the point where water is escaping through the previous rust patch indication that the pipe has corroded through in total.

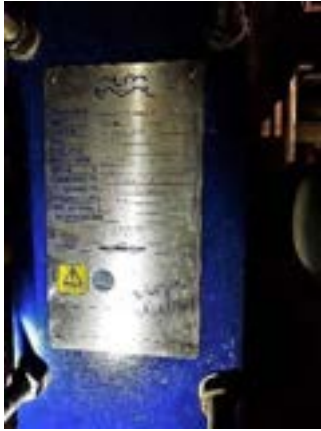
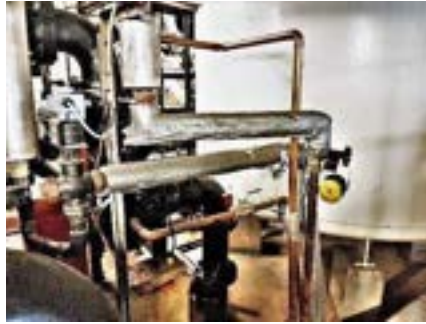
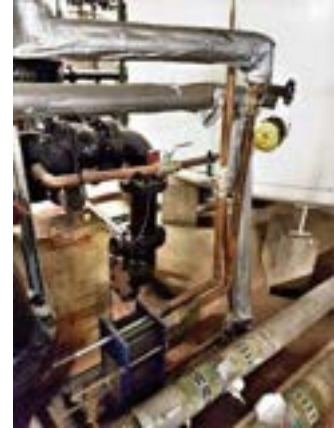
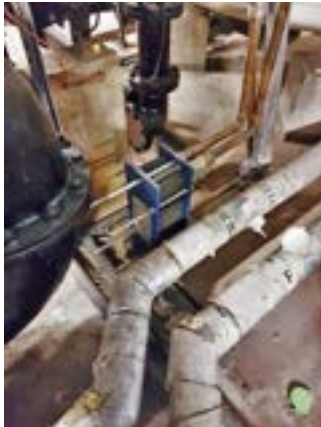
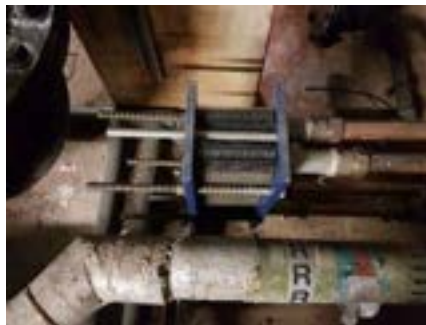
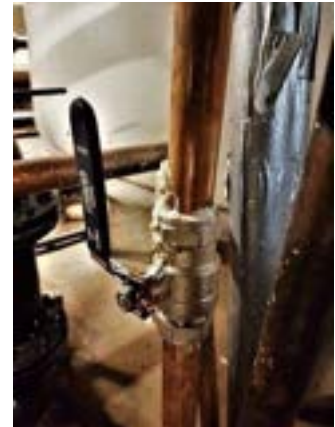
The plate heat exchanger to the teaching pool. Both the primary and secondary heating pipework has been very crudely installed and there is a very bad leak on the isolation valves. The original Staefa 3 port control valve is still connected but is believed to be inoperable.

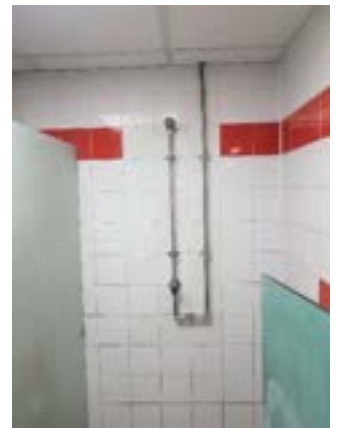
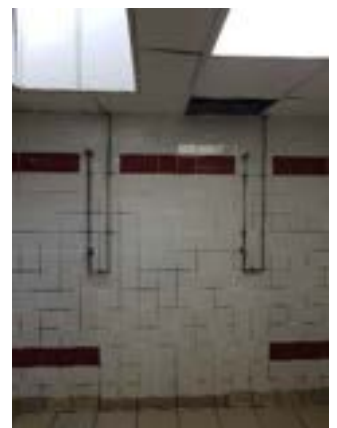
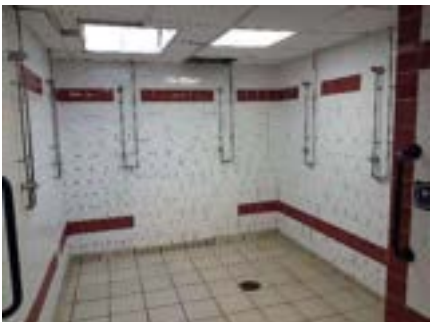
A selection of the showers around the various changing rooms and toilets. In the majority of cases the showers are on non-convulsive push action valves and, presumably a common thermostatic mixer valve somewhere in the ceiling void. However, in some areas, mainly disabled showers, the thermostatic mixing valves are installed as surface fixed at the point of use. We were unable to establish how the thermostatic valves were accessed in order to undertake statutory TMV tests.

We picked up apocryphal evidence of poor performance of the showers but looking at number of showers installed and the volume of hot water available we are reasonably satisfied that the volume of water available is sufficient for the maximum demand of the showers and that the problem most probably revolves around undersized hot water service flow and return pipework.

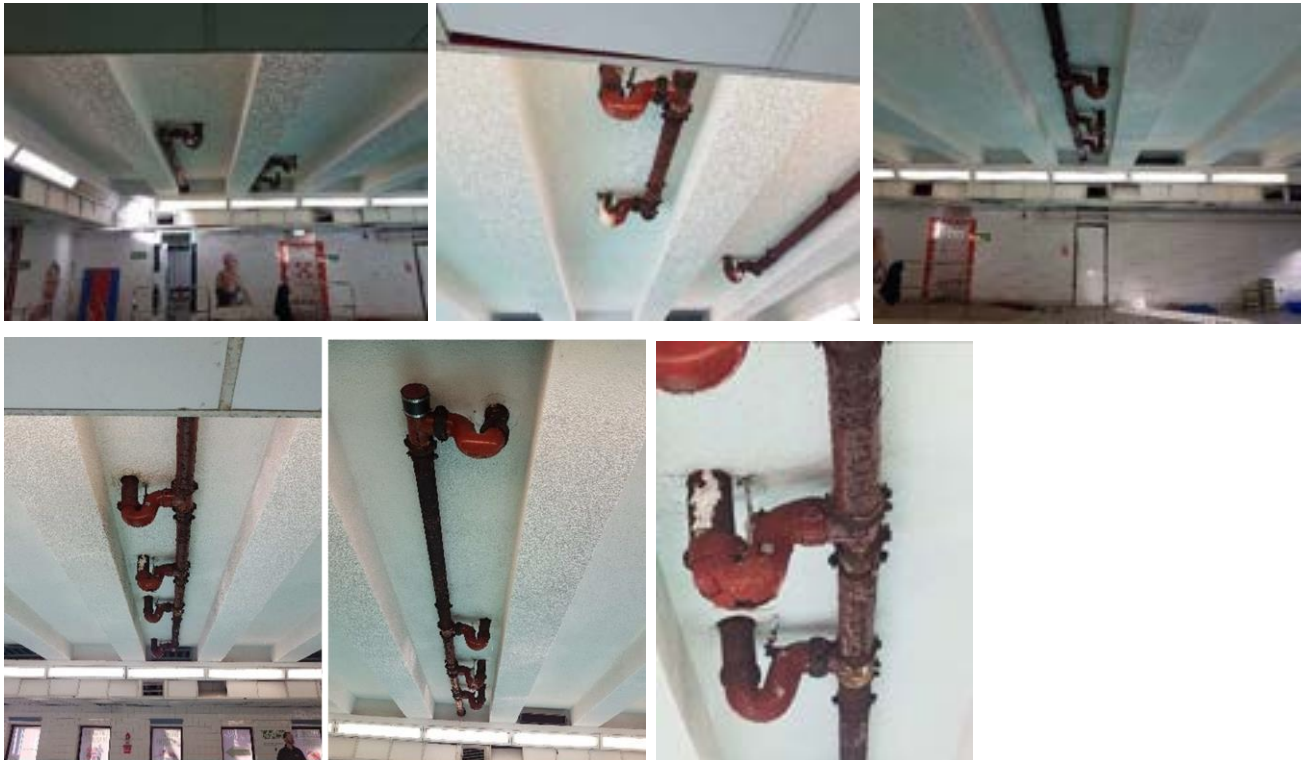
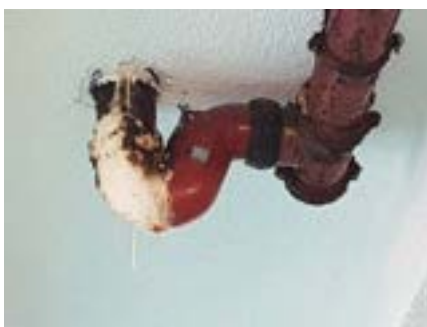
The disabled toilet in the teaching pool hall is a typical example of a mixture of cast iron, plastic and copper pipework where joint leaks are in evidence.

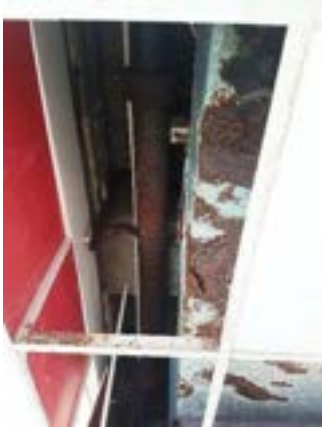
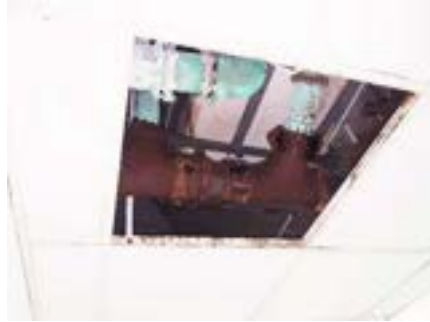
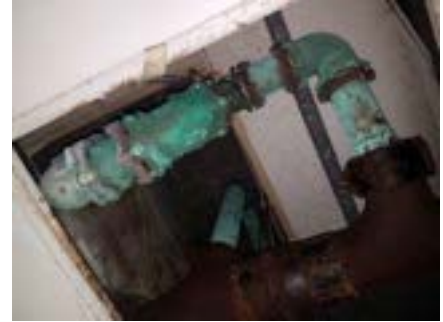
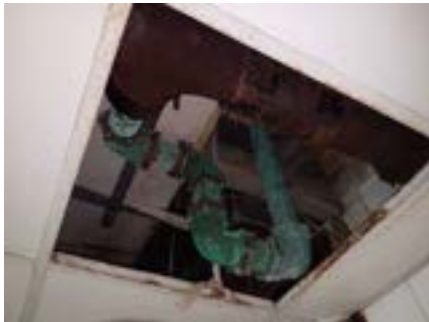
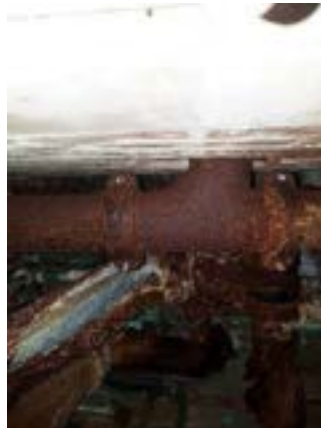
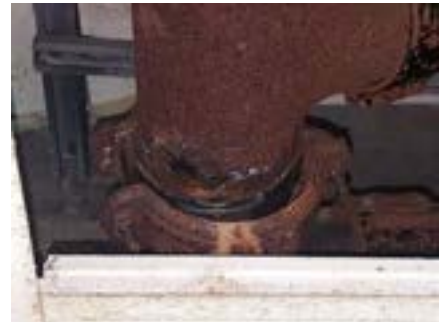
The floor channels and gullies in the male changing rooms and toilets pass through the concrete slab and appear at high level above the teaching pool.

The pipework is all in cast iron with Timesaver mechanical joints and is, frankly, in a mess. The paint is flaking off all the pipework, some of the joints are not correctly aligned (this will eventually cause the joints to leak) and there is major seepage where they pass through the concrete slab.

None of the joints appear to be leaking but the seeping water is most probably from washing down the changing rooms floor above and means this dirty water is finding its way into the teaching pool.

This matter is completely unacceptable and requires urgent attention

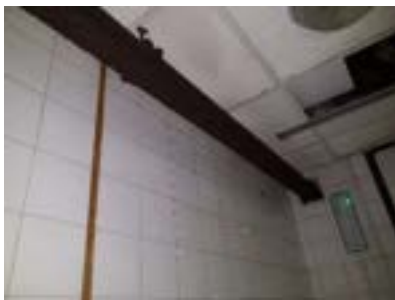
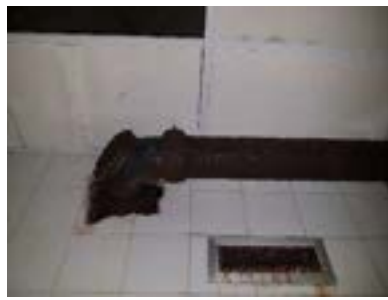
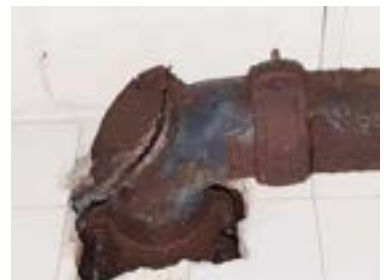
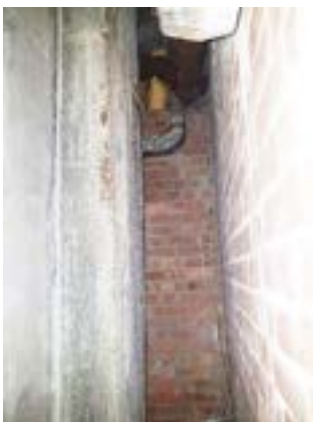
The cast iron drainage at high level falls back to connect to a falling horizontal drainage run within the bulkhead to the north side of the teaching pool hall. This horizontal run not only picks up the exposed pipework runs but also other drainage services through the concrete slab. The pipework is in an appalling condition with leaks and broken joints in evidence.

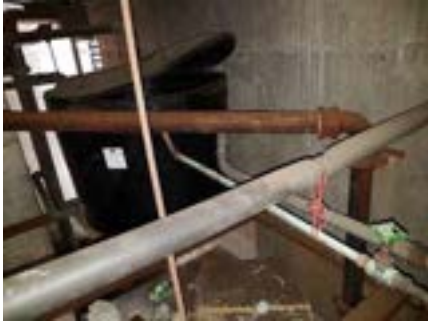
At the top of the vertical services riser are two cast iron rainwater pipes that drain the flat roof of the tank room and which combine to form a single pipe that drops down the vertical services riser before eventually passing into the teaching pool ceiling void and, most probably, connecting into the rainwater pipe observed in the services riser seen in the centre of the picture.

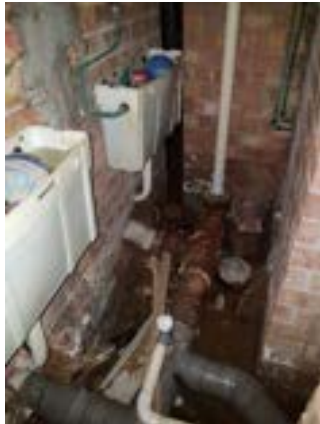
There is a rainwater pipe observed in the far left hand corner of services void behind the main pool female toilets.

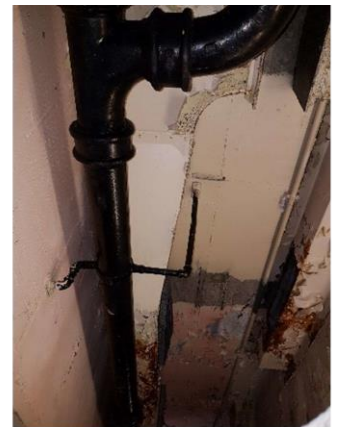
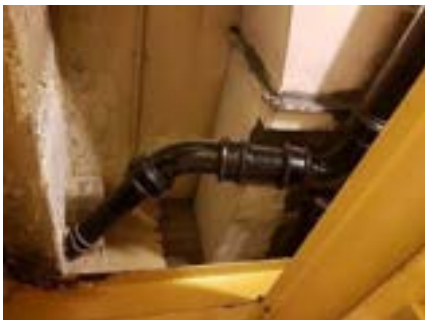
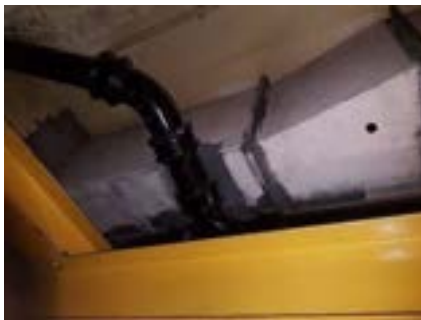
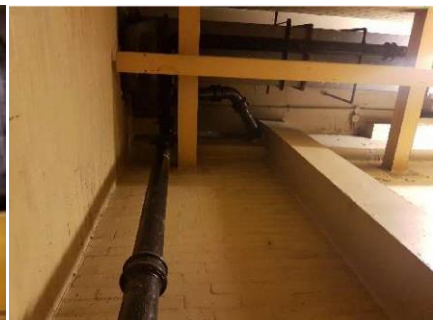
At high level above the fire escape stairs in the southwest corner of the ground floor and basement there is a system of cast iron pipework with branches at every structural column and that starts in the western corridor adjacent to some life expired and corroded ductwork. The branches appear to be the rainwater drains from the southern edge of the main roof built into the concrete columns.

The cast iron drops to low level just before the door into the basement plantroom.

Generally, the cast iron pipework is in good condition although there are a couple of branches where there are substantial leaks that actually appear to be from the concrete structure and not the pipework.

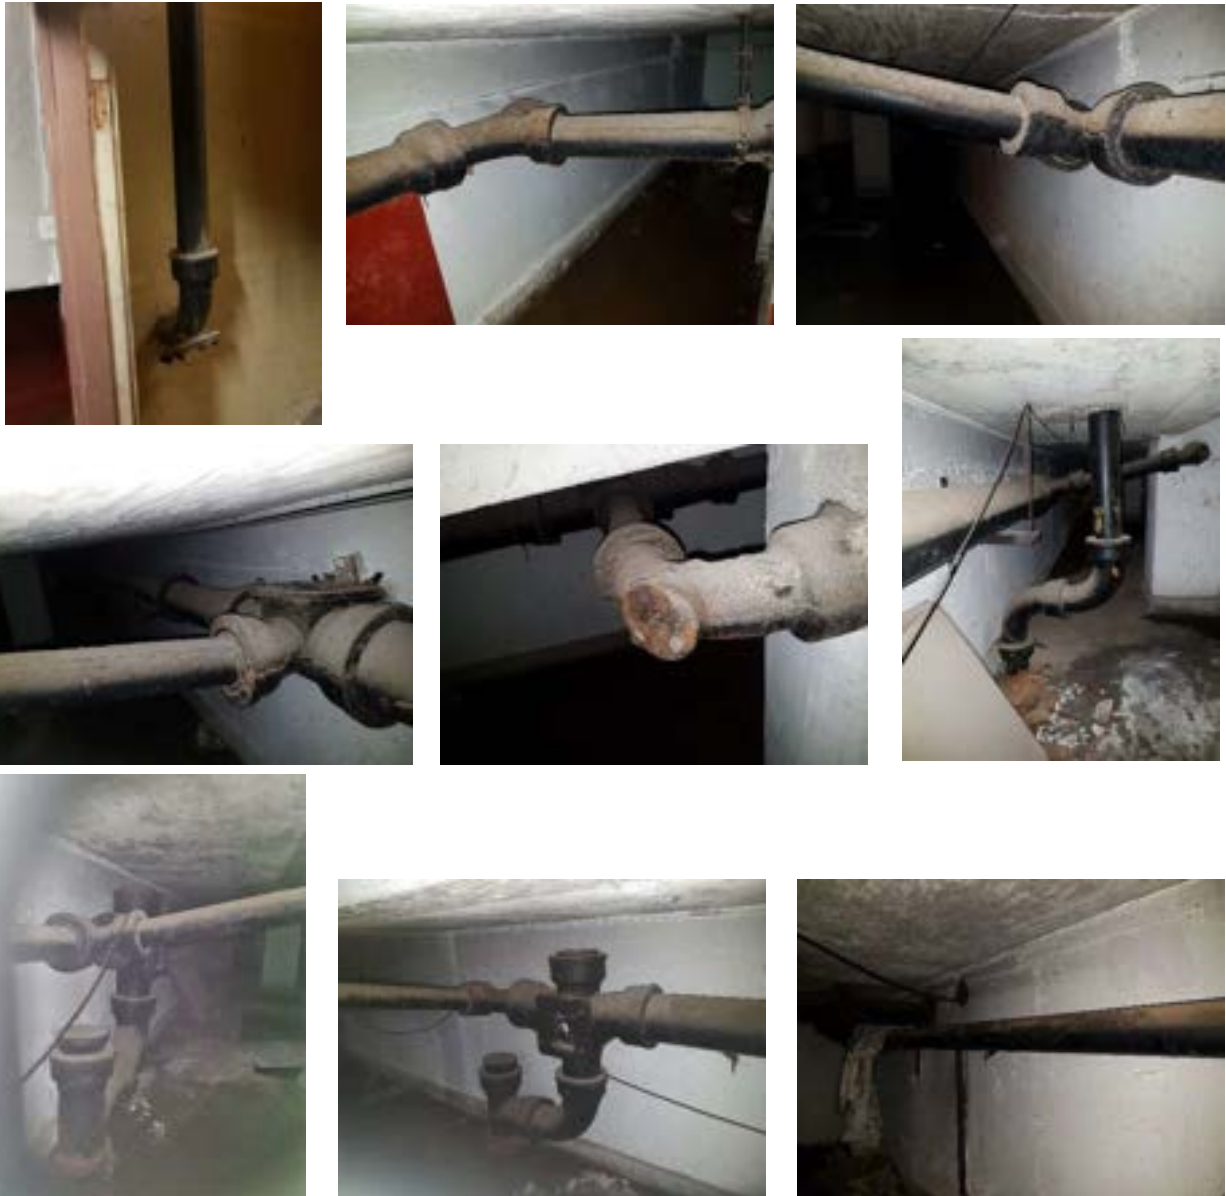
On entering the basement plantroom the cast iron rainwater drainage turns horizontal and then through 90° to pass on a fall all the way along the south wall of the plantroom to a discharge point just to the east of the previously discussed main inspection chamber.

The pipework is installed at low level beneath the edge beam and picks up rainwater connections that exit from each of the columns passed. The branches appear to be the rainwater drains from the southern edge of the main roof built into the concrete columns.

There are cleaning points along the route but the extremely restricted access to the pipework means these appear never to have been accessed.

Beyond the access point there is another branch that joins from the east direction under the mains cold water incoming main.

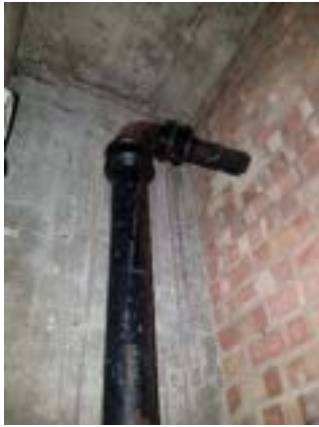
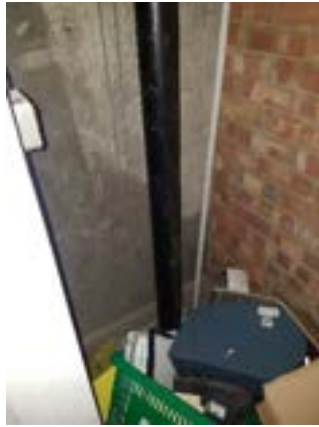
In a storage room off the western staff corridor at ground level there is a cast iron rainwater pipe that appears to be a rainwater drain for the flat roof identified on the drawings as the Sun Terrace.

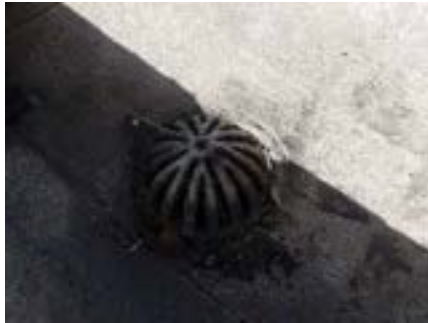
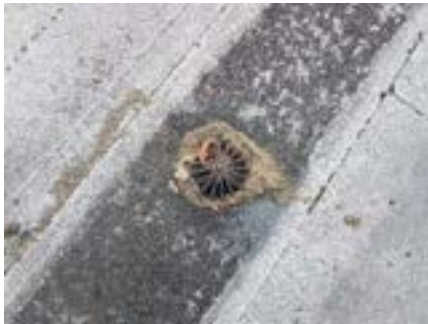
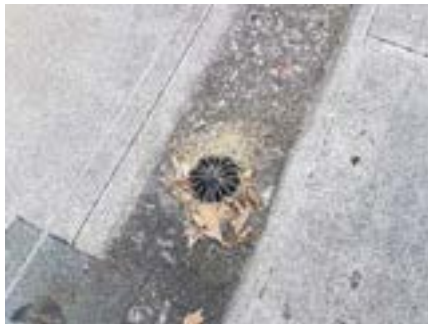
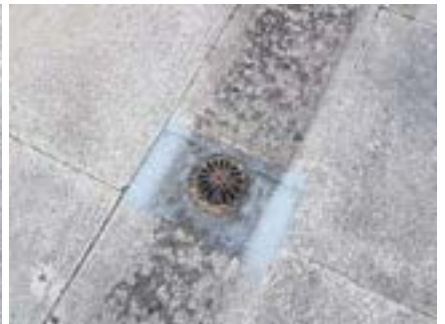
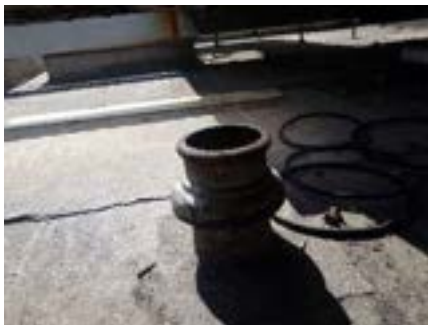
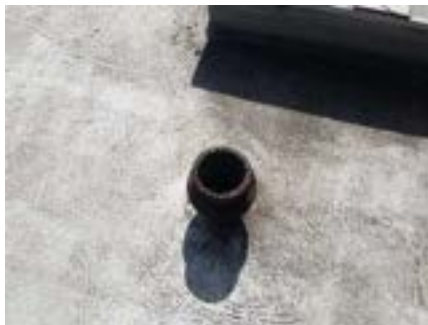
A selection of the rainwater outlets on the roof over the teaching pool showing broken and partially blocked covers. Also two soil and vent outlets neither fitted with a balloon cage to protect debris entering and blocking them.

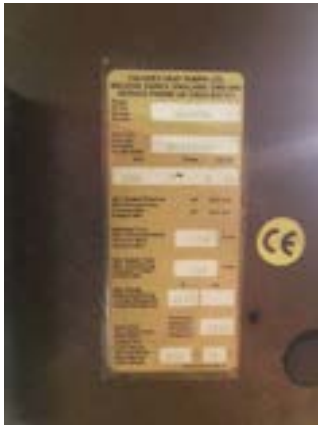
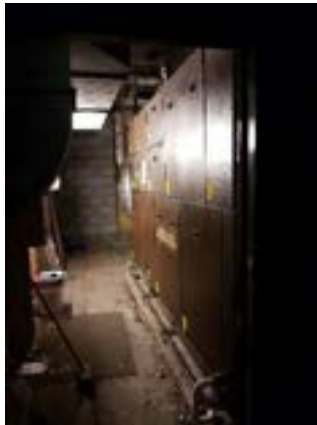
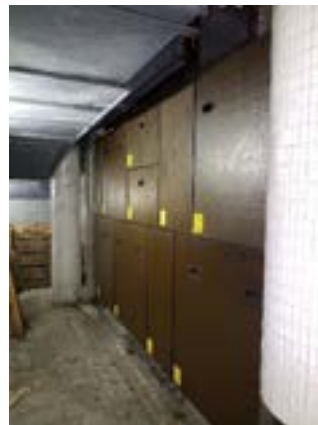
The Calorex manufacturers data plate, the view on entering the new plantroom, the view from the north side clearly showing how the new plantroom is an extension built around the old external columns and a view of the supply air connection off to the main pool hall.

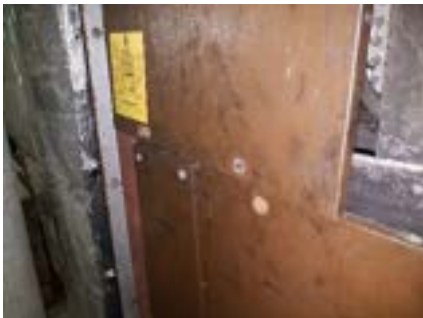
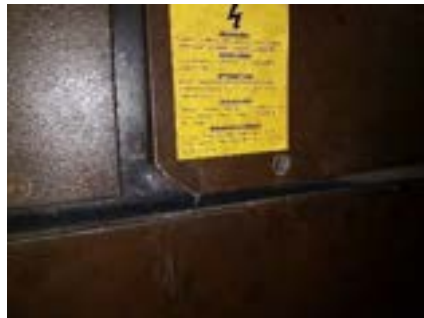
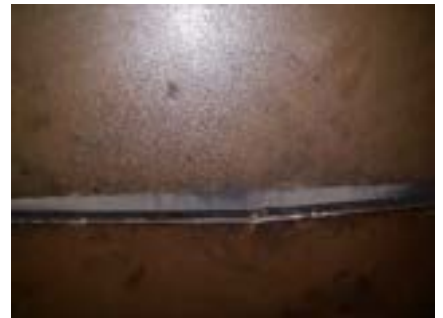
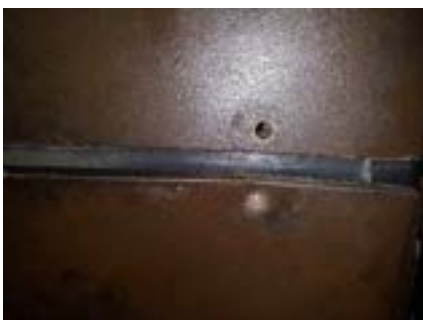
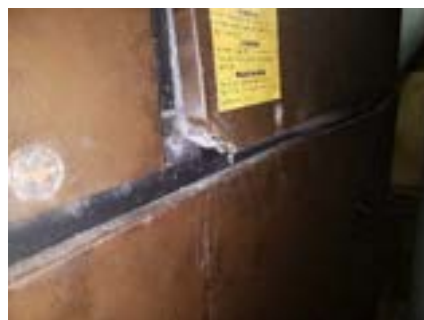
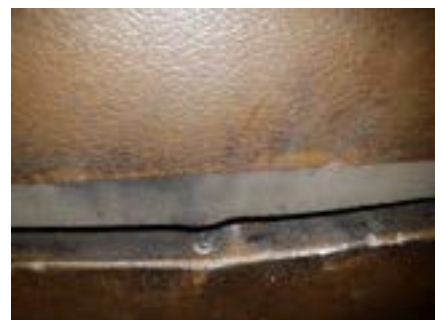
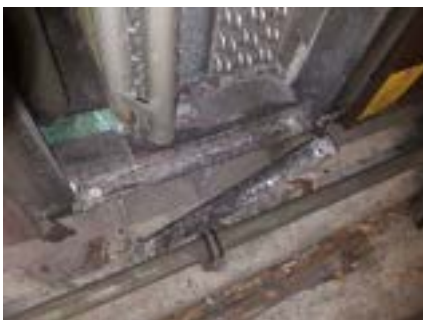
A selection of the access panels to the air handling unit showing the level of damage and missing turn-screws and damaged panels.
The panel seals are in a poor condition and leaking and in one instance rotted away completely.

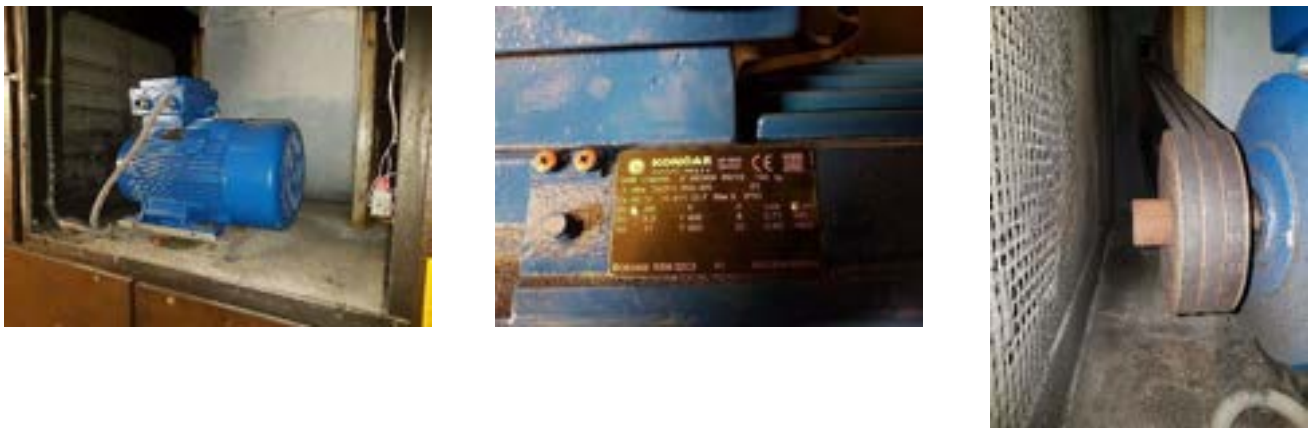
The motor to the return air/exhaust fan, the manufacturers plate and the fan belts.

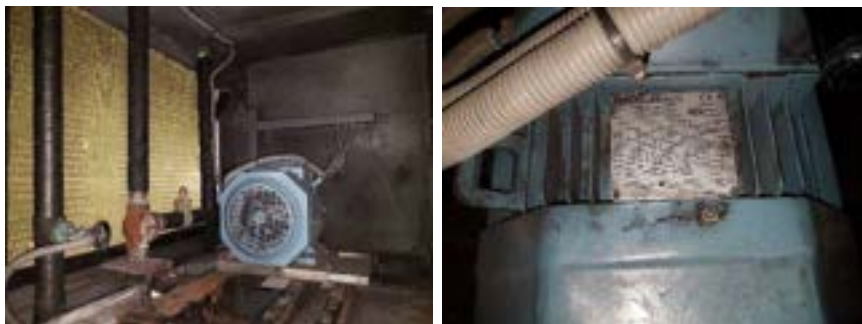
The supply air/fresh air fan motor and manufacturers motor plate

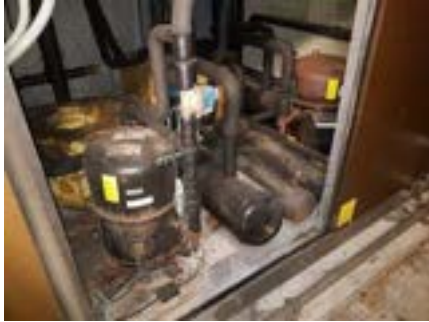
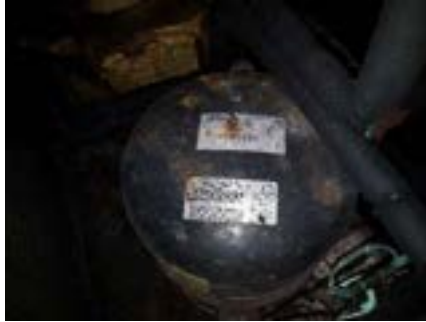
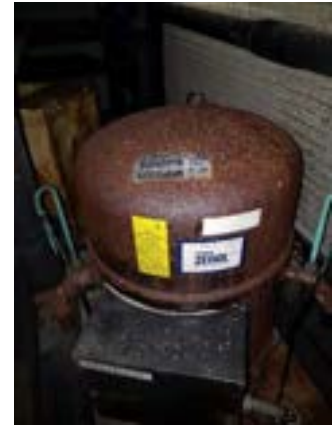
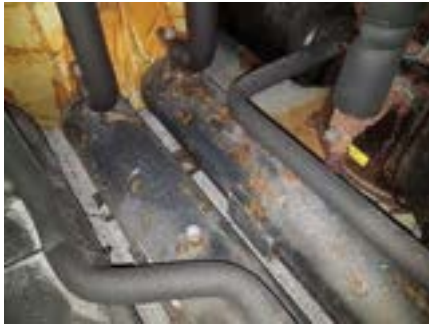
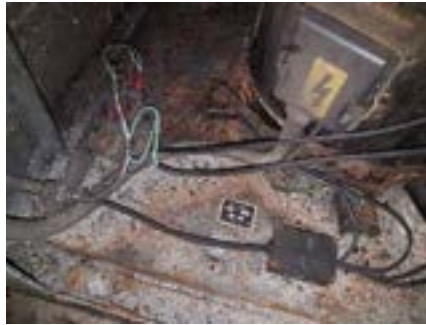
The non-operational refrigeration/de-humidification section. There is a high level of corrosion to both the casing and the equipment & wiring.

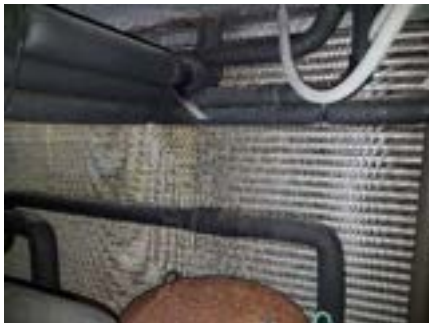
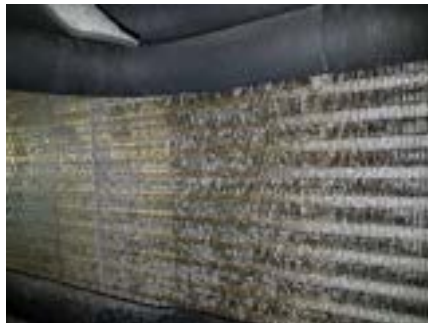
The de-humidification coil is very heavily corroded and the internal condensate drain channel was blocked.

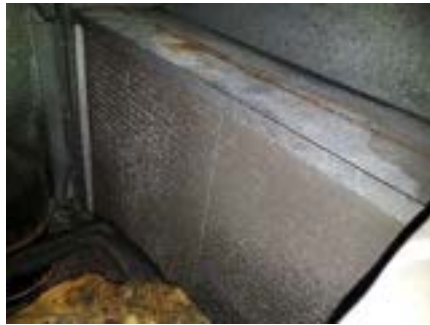
The lower recovered heat re-heat coil is very dirty and highly corroded. The coil has unlikely ever been cleaned and the accumulated level of dirt and dust mixed with the condensation has created a highly corrosive covering to the coil.

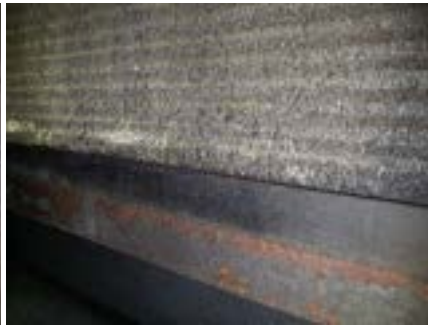
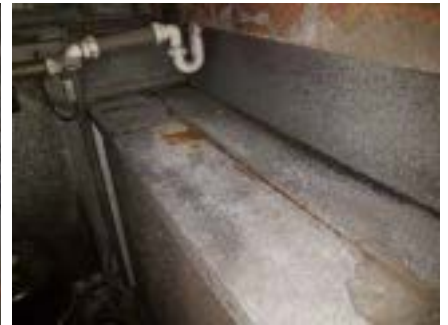
The upper heat recovery coil is very dirty and highly corroded. The coil has unlikely ever been cleaned and the accumulated level of dirt and dust mixed with the condensation has created a highly corrosive covering to the coil.

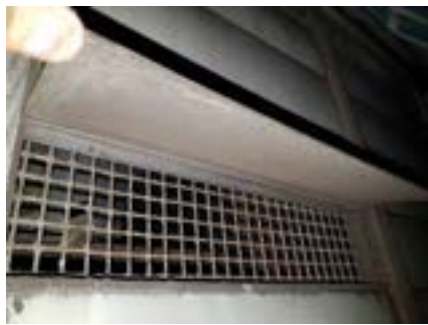
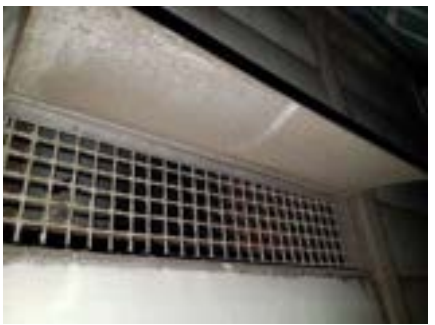
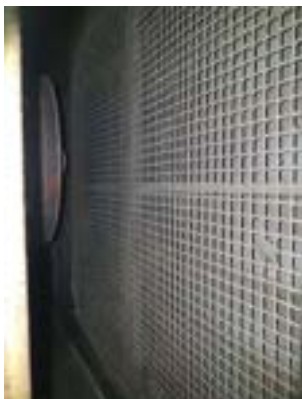
The reheated and recycled air is drawn by the supply air/fresh air fan through simple gravity non-return dampers. These dampers are operational but very dirty as is the mesh grille protecting them on the exhaust fan side.

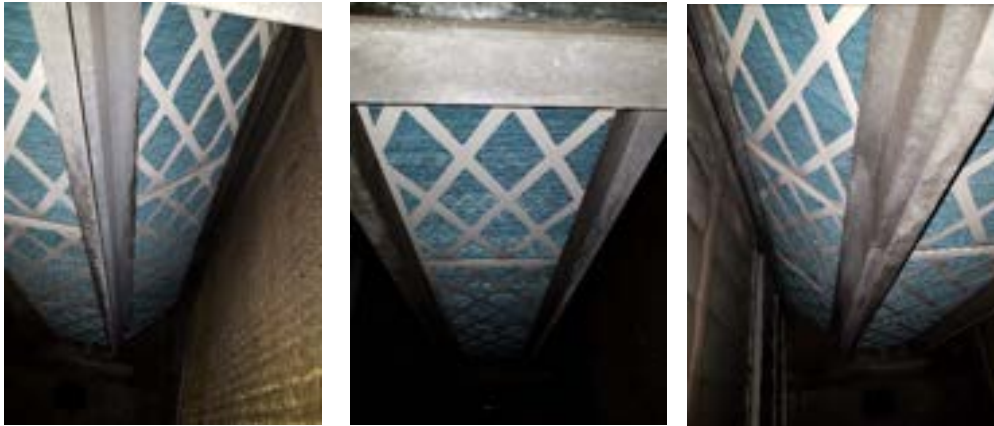
There is a bank of 9 fresh air panel filters at 560mm x 320mm x 15mm.
The filters look to be relatively new and are extremely clean.

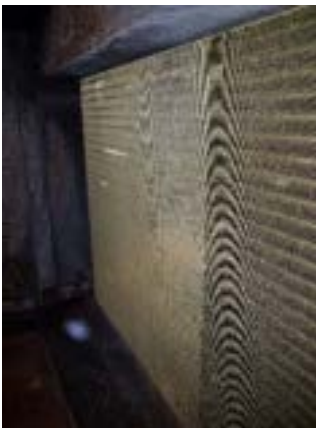
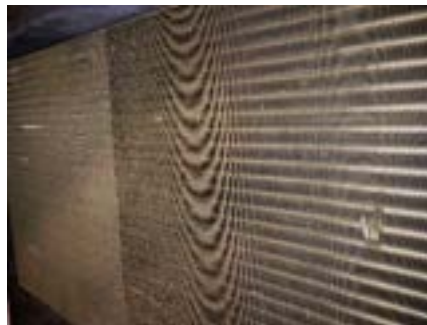
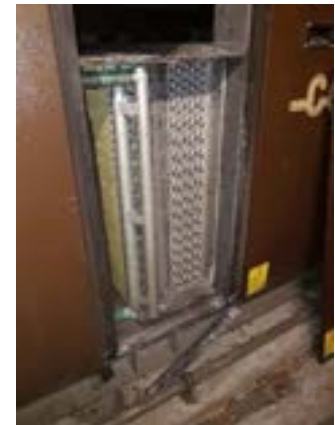
The lower re-heat coil is very dirty and highly corroded. The coil has unlikely ever been cleaned and the accumulated level of dirt and dust mixed with the condensation has created a highly corrosive covering to the coil. The coil is in two parts, the larger section is fed from the recovered pool water whilst the smaller is fed from the LPHW heating system.
