Condition Survey & Report
for the
**Mechanical & Electrical
Services Installation**
at
St Georges Swimming Pool
221 The Highway
London, E1W 3BP

Report produced for
**London Borough of Tower
Hamlets**
Technical Services Team
2nd Floor (Annexe)
Mulberry Place
5 Clove Crescent
London, E14 2BG

Reference	21012-CSR-101a
Prepared by	S Godden
Date	November 2021

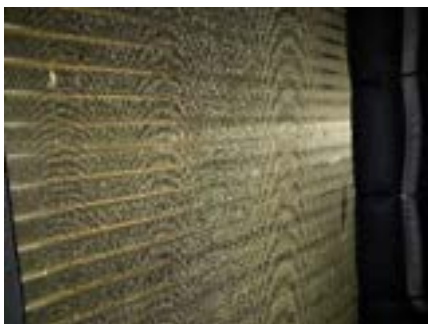
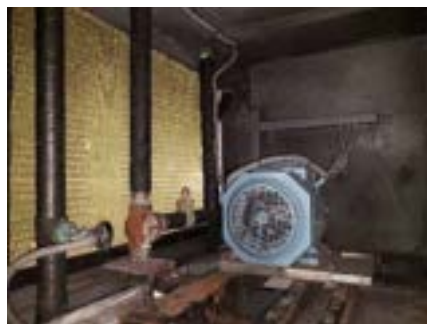
The upper reheat coil is fed from the LPHW heating system and is very dirty and heavily corroded. The coil has unlikely ever been cleaned and the accumulated level of dirt and dust mixed with the condensation has created a highly corrosive covering to the coil.

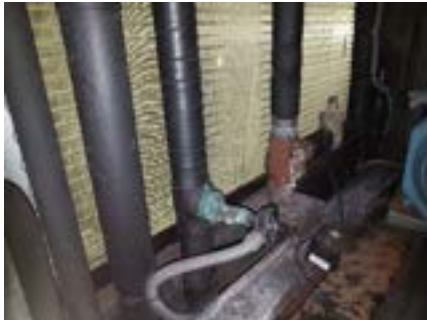
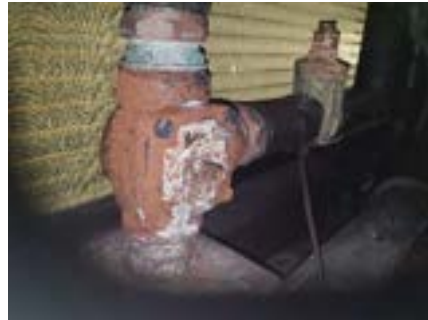
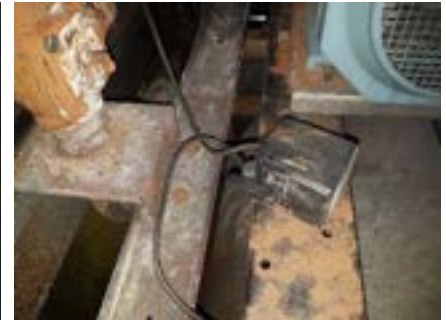
The heating controls to the LPHW re-heat coil. Note the actuator removed from the three port valve; it is our understanding that the staff manually reset the level of this valve depending on whether the pool hall is too hot or too cold. Also note the level of corrosion on the valve from leaks and the exposed wiring.

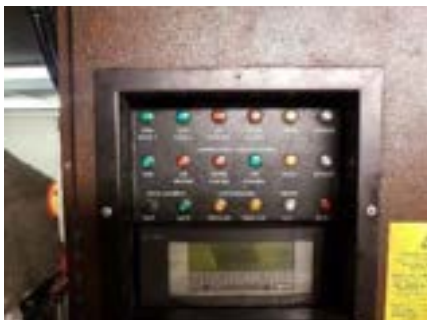
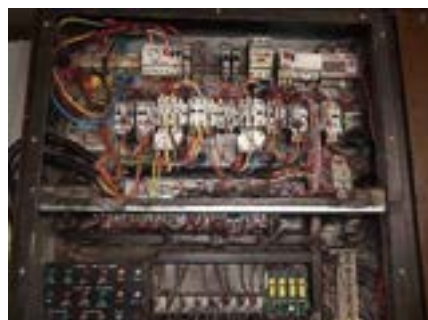
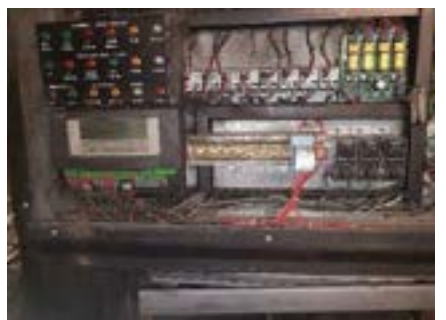
The manufacturers control panel. The liquid crystal display is non-operational but the circuits are live. There is no wiring diagram and the panel appears to have been heavily modified and there is a hand-written notice on the access panel to the controls regarding the operation of the air handling unit and the valves.

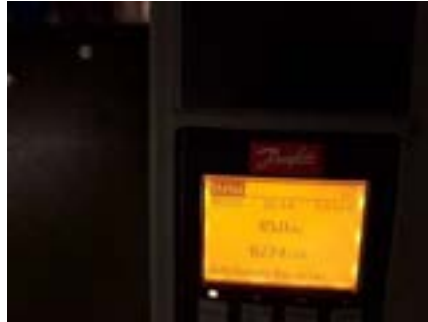
The supply and the extract fans have recently been fitted with inverter drives.

It is believed the fitting of these is to enable some level of control over the level of heating to the main pool hall to compensate for the lack of control over the heating by the three port valve.

This seems an awfully expensive approach over actually getting the heating control valve to operate correctly. It will also be detrimental to the conditions in the main pool hall because it changes the level of ventilation required purely on the basis of temperature and not the overall conditions or personnel.

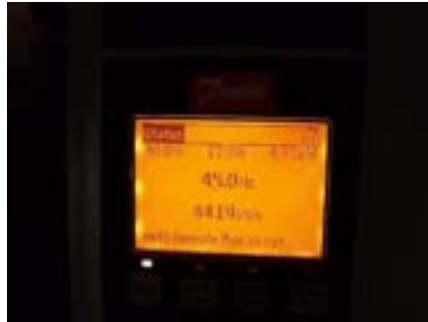
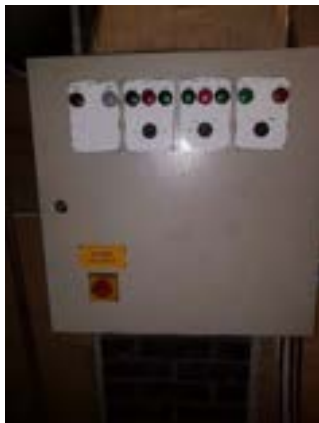
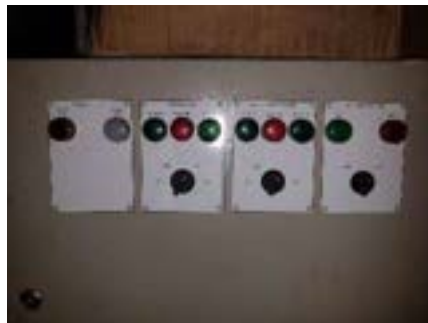
There is a small control panel on the south wall of the new plantroom that appears was designed to control the heating pumps, the recovered heat pumps and the recirculation fan. The panel is switched off and offering no control the air handling unit and the associated pumps.

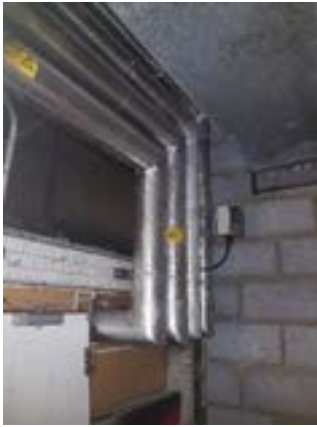
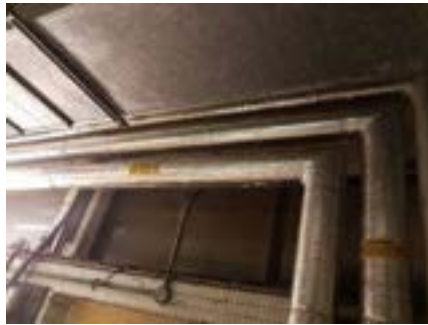
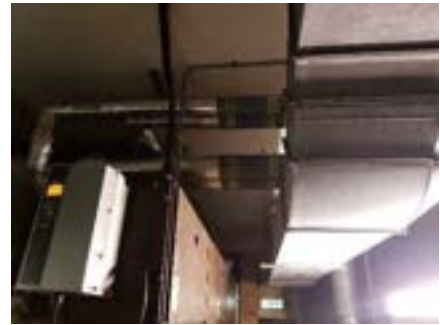
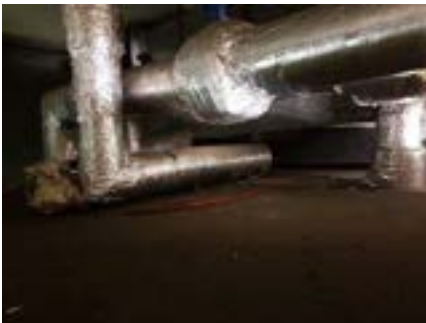
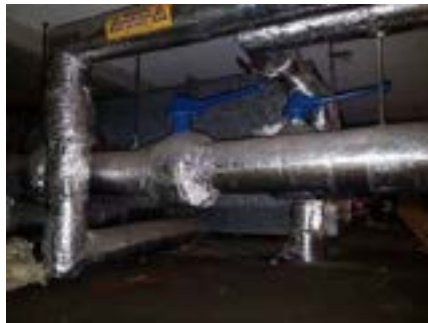
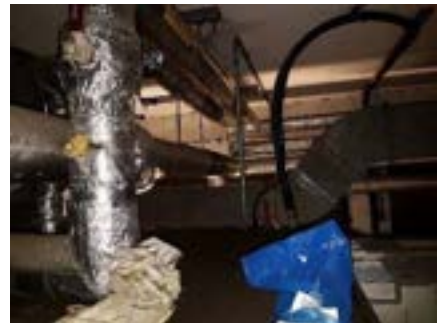
The recovered heating and the LPHW heating circuit pipework where they enter the new plantroom from the old fresh air plenum in the basement plantroom. The larger pipes are the recovered heating circuit whilst the smaller pipes are the LPHW circuit. The pipework enters the air handling unit from above and drops to connect with the 3 port control valves and the heating coils. These heating circuits are installed in mild steel tube with lever operated isolating valves which are clean and thermal insulation with a foil faced vapour sealed finish with correct identification and direction arrows.

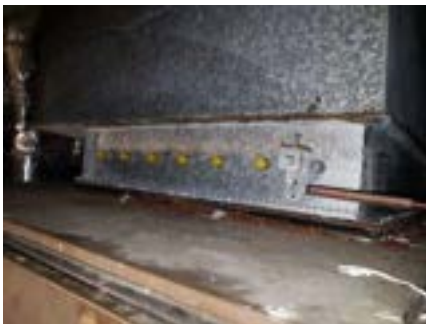
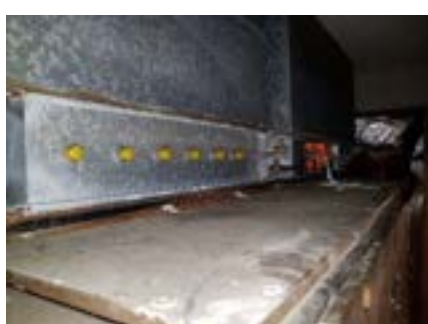
The linked fresh air inlet and exhaust air outlet dampers.

Although linked, necessary in order to maintain balanced conditions, these dampers are inoperative partly because of seizure and partly because there is nothing driving the actuator.

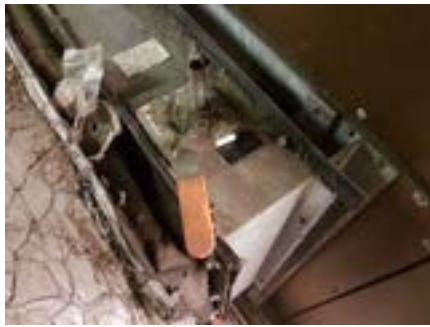
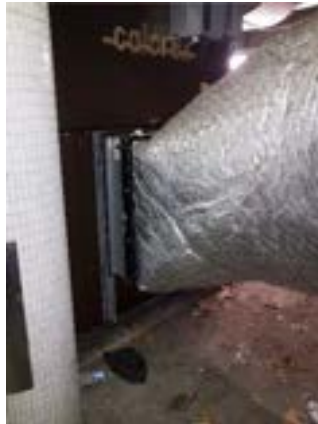
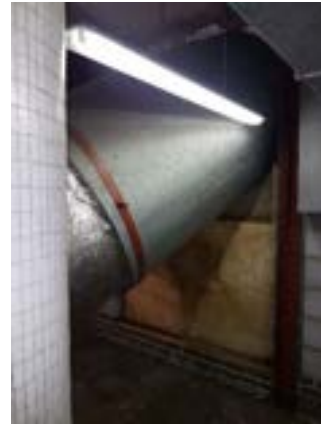
There is a manual volume control damper on the supply air ductwork to the pool hall installed in an unconventional vertical arrangement. Also note the damage to the flexible connection and the large diameter attenuator installed on an angle.

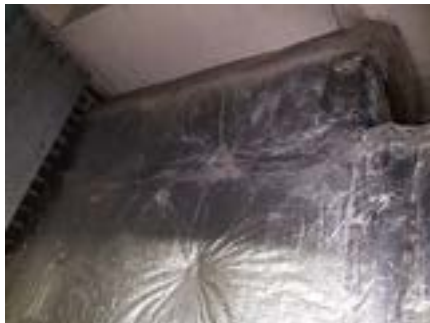
The return air duct from the main pool hall is well insulated where it enters the new plantroom through the flat roof and the connection is dry indicating it is weathertight.

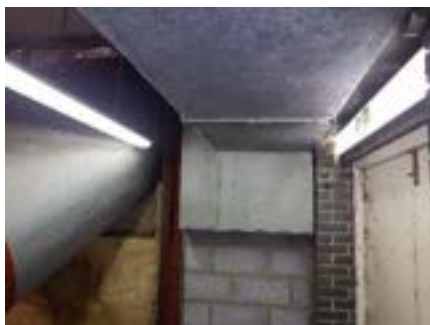
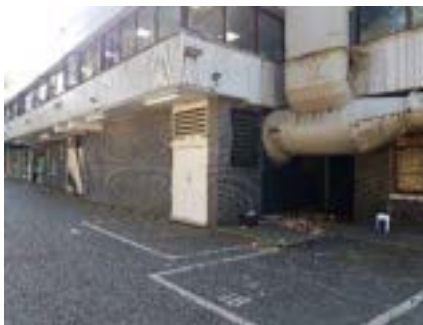
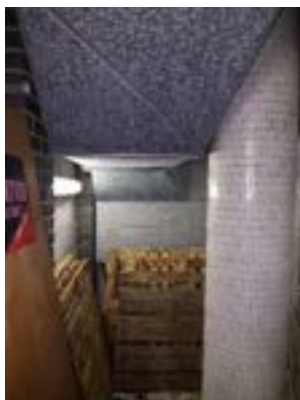
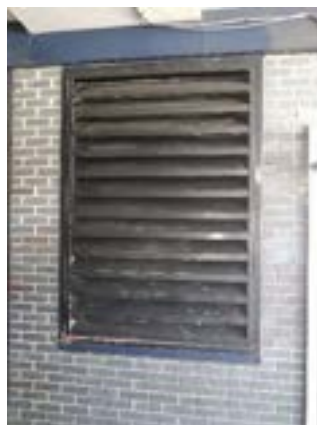
The fresh air intake and extracted air exhaust connections at either end of the new plantroom along with the respective external louvres at either end of the new plantroom.

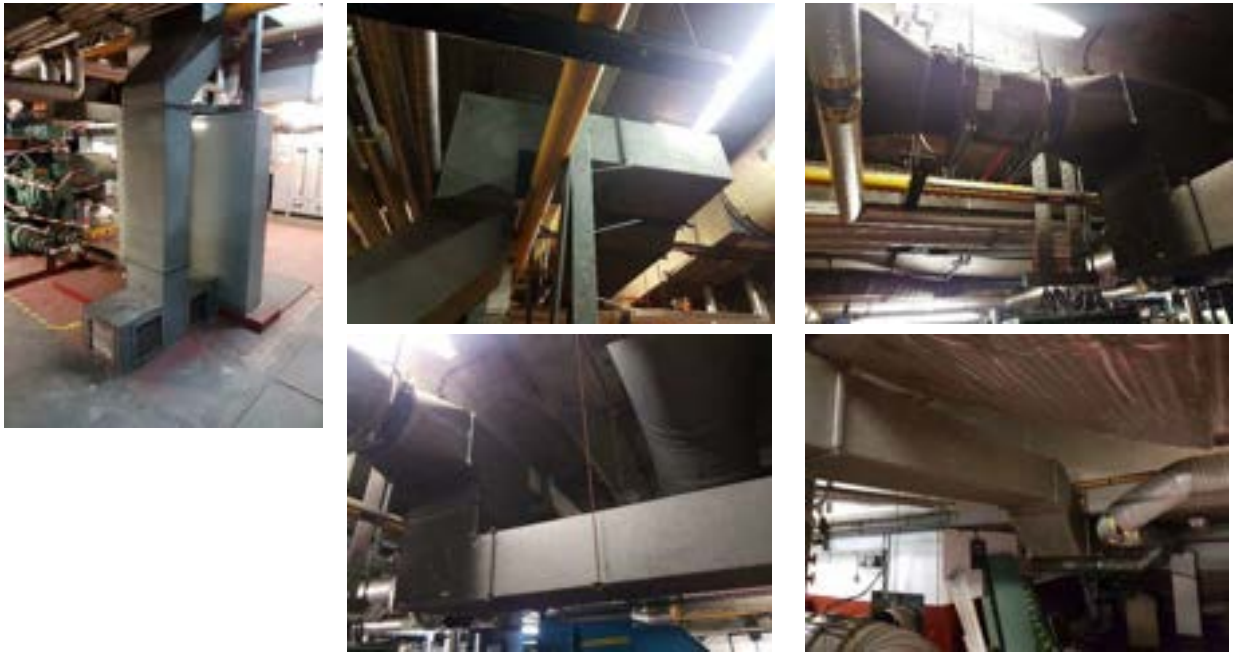
Single only – no back up facility, failure would isolate boilers

Not proved controls interface to boilers – boilers must be isolated if fans fail to run

The boiler combustion supply air system showing the 3 no. grilles the ductwork at high level, the single case axial supply fan and where the system enters the old fresh air plenum.

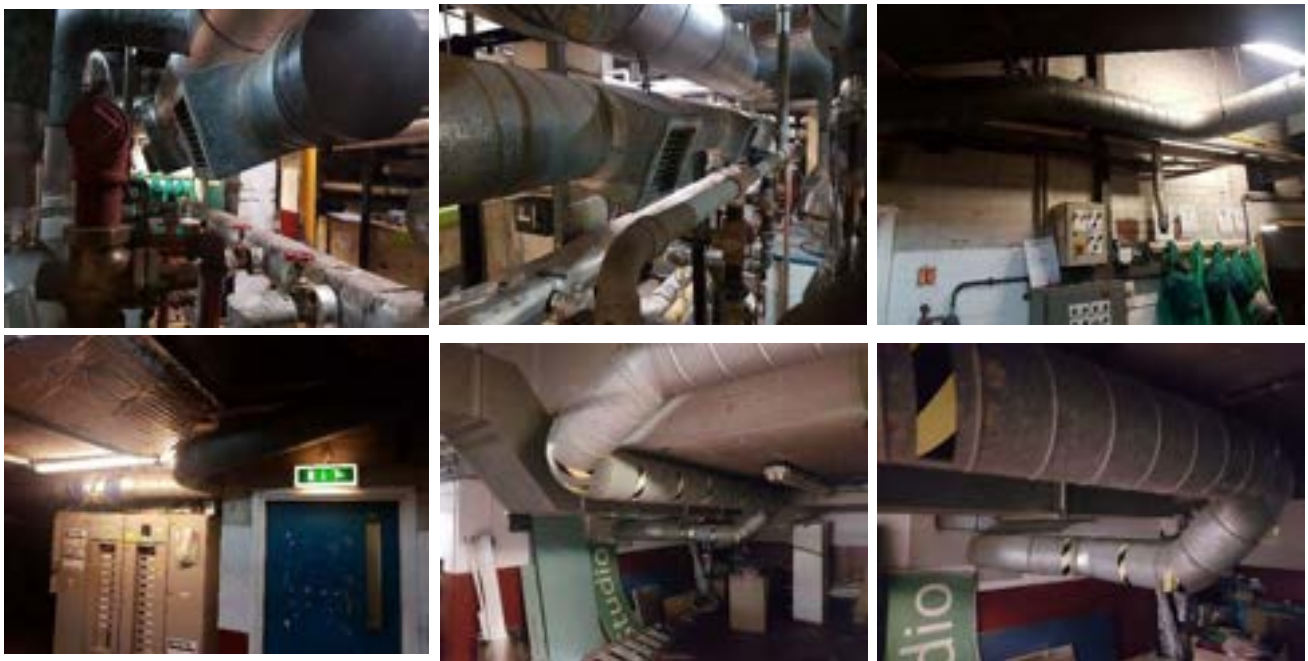
The boiler combustion air extract system showing the 3 no. grilles above the boilers, the ductwork at high level, the cased axial extract fan located above the main electrical distribution for the building and where the system enters the old fresh air plenum.

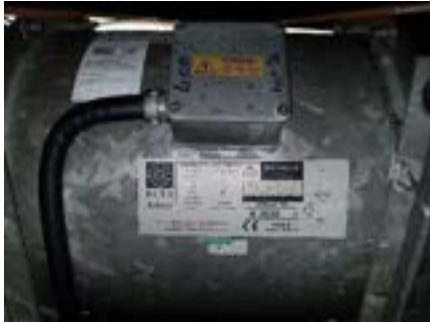
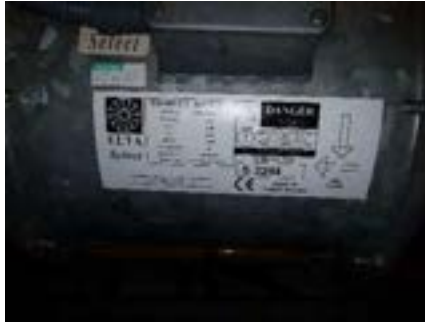
The manufacturers data plates on both the boiler combustion air supply and extract fans.

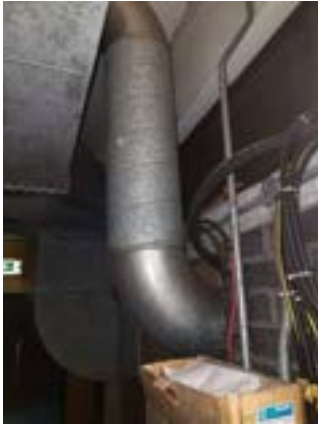
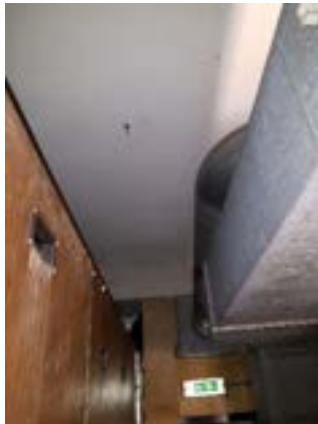
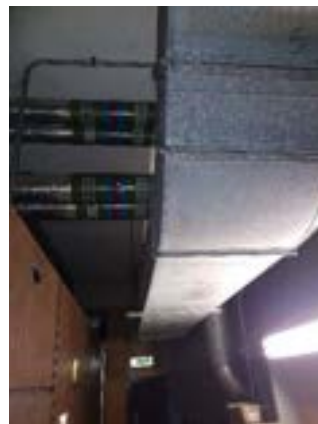
The boiler combustion supply and extract ventilation ductwork must rise in the old fresh air plenum as they appear through the south wall of the new plantroom and rise to high level in there. The supply air duct turns towards the west wall whilst the extract duct turns and heads towards the east wall.

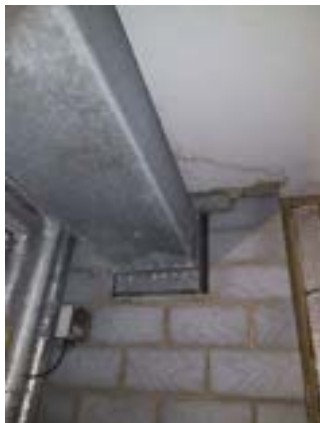
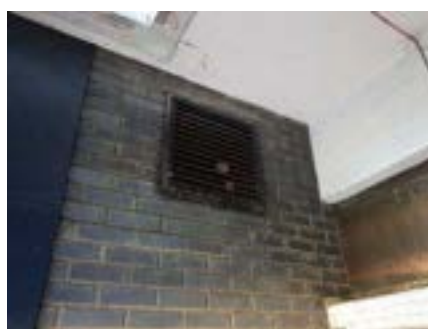
The boiler combustion supply and extract air connections to the external walls within the new plantroom and the respective external louvres on the exterior of the building.

Both the louvres are dirty and require a good clean which is most probably applicable to the ductwork systems as well.

Also note the absence of any fire dampers or fire protection to the ductwork required because the boiler combustion supply and extract ductwork cross through different fire compartments.

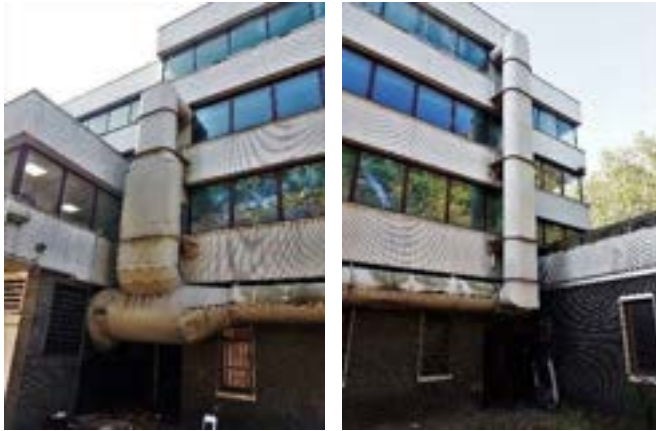
The main pool hall supply air duct where it exits the new plantroom and rises to serve the first and second floors and where it continues and rises to serve the third floor.

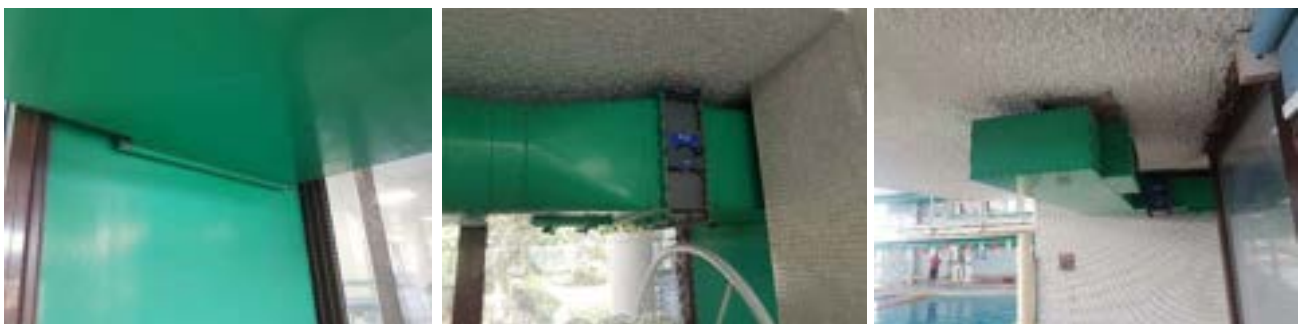
The point where the first floor supply air duct enters from external to the building and splits into two branches, one to the east with just a single grille and the other to the west where the duct covers the part of the north face and the complete west and south face of the main pool hall.

Also note the absence of any fire dampers.

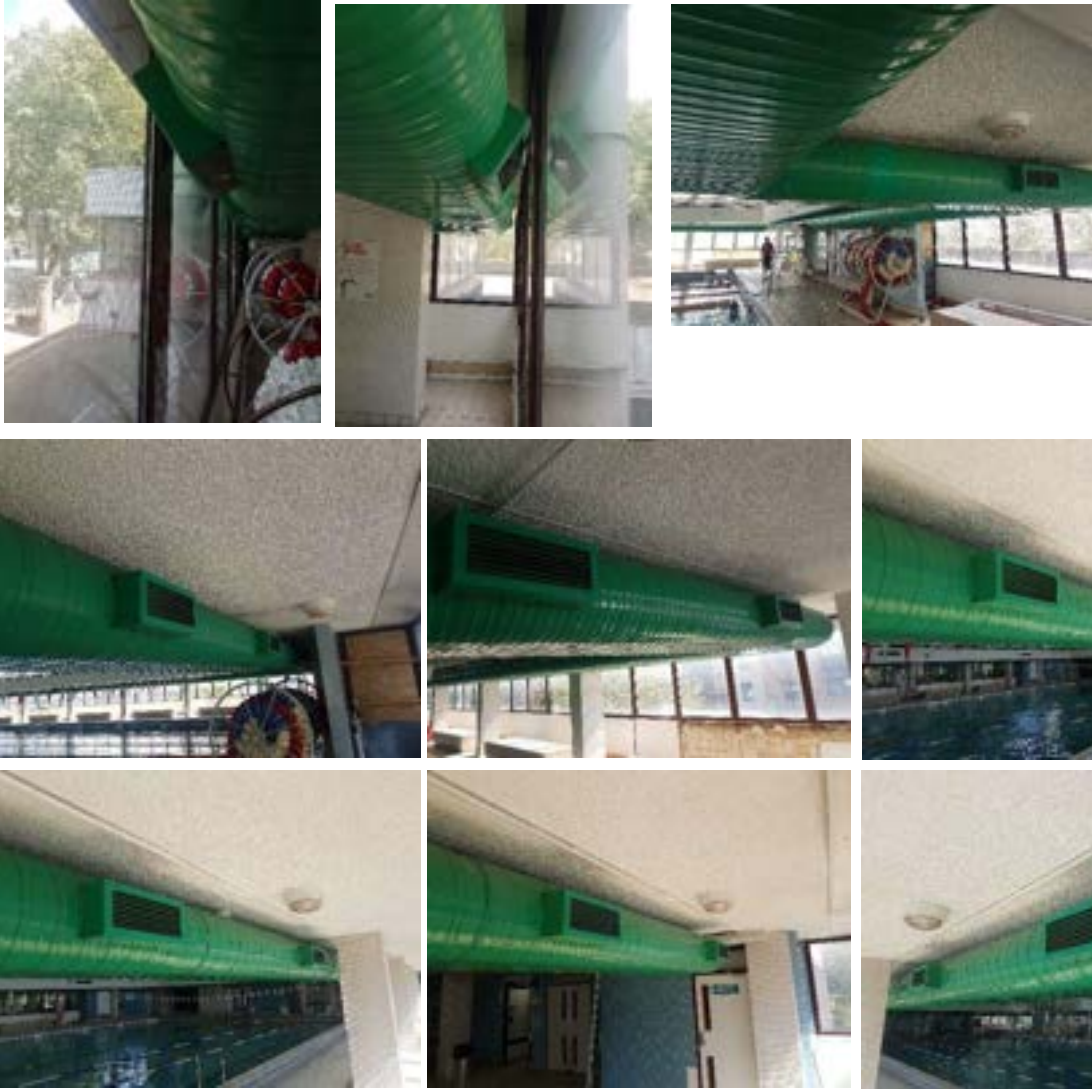
The supply air ductwork around the 1st floor level of the main pool hall. The dirty grilles are most probably a reflection of the interior of the ductwork as well and all need cleaning.

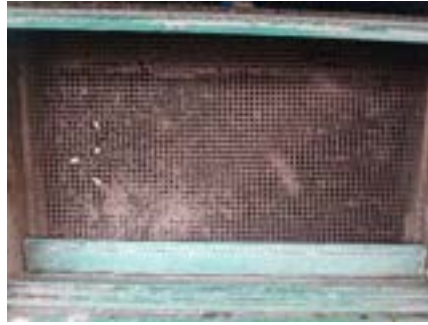
The supply air ductwork around the second floor viewing gallery. The ductwork is installed as a continuous loop from the entry point therefore there is no static pressure point for the fan. Of note is an open electrical junction box that appears to be live.

There is also a louvre into the vertical riser that appears to have been the previous return air path and where fresh air and heat is still being lost and wasted.

The dirty grilles are most probably a reflection of the interior of the ductwork as well and all need cleaning and there is no fire damper.

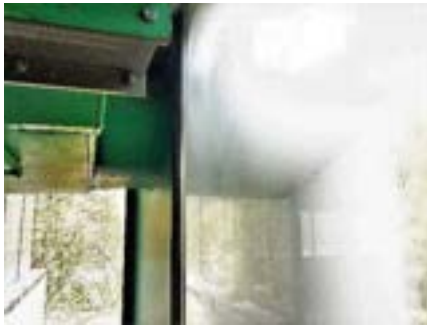
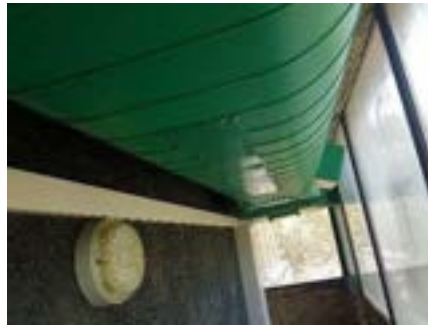
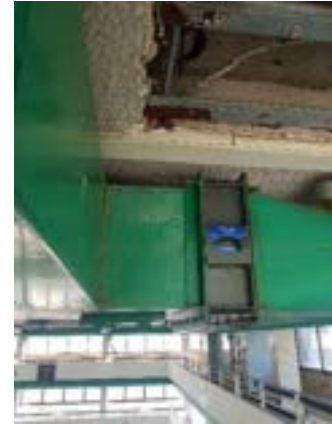
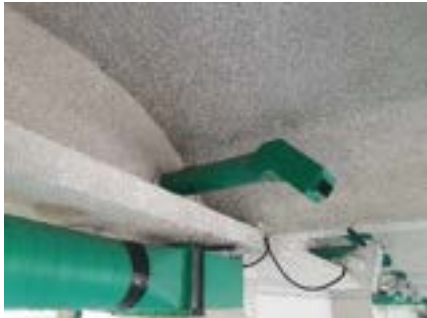
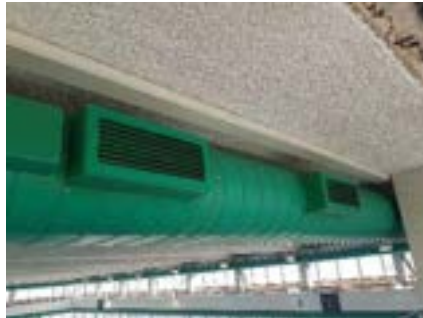
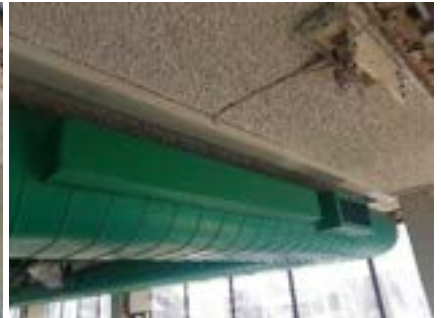
The supply air ductwork around the third floor viewing gallery. The ductwork is installed as a continuous loop from the entry point therefore there is no static pressure point for the fan.

The dirty grilles are most probably a reflection of the interior of the ductwork as well and all need cleaning.

Also note the absence of any fire dampers.

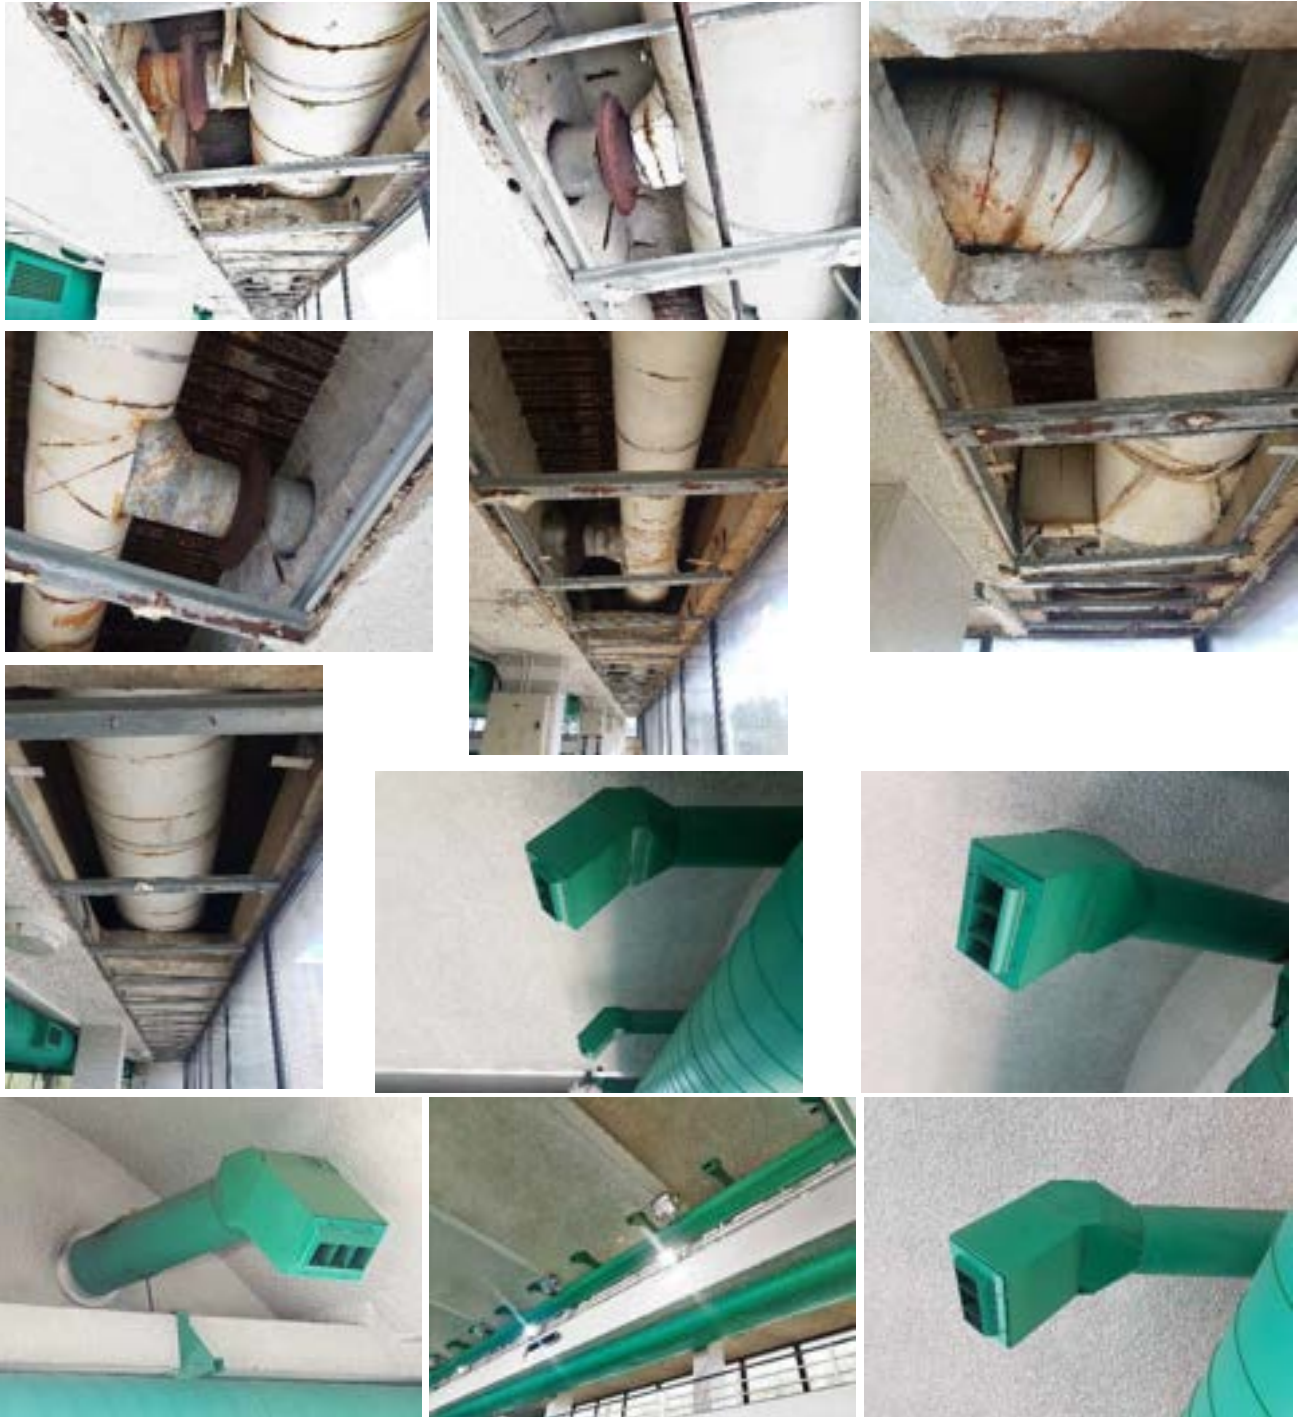
Of interest at third floor level is the original supply air distribution system comprising a circular duct that commenced in the vertical services riser and passed as a continuous loop around the complete pool hall and which appears to have served high velocity nozzles located all around the main pool hall at high level through individual branches each fitted with an iris style volume control damper. It is also interesting that these high velocity nozzles have been painted the same colour as the operational ductwork.

Whilst this system is out of use, the connections into the vertical services riser still exist and account for the smell of chlorinated air within the riser. This movement of air is wasting valuable energy and needs to be removed.

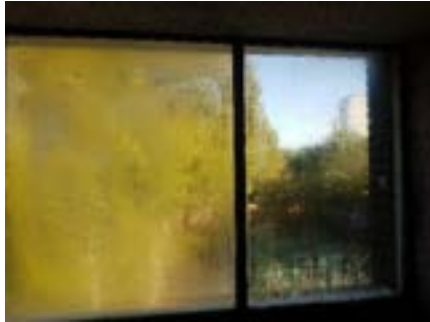
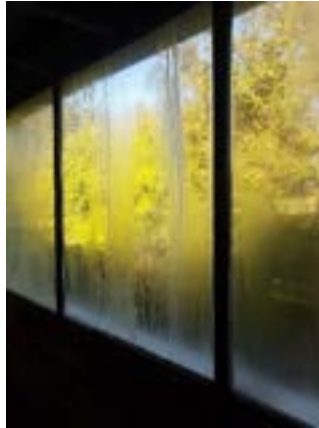
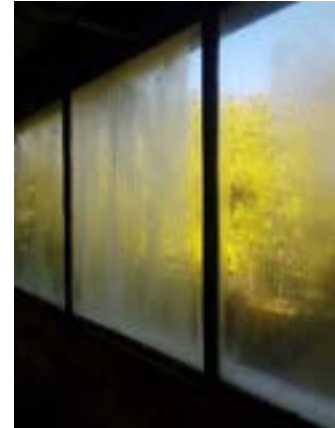
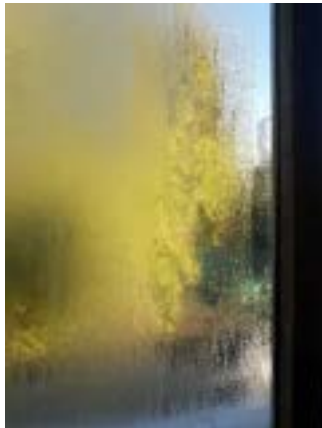
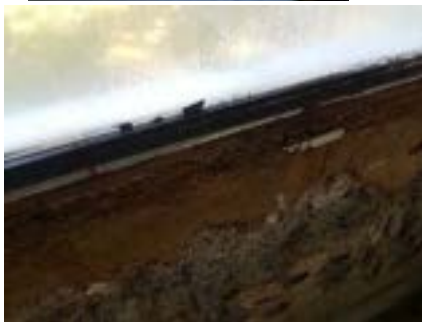
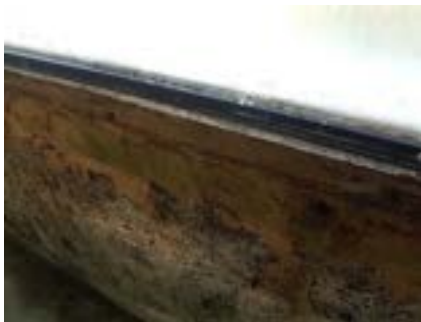
On 18 October 2019 the level of condensation at third floor viewing gallery level was particularly bad and it was apparent that this was c=occurring in the areas where the plaster finish to the walls had previously become detached

The level of condensation on the windows, particularly in the 3rd Floor Viewing Gallery has deteriorated seriously and cause heavy corrosion to the window frames as well.

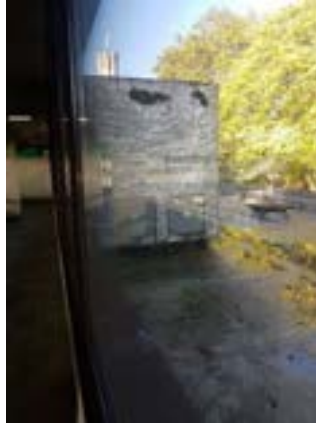
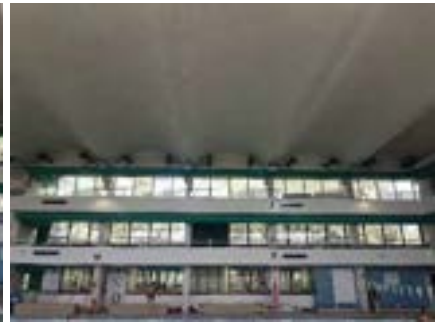
The large extract/return air louvre on the north wall of the second floor public viewing gallery. The position of the return air duct through the flat roof into the first floor fitness suite and then the new plantroom.

The location of the return air louvre is easy to identify on the north side of the second floor visitor's gallery.

Of note is the absence of any fire damper behind the louvre.

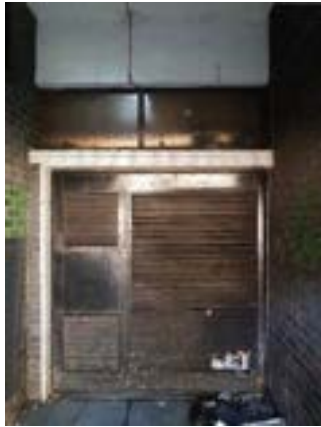
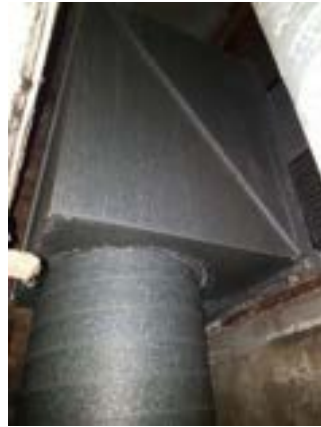
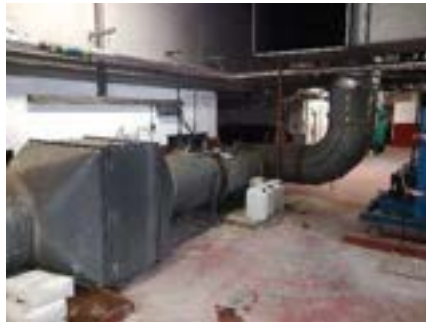
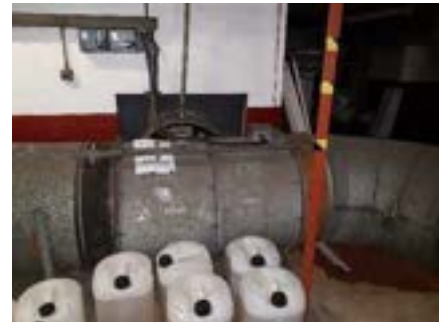
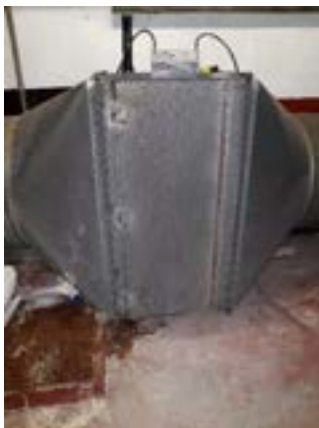
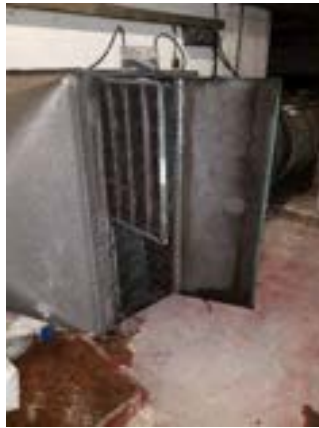
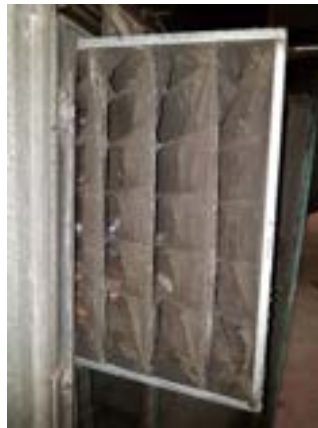
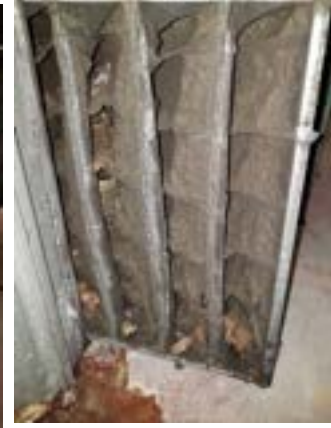
The supply air to the changing rooms originates at a weather louvre at ground level on the north wall of the building and to the west of the new plantroom. The louvre, along with two smaller louvres that provide natural ventilation to the basement plantroom, are installed in an opening that has the appearance of having previously been a doorway.

A 760mm diameter circular galvanised steel duct extends from this louvre to eventually connect to a twin-bank of bag filters. These filters are in a disgusting, rotten state and haven't been touched in years and present a severe health hazard. There is evidence of corrosion and a water leak from the filter housing most probably the result of the blocked filters.

The duct connects, via a flexible connection, to a contra-rotating galvanised steel case axial fan.

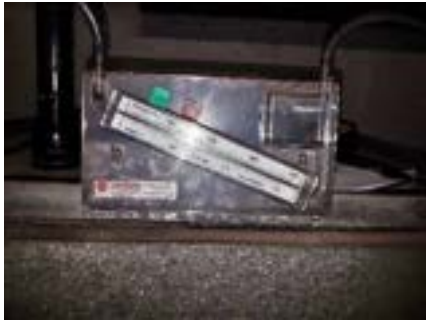
The filters have a pressure loss manometer fitted across them but this without any fluid

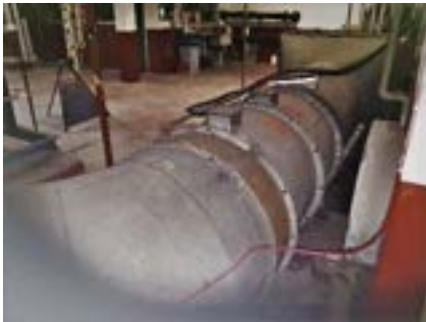
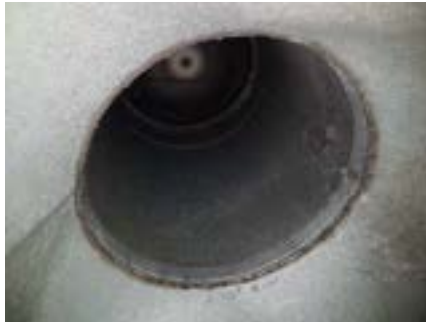
The supply air fans are noisier than we would have expected but are relatively clean, most probably because of the blocked filters. The lack of airflow may also be the cause of the noise.

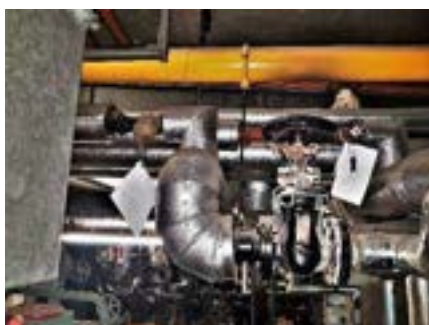
The flow and return to the heating coil have previously been discussed but the Staefa 3 port diverting valve is non-operational as witness the manual procedure labels on the local isolating valves.

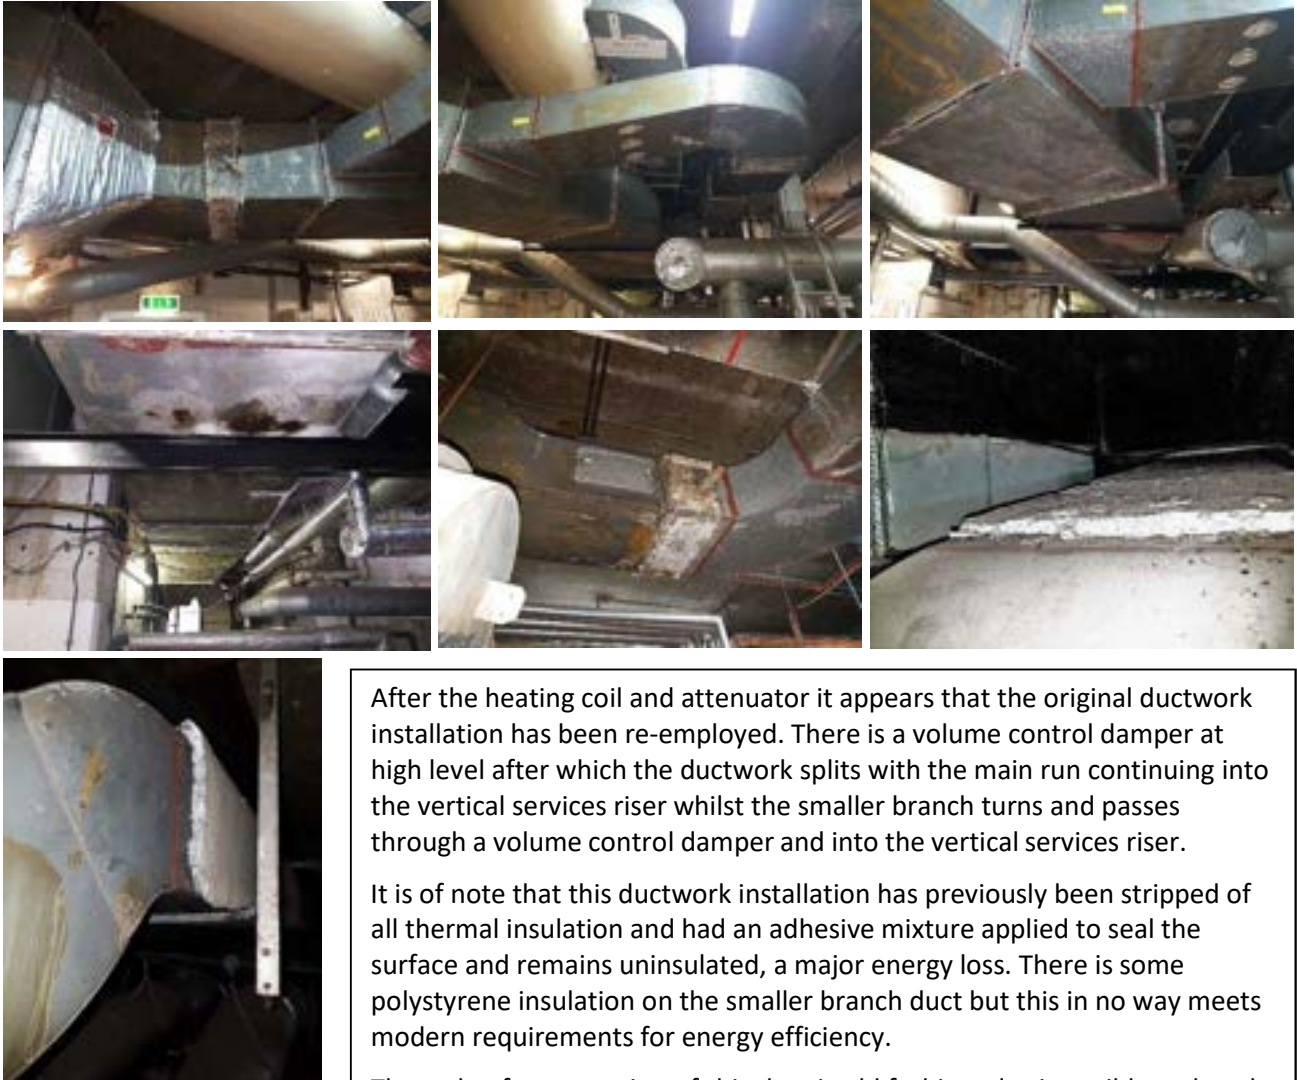
After the heating coil and attenuator it appears that the original ductwork installation has been re-employed. There is a volume control damper at high level after which the ductwork splits with the main run continuing into the vertical services riser whilst the smaller branch turns and passes through a volume control damper and into the vertical services riser.

It is of note that this ductwork installation has previously been stripped of all thermal insulation and had an adhesive mixture applied to seal the surface and remains uninsulated, a major energy loss. There is some polystyrene insulation on the smaller branch duct but this in no way meets modern requirements for energy efficiency.

The style of construction of this duct is old fashioned using mild steel angle to form the joints, a method that has not been regularly used for more than 40 years and provides evidence that is a part of the original installation.

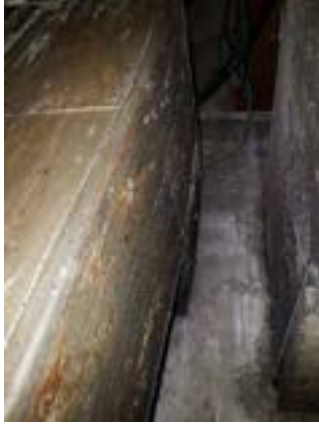
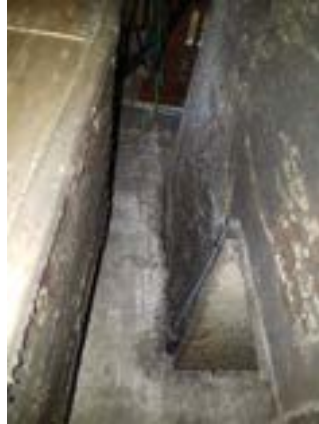
The supply air ducts are difficult to access within the vertical services riser but both leave the riser by passing through the wall approximately in the area of the first floor changing rooms.
Also of note is the absence of any fire dampers in the wall.

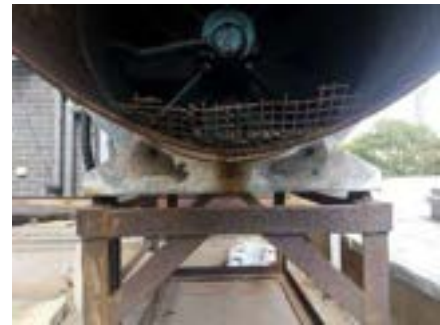
The changing rooms extract fans at first floor roof level are the lower, circular fans. The upper, rectangular outlet is believed to be the previous main pool extract/exhaust duct outlet and is out of use.

The extract fans are very dirty which will be a serious impediment to their performance and the 2nd stage fan is non-operational even though the isolator is turned on.

The bird mesh protection to the front of the fan outlet is corroded away.

The contra rotating extract fans are reasonably well supported with anti-vibration mounts although these are showing signs of UV degradation.

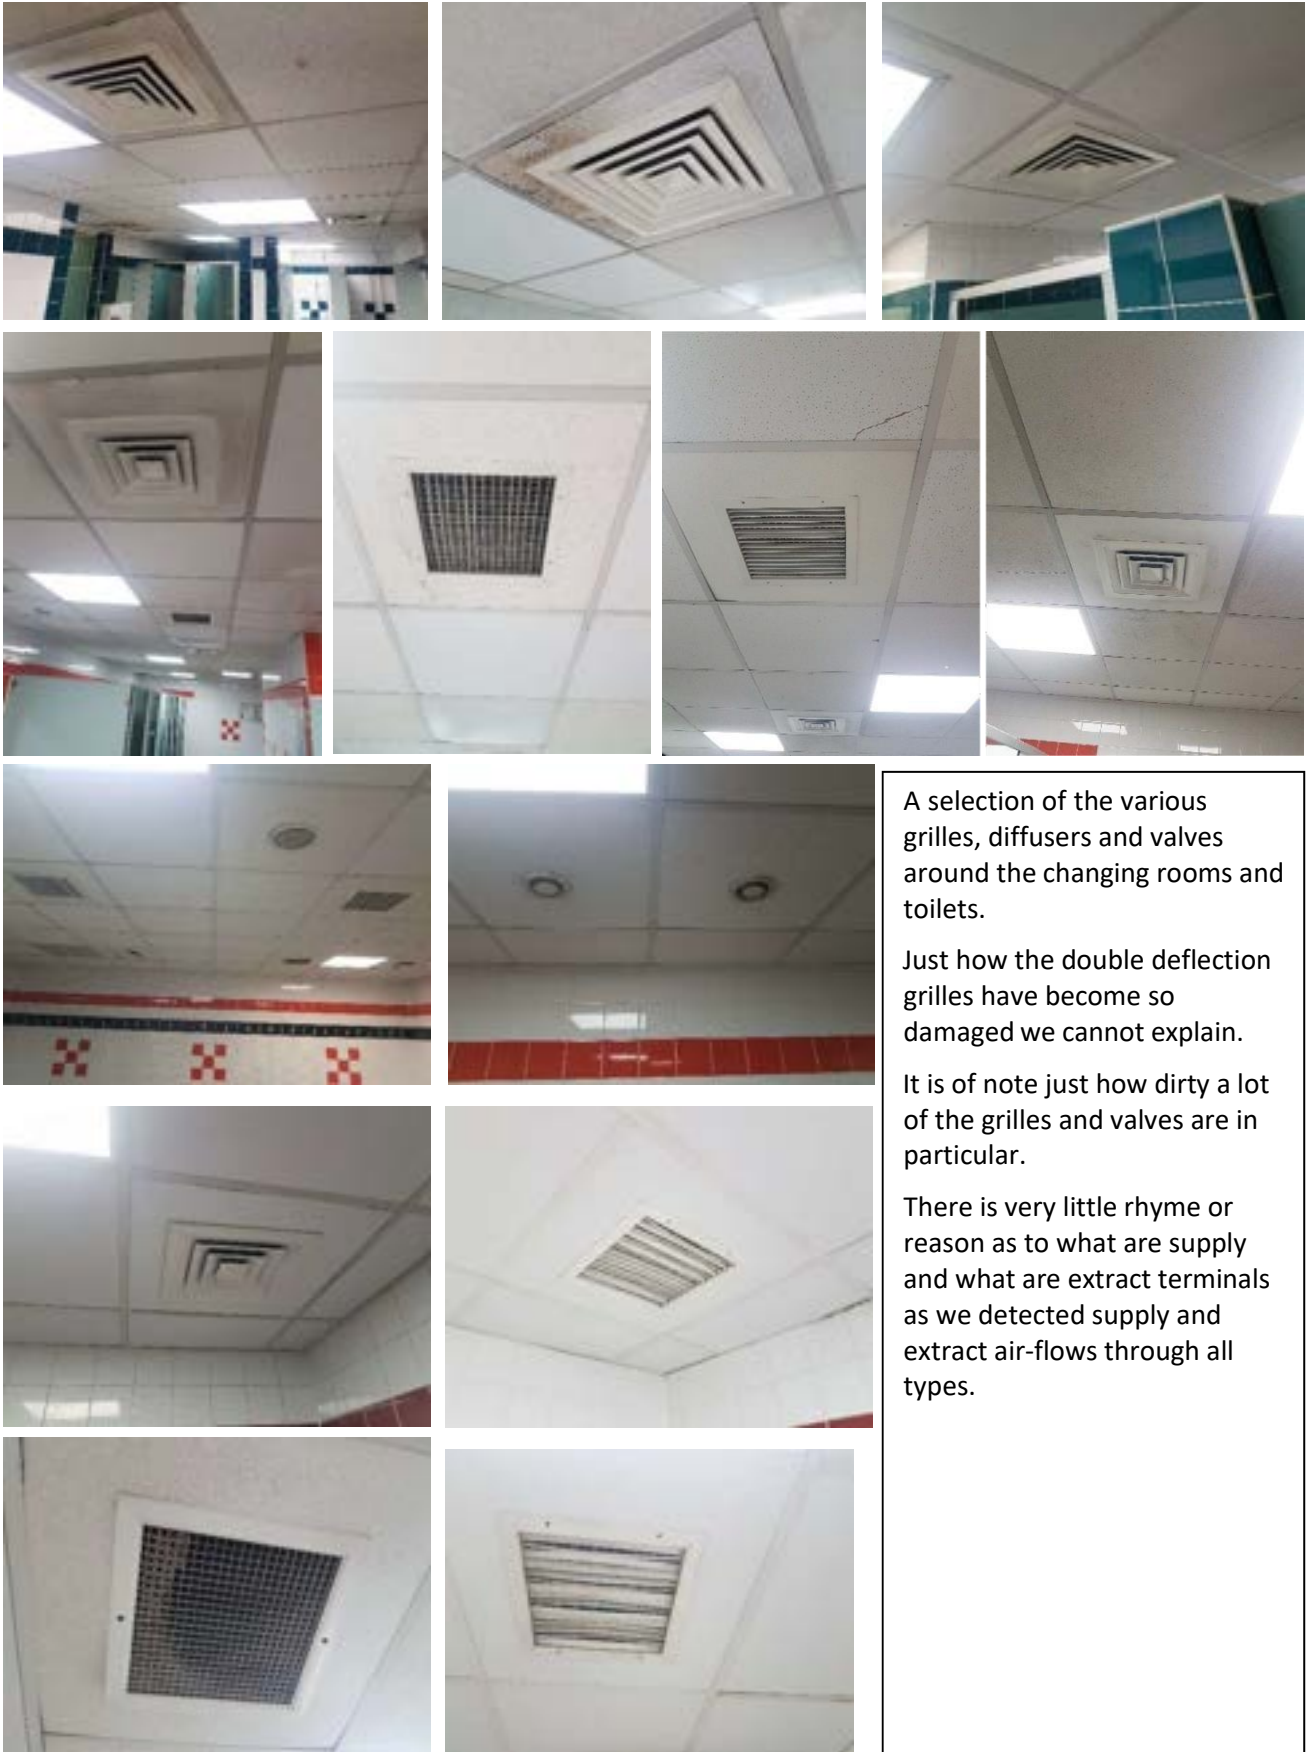
A selection of the various grilles, diffusers and valves around the changing rooms and toilets.

Just how the double deflection grilles have become so damaged we cannot explain.

It is of note just how dirty a lot of the grilles and valves are in particular.

There is very little rhyme or reason as to what are supply and what are extract terminals as we detected supply and extract air-flows through all types.

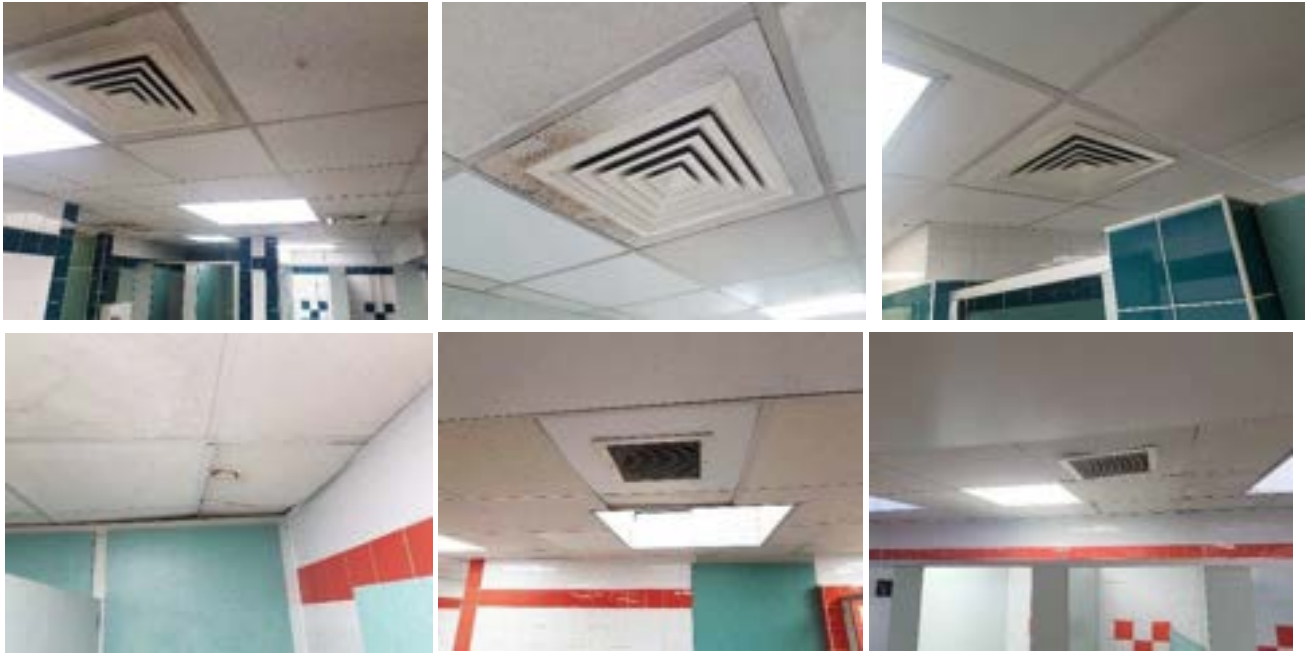
A further selection of grilles and valves around the various changing rooms and toilets.

Because of difficulty in gaining access to the ceiling voids whilst the building was open to the public we cannot say which are supply air and which are extract although a reasonable assumption would be the extract devices are considerably dirtier than the supply ones mainly because of the lack of supply air flow due to blocked filters.

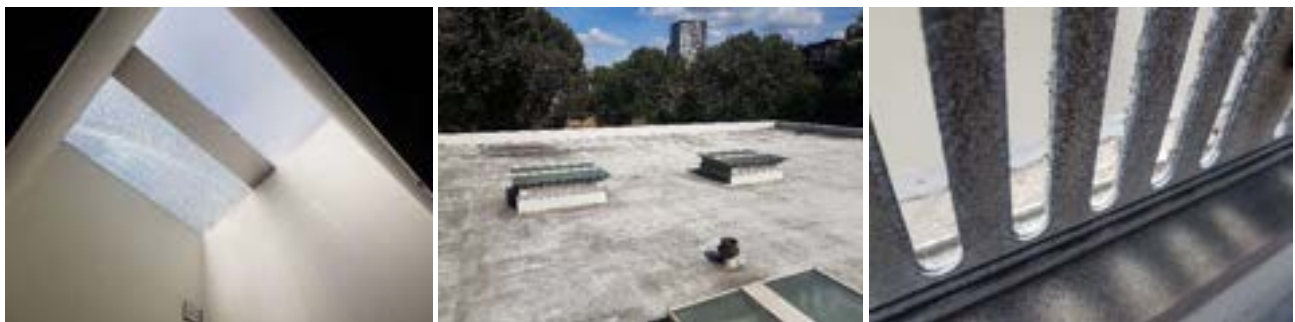
Within changing rooms where there are roof lights, these are fitted with hit & miss type sliding aluminium type closures to regulate the air flow. In all instances we observed these sliding dampers were heavily corroded in the open position and therefore wasting heat and valuable energy.
