Condition Survey & Report
for the
**Mechanical & Electrical
Services Installation**
at
St Georges Swimming Pool
221 The Highway
London, E1W 3BP

Report produced for
**London Borough of Tower
Hamlets**
Technical Services Team
2nd Floor (Annexe)
Mulberry Place
5 Clove Crescent
London, E14 2BG

Reference	21012-CSR-101a
Prepared by	S Godden
Date	November 2021

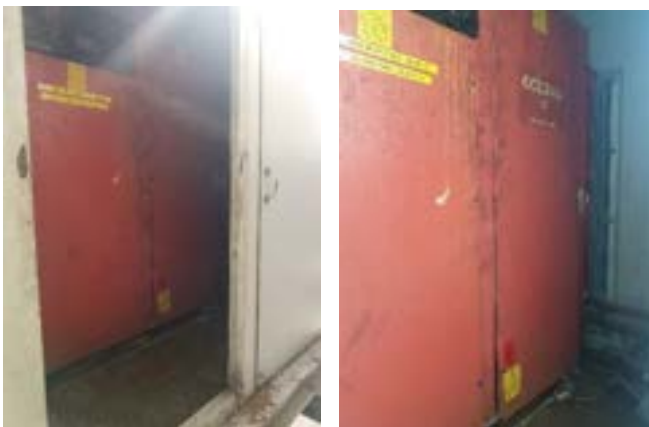
The access to the air handling unit is not satisfactory in that personnel have to climb onto and stand on one of the two steel beams whilst undoing four no. stainless steel nuts in order to lift off the GRP access panels and then carefully get off the steelwork to put the access panel in a place of safety.

A view of the heat recovery air handling unit inside the roof plantroom illustrating the extremely limited personnel space available.

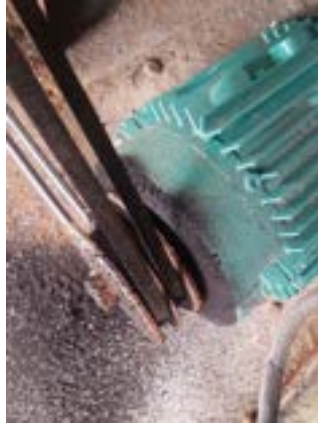
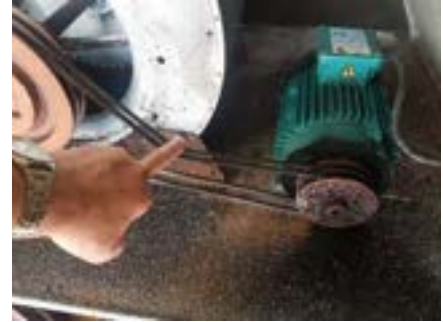
The supply air fan and motor. The fan belts are both different and neither are correct. The belts are so loose they are continually slipping leading to shredding that is leaving a heavy residue of rubber particles on the floor of the air handling unit casing and, more importantly, the motor creating a serious fire hazard.

The supply fan impellers are quite dirty.

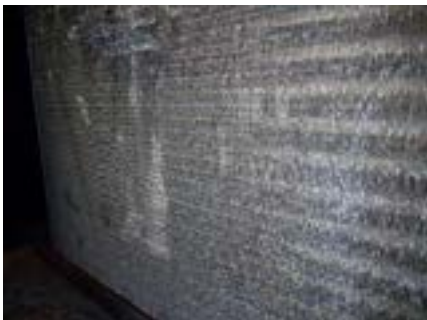
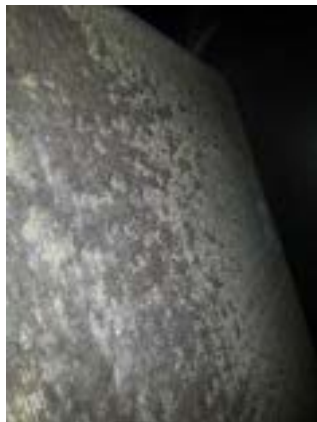
The LPHW heating coil showing heavy corrosion and damage to the front face and the nearly completely blocked intake face.

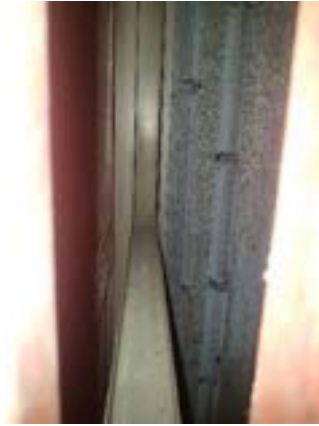
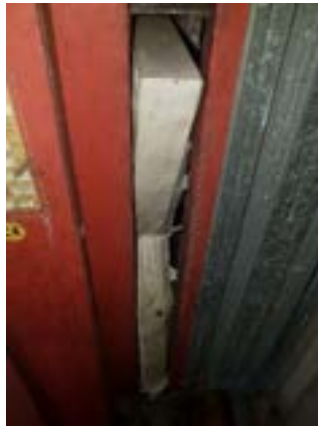
The upper filter chamber with no filter installed.

The lower filter chamber showing the heavily soiled and damaged filter which was unremovable.

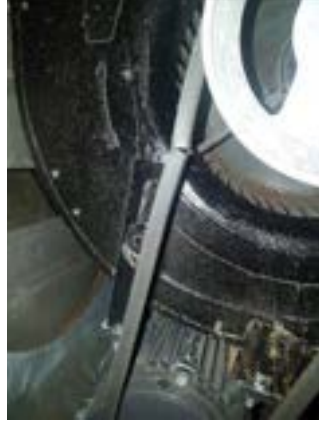
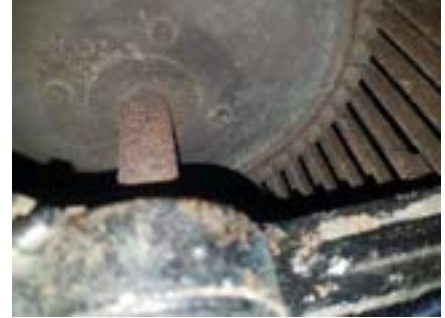
The extract/exhaust fan and motor and the fan belt. The fan belt is very tight fractured in two places indicating it is the incorrect belt and will soon fail. The extract fan impellers are very dirty and corroded.

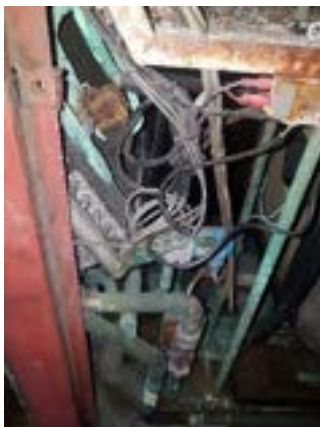
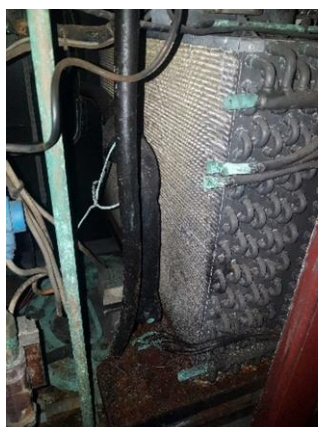
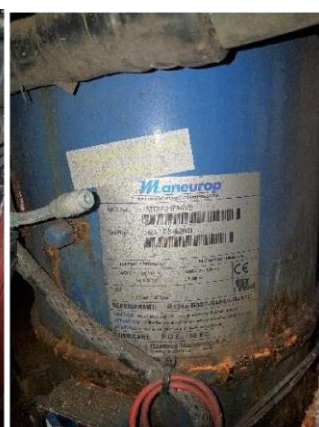
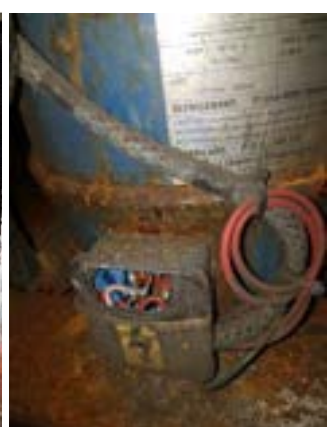
The refrigeration/dehumidification section of the heat recovery air handling unit illustrating the high level of corrosion and exposed wiring.

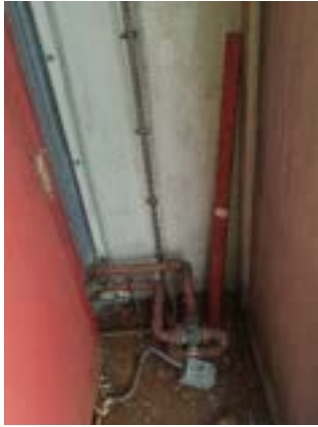
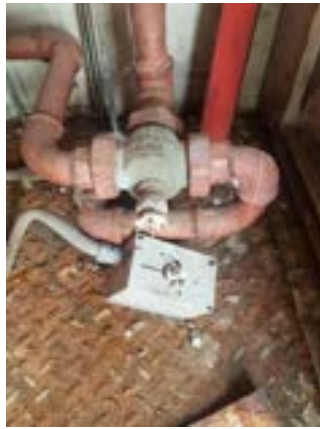
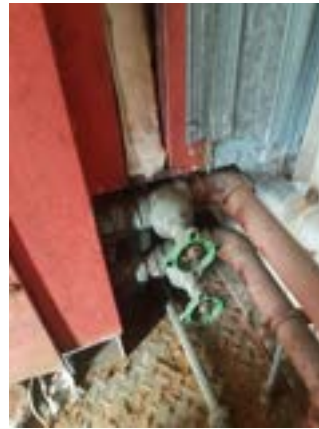
The LPHW heating circuit where this enters the roof plantroom and connects to the heating coil in heat recovery air handling unit. None of the pipework is insulated and the three port diverting valve is seized in the full flow position with the heat being manually controlled by operating the isolating gate valves.

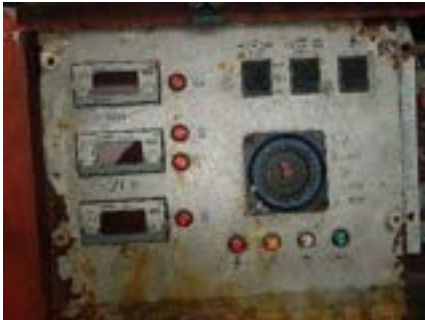
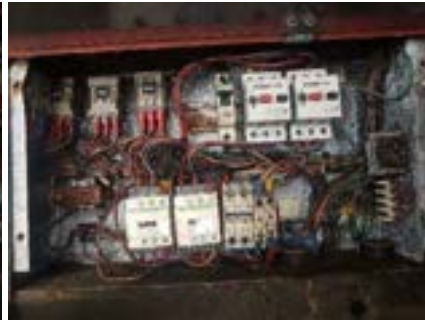
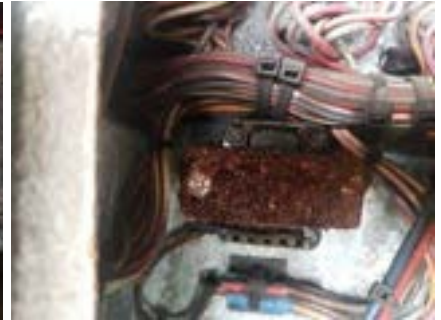
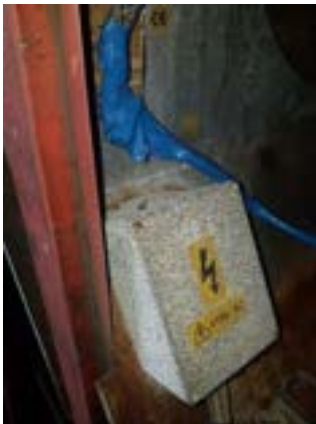
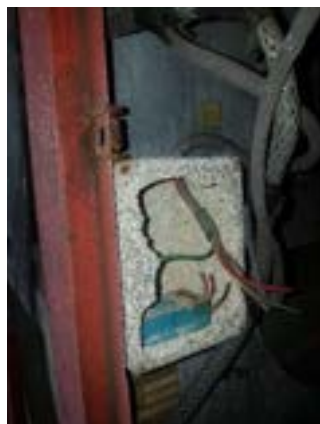
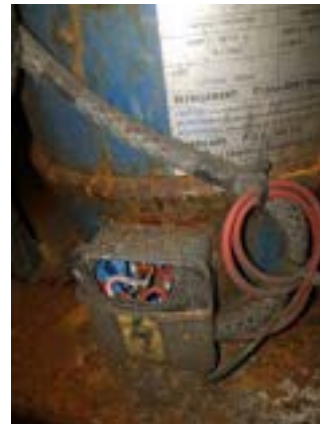
The control panel and electrics within the unit are in a disgraceful state with unidentified and bare, open ended pipework all over the place. This is a serious health and safety danger and need urgent remedial attention.

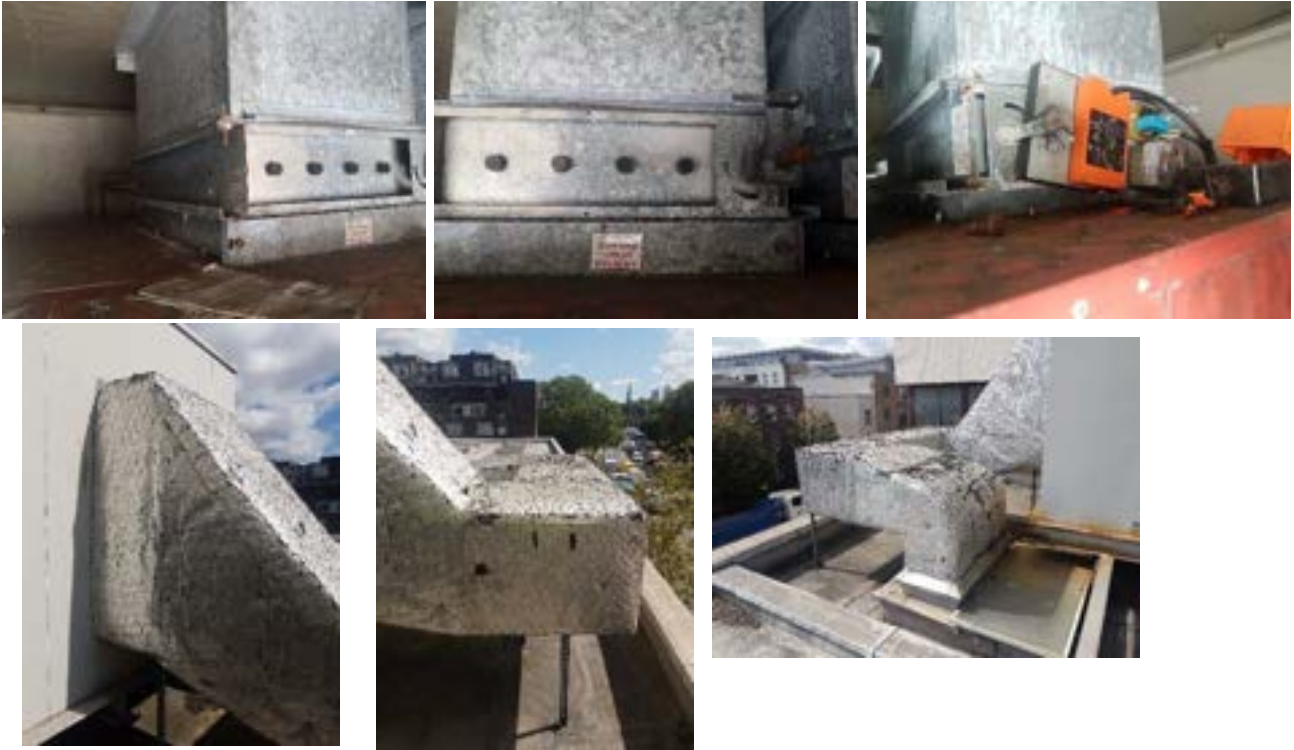
The supply and extract ductwork to the teaching pool on the first floor flat roof. There is a single entry point and a single exit point on both these ductwork systems.

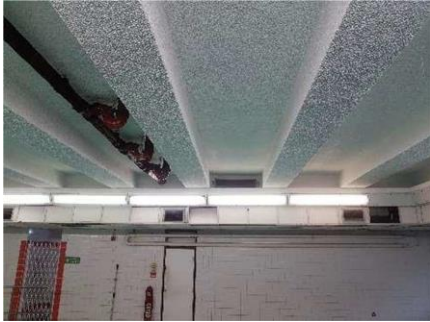
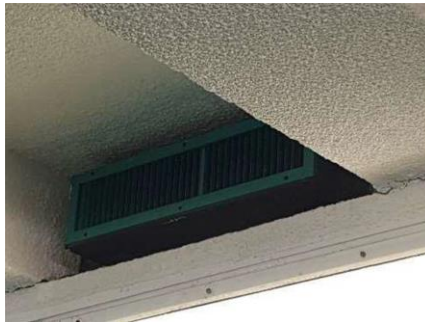
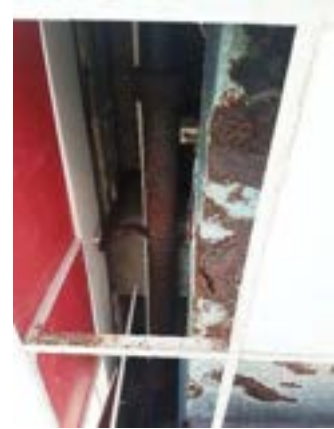
The single supply air grille to the teaching pool in the space between the concrete beams. The grilles in the bulkhead below the concrete beams appear to be the original supply air installation and the ductwork they are connected to is corroded through and falling apart. The supply air double deflection grille is typical of the extract air grilles as well.

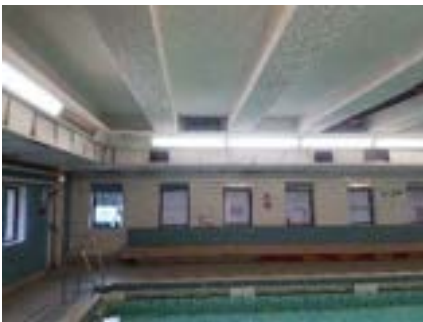
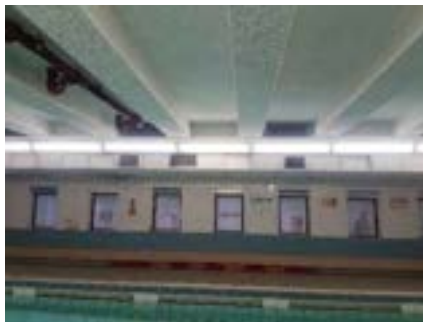
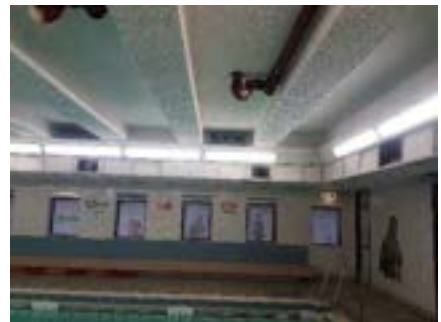
The return air grilles are located on the south side of the teaching pool hall and located between the concrete beams. There are four return air grilles and we cannot explain why there is a higher provision for return air over supply. The bulk head contains what appears to be the return air duct from the previous installation.

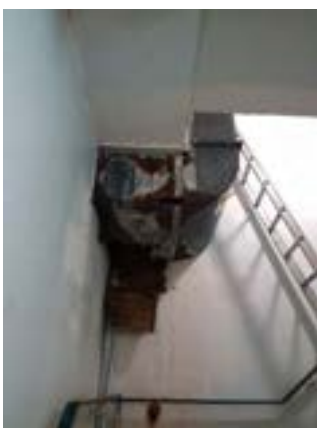
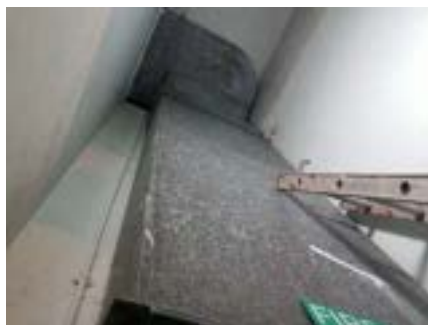
At the foot of the stairs that rise from the teaching pool hall to the main pool hall is what is believed to be the original return duct from the teaching pool hall rising to join with the main pool hall return air duct and make their way to the vertical services riser where they drop back to the basement plantroom. The condition of this duct is the same as observed in the bulkheads on either side of the teaching pool.

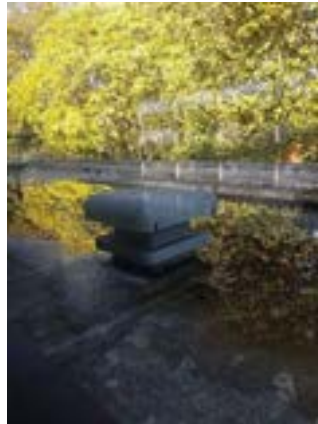
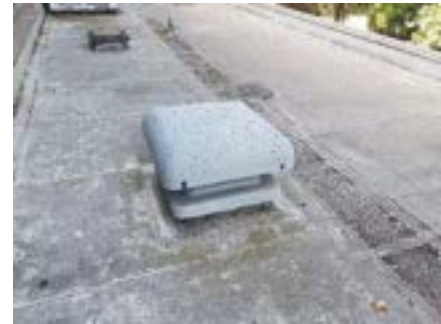
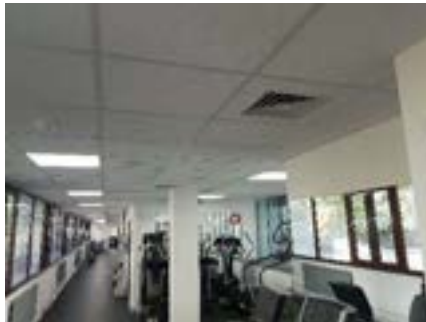
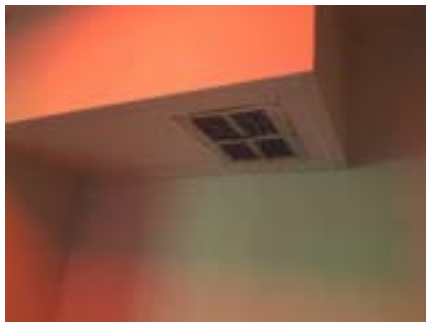
There are six ceiling mounted extract grilles in the first floor fitness suite. These grilles appear to be powered by a curb mounted extract fan located on the first floor flat roof.

The fan has a manual controller located at high level on the wall near the entrance to the fitness suite. The extract fan is non-operational and the extract grilles are very dirty.

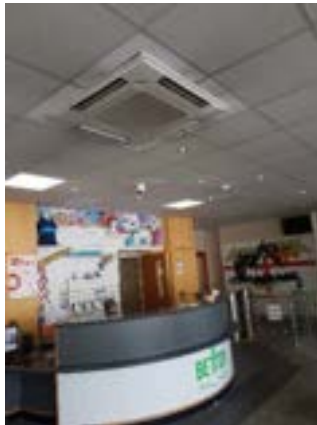
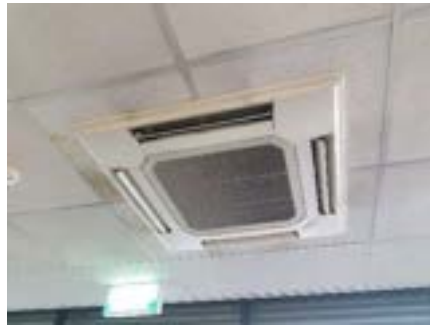
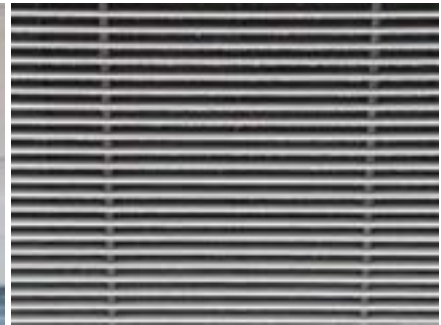
The two internal cassette units both displaying dirty grilles. The level of surface dust suggests dirty interiors and coils, one of the known biggest single cause of high head pressures and failure of external unit compressors and controls.

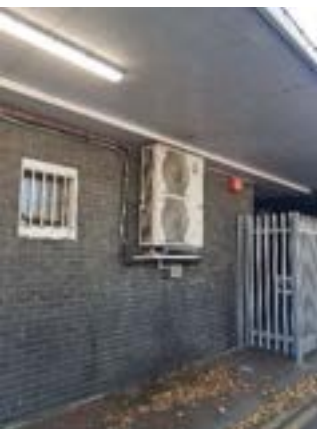
The external heat pump installed beneath the first floor overhang on the north face of the building overlooking the car park. The unit is extremely dirty and this is an indication that the coil will be partially blocked, one of the known biggest single cause of high head pressures and failure of external unit compressors and controls.

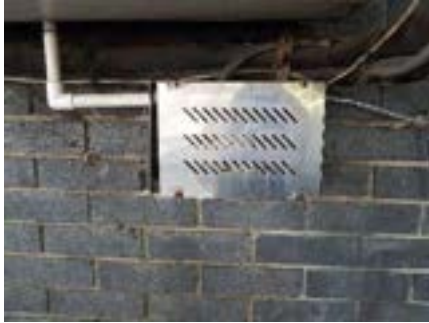
The external heat pump is fitted with a pump to remove the condensate created during the heating cycle.

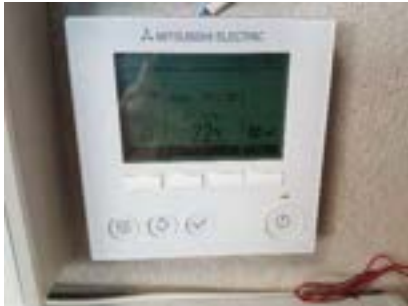
The remote controller for the two internal cassette units located in the light switch cupboard behind the reception desk and is fully operational.

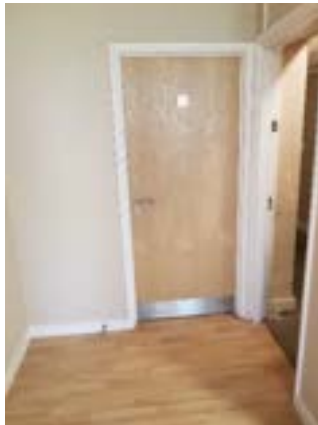
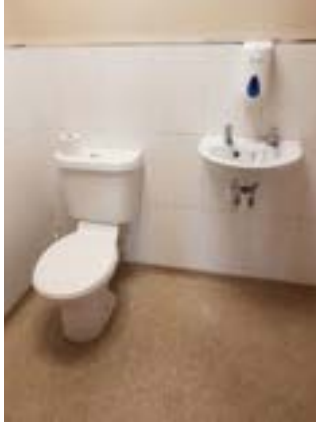
There is a large lobby area on entering the dance studio area that gives access to a male toilet. The toilet is relatively modern and in good condition.

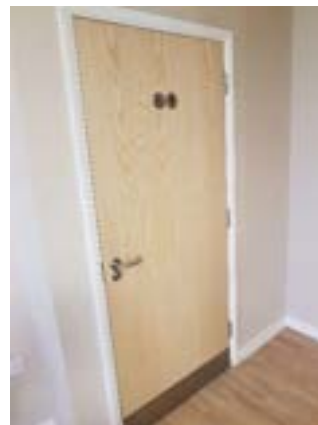
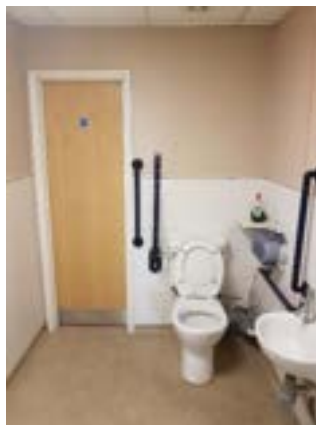
There is a large lobby area on entering the dance studio area that gives access to a female and disabled toilet. The toilet is relatively modern and in good condition.

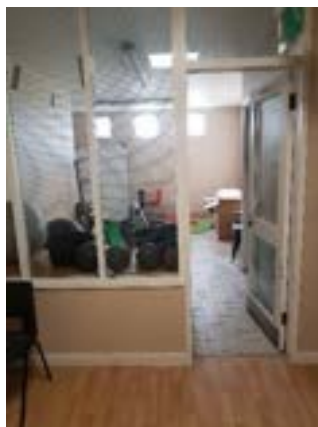
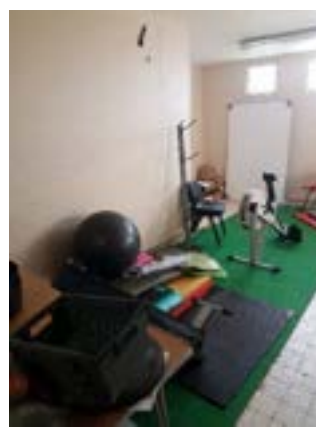
There is a large lobby area on entering the dance studio area that gives access to a room on the south face of the building used as an equipment storage area

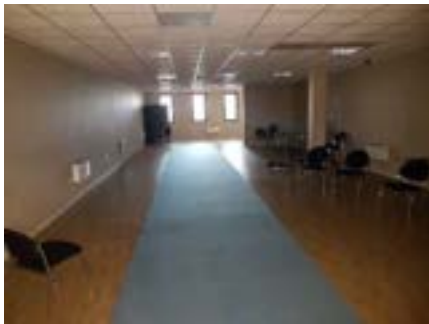
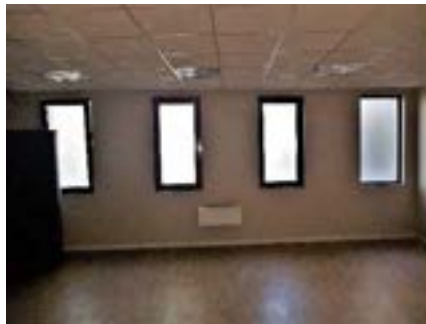
Looking straight ahead to the west wall in the lobby area there are a pair of doors that eventually give access to an external courtyard and next to them an open plan area again used for equipment storage.

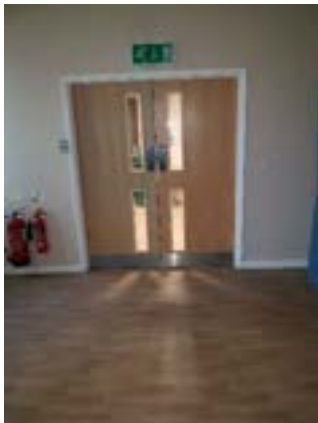
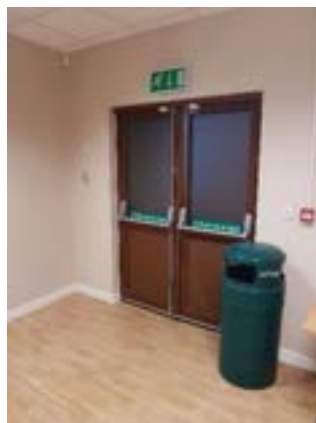
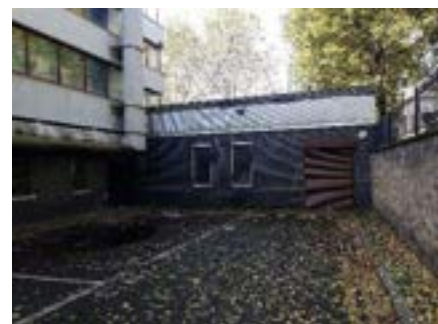
Through the double doors to the north of the lobby area gives access to the main dance studio area. Heating is provided by 8 No electric convector heaters and ventilation from 4 No openable windows on the north face of the building

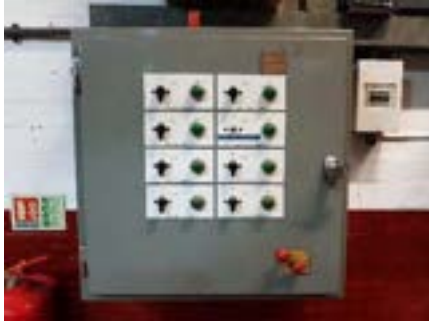
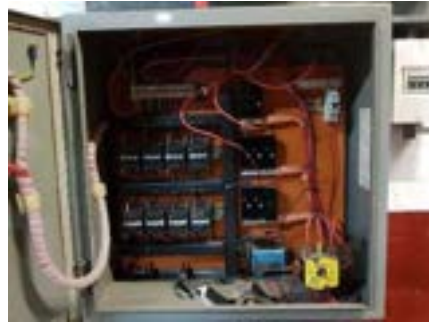
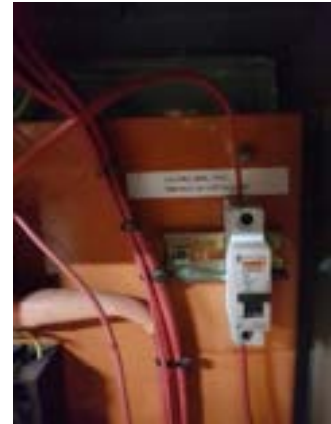
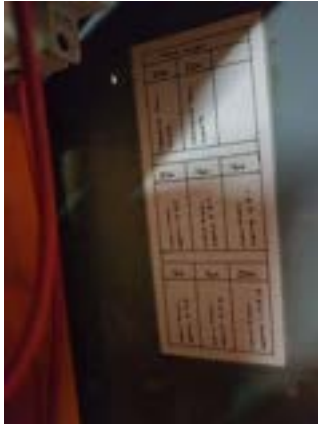
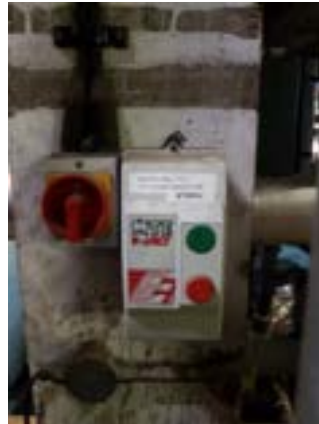
See the Appendix report from ControlCare Ltd for further details.

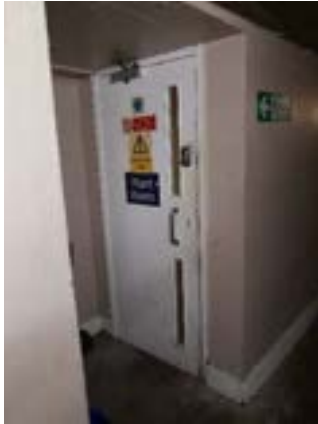
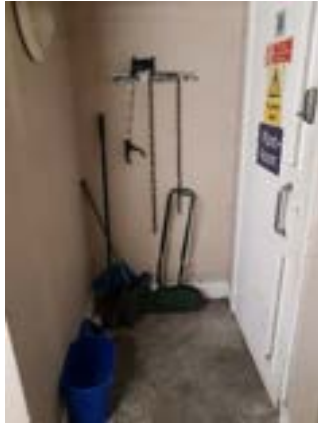
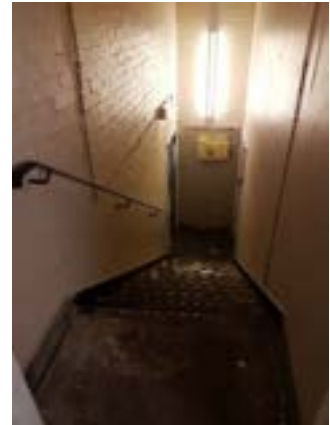
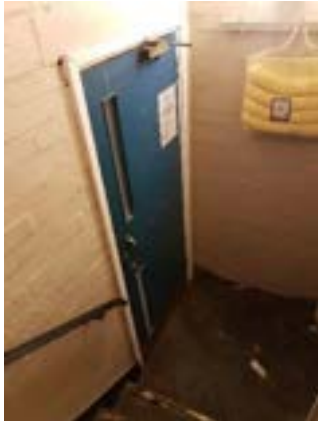
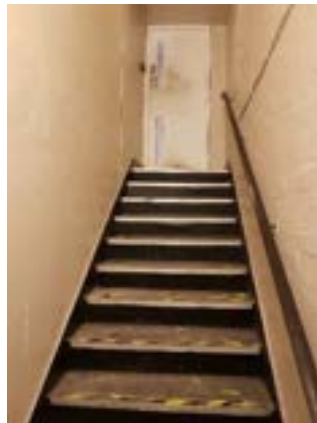
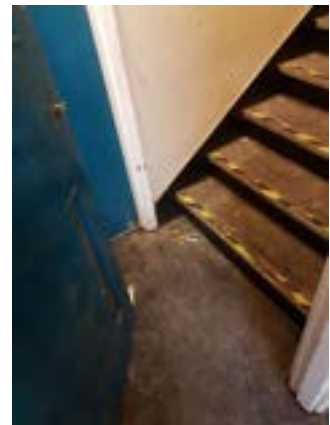
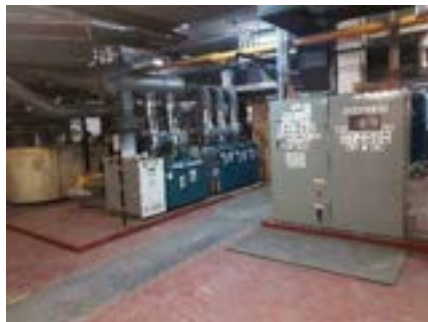
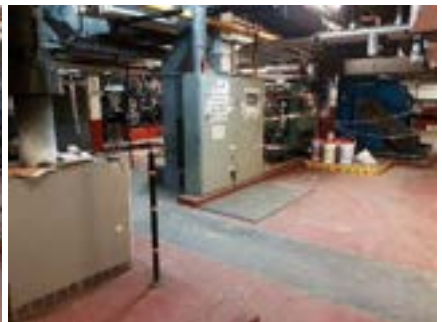
1	Building	Basement Plantroom and Ground Floor	Condition
2	Description	General Access	
3			
4			
5			
6			
7			
8			
9			
10			
11			
12			
13			
14			
15			
16			
17			
18			
19			
20	Operational Condition		B
21	Lifecycle Assessment A		C
22	Lifecycle Assessment B		F
23	Notes		
<p>All access to the basement plantroom is suitable only for personnel and small parts/equipment</p> <p>No access is available for large parts and equipment</p> <p>There is a lifting beam that carries no certification and is corroding</p> <p>Basement plantroom has never been rationalised after previous refurbishment works</p>

The main access to the basement plantroom from the ground floor staff corridor illustrating the cluttered access and stairs. Whilst these comply with building regulations regarding size they are not suitable for the import of large items of plant and equipment. On entry to the basement plantroom there is a lot of space to manoeuvre around.

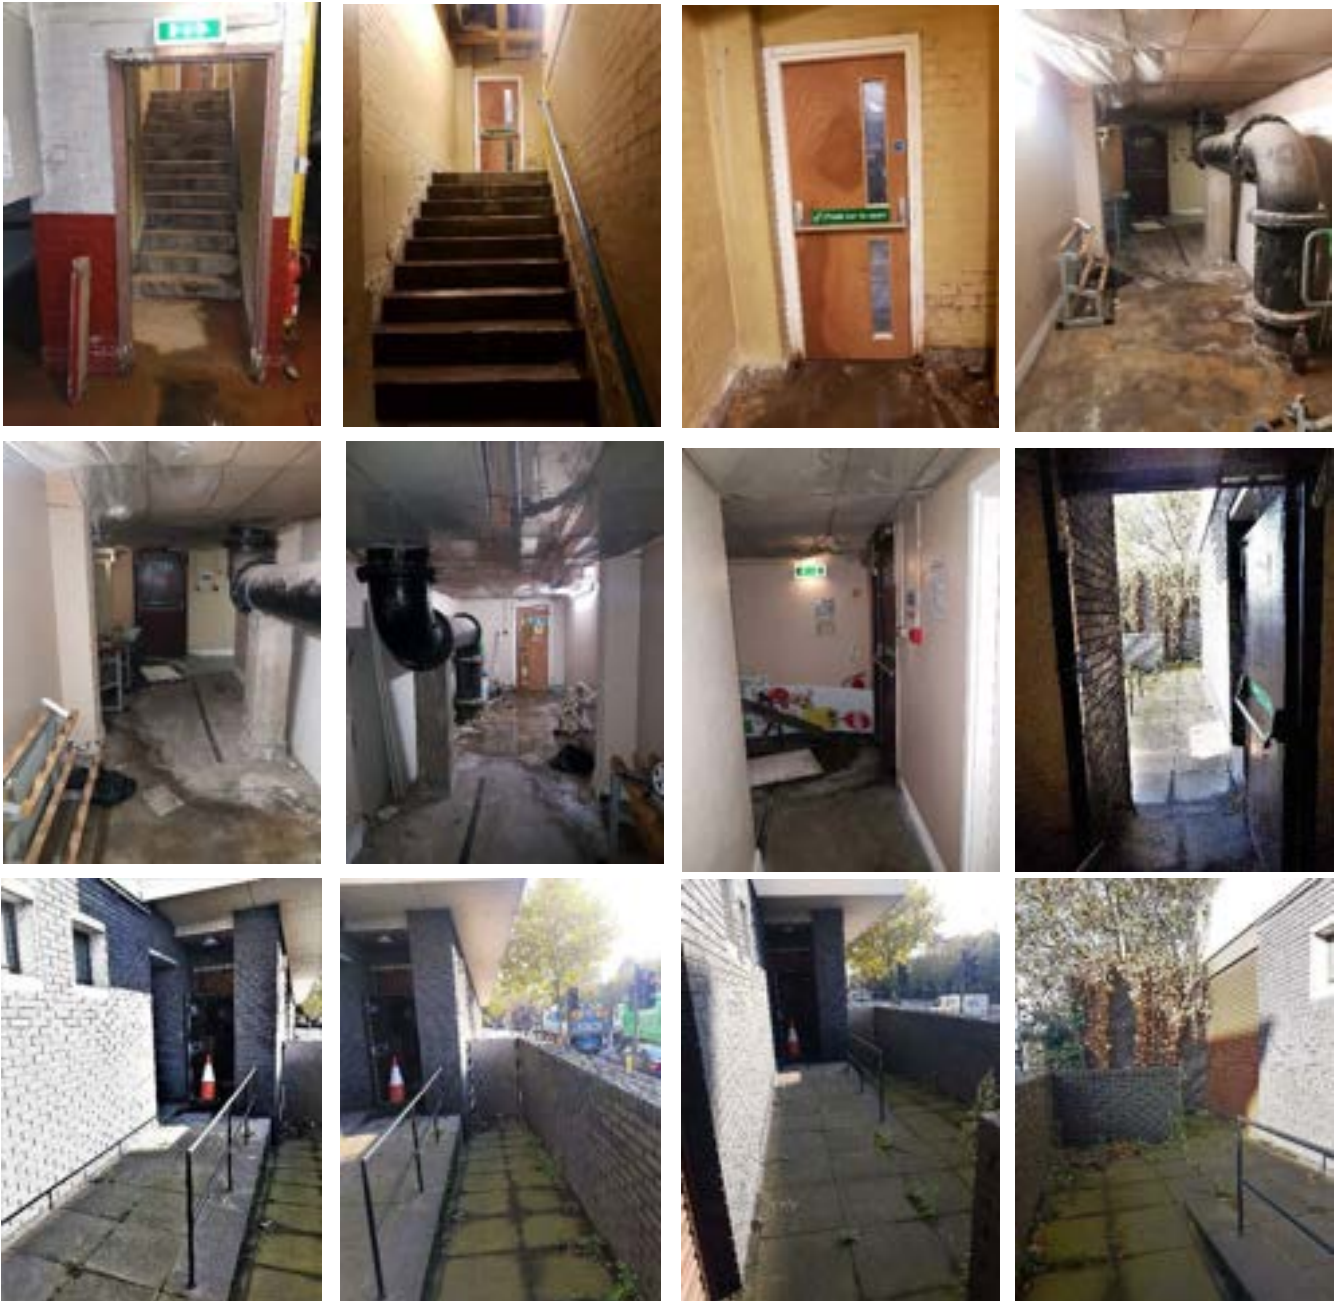
There is a fire escape stair in the southwest corner of the basement plantroom with stairs up to ground floor level and the staff corridor. The fire escape door opens into an enclosed courtyard with two pedestrian access points onto the highway.

The courtyard is basically only personnel wide and consists of ramps and steps and is considered unsuitable for manoeuvring anything other than the smallest plant or equipment.

Note the roller shutter door at the end of the building.

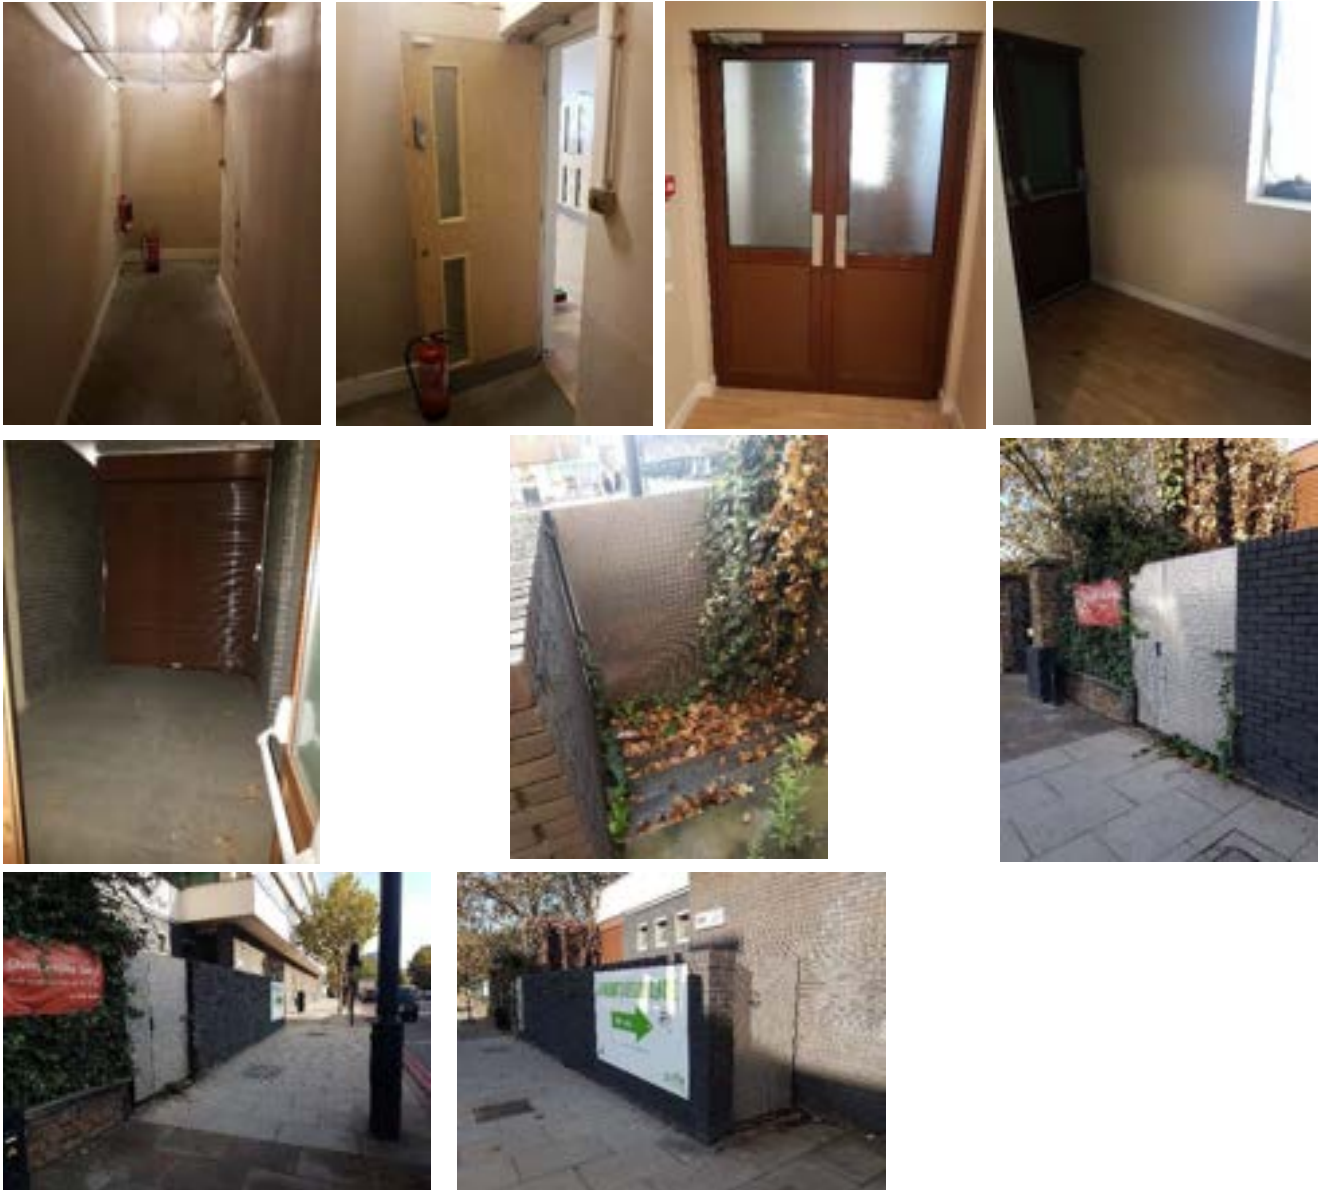
Off the ground floor staff corridor to the west of the building there is an entrance corridor and door that opens into what is described on the drawings as the laundry. This area now consists of a large and small hall and a storage area along with a male/female and disabled toilet.

The corridor continues through a double door into a left handed corridor and two fire escape doors that themselves open into what can be best described as an industrial type reception area more than likely planned for handling goods in and out of the original laundry. The area has a roller shutter door that opens onto the previously described courtyard with access onto The Highway.

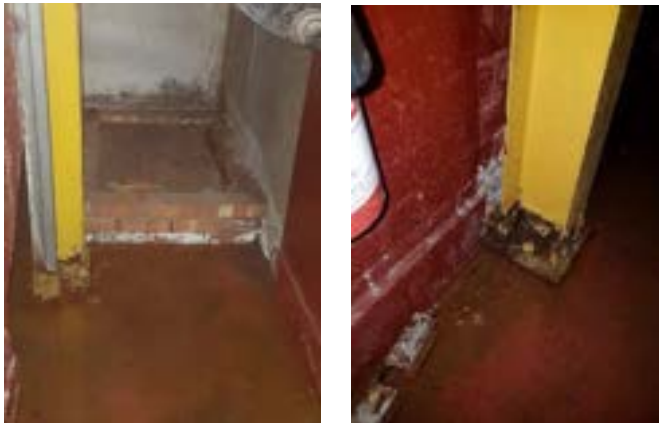
There are two supporting columns to the lifting beam located in the southwest corner of the basement plantroom.

These two columns have been exposed to the previously noted flooding of this part of the plantroom and fairly heavy corrosion is in evidence.

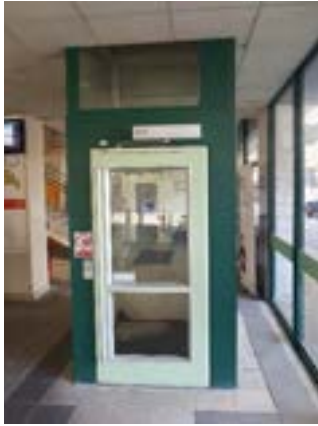
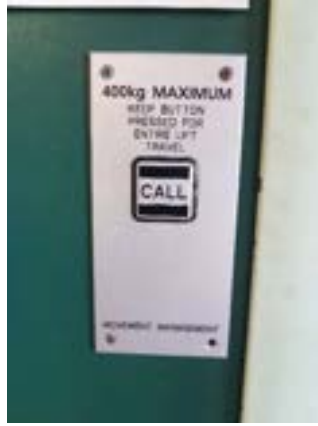
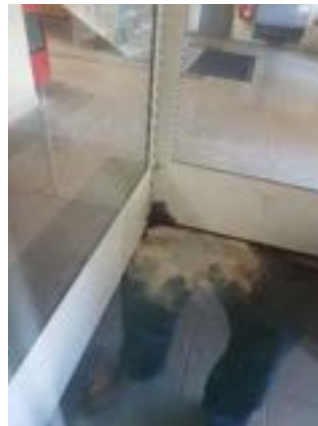
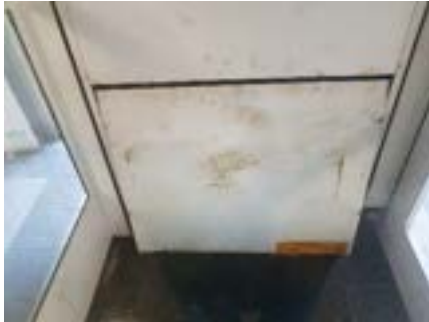
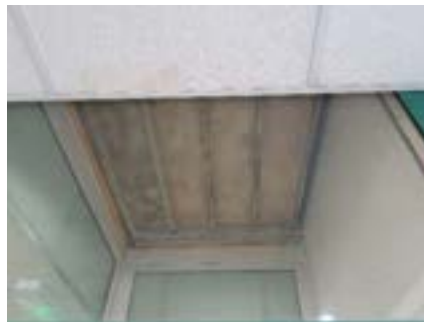
1	Building	Ground and First Floor	Condition
2	Description	Access Platform Lift	
3	Manufacturer	Movement Management	
4	Type	Internal traction cable platform lift	
5	Power – volt x phase x hz	240/1/50	
6	Power - kW	Not known	
7	Power – Fuse Amp	Not known	
8	Model	Not known	
9	Capacity - kG	400	
10			
11			
12			
13			
14			
15			
16			
17			
18			
19			
20	Operational Condition		D
21	Lifecycle Assessment A		D
22	Lifecycle Assessment B		F
23	Notes		
Lift closed by insurance assessors Water damage to traction cables Water damage to controls & wiring Corrosion of structural casing

The platform lift housing at ground floor level showing the alleged water ingress damage and resultant corrosion. By all accounts there is serious water damage to the controls mechanism hence the removed panel that hasn't been replaced but we were unable to confirm this as we were prevented from entering the lift by the General Manager because "the insurance assessors have said it is not safe", not a particularly helpful stance for an engineer engaged to prepare a condition report.

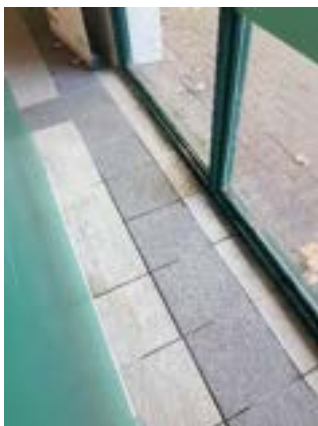
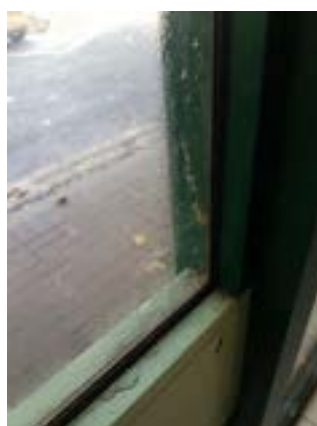
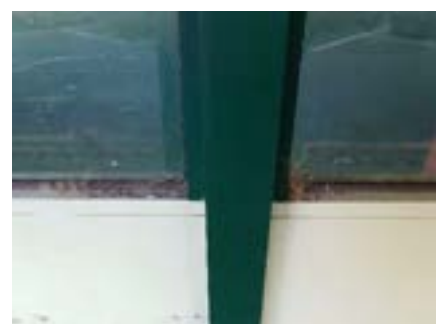
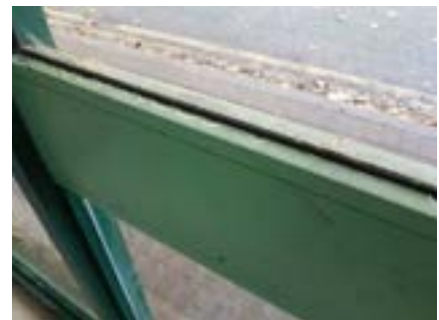
It is alleged that the water damage is the result of excessive condensation build-up on the single glazing that forms the north wall of the reception area. We observed a wet patch on the floor and heavy moisture on the internal window bars whilst the exterior of the window bars were observed as being dry.

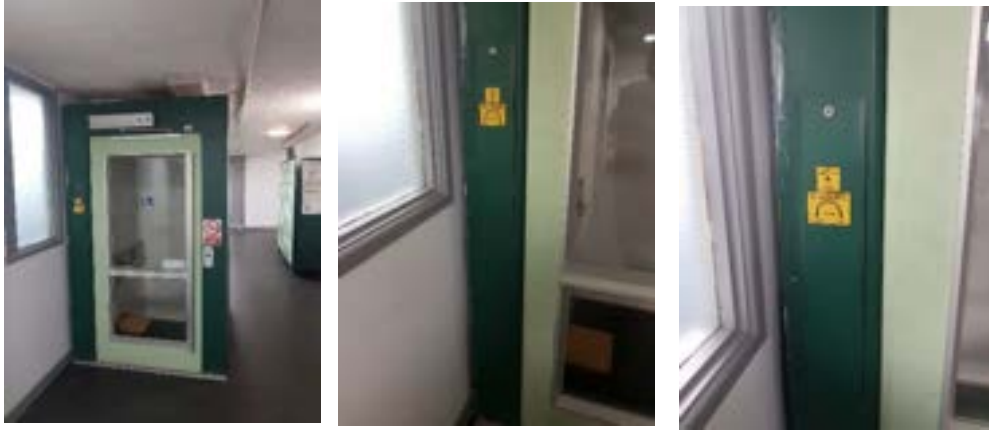
The platform lift is currently parked at first floor level.

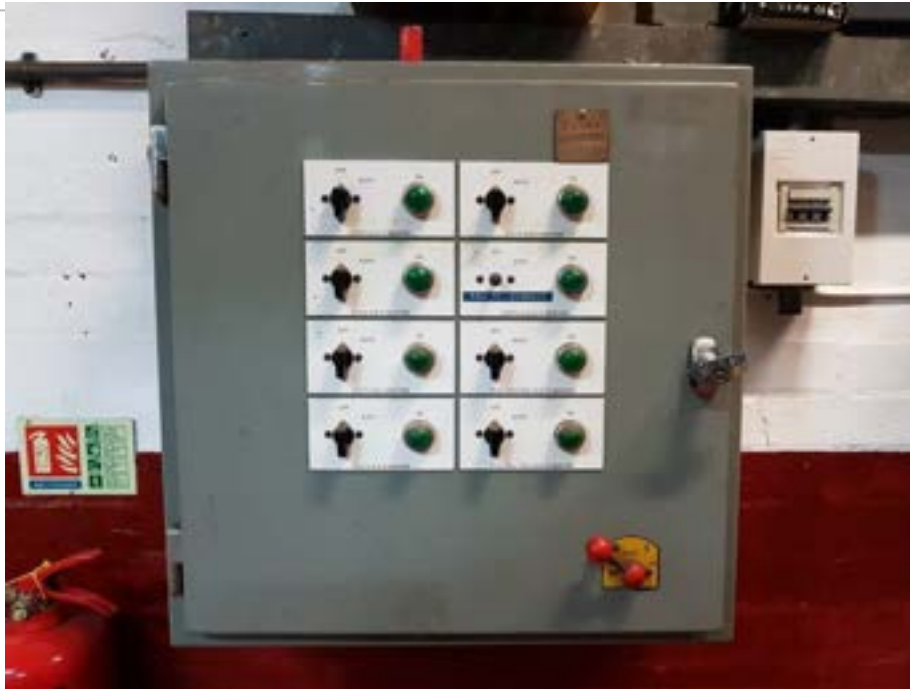
Pool Seating Panel (Above) - located in basement plant room

Legacy panel to control the heating of seats around the main pool area.
Now only powers small pool run around heating pump.

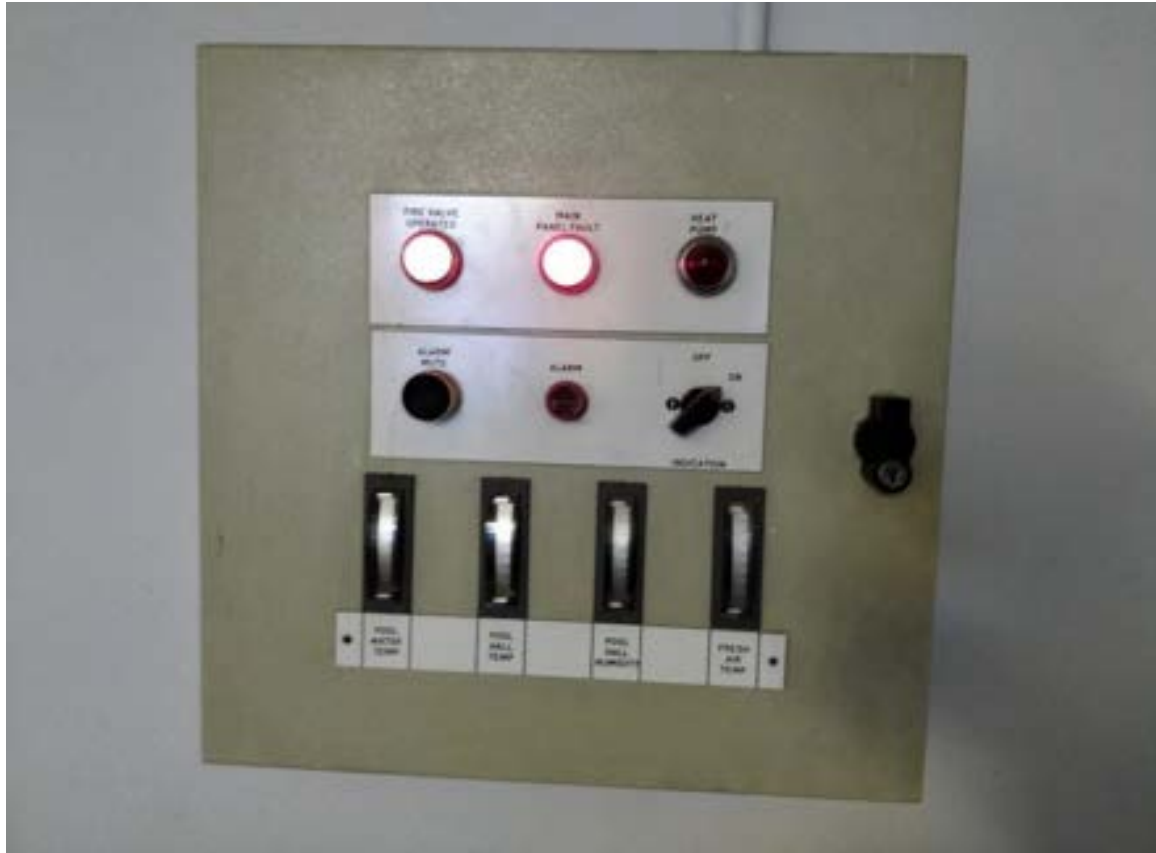
Monitoring Panel - located in ground floor office

Monitoring panel of main pool temperatures and main plant faults - temperatures not reading and showing plant fault and fire fault.

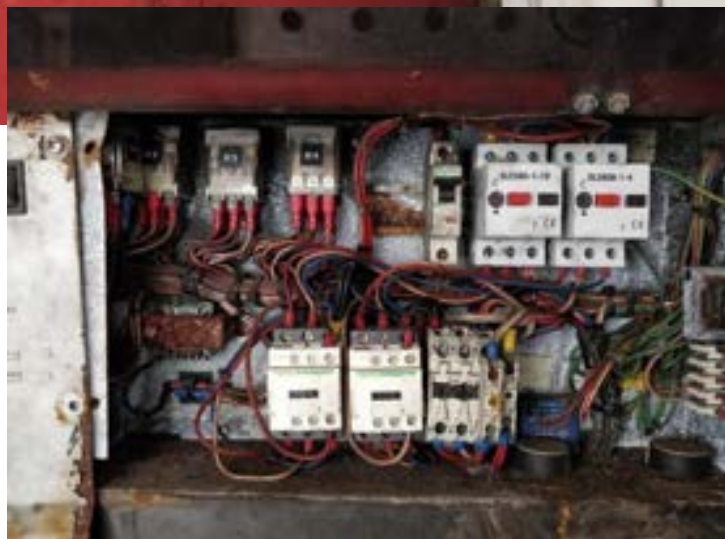
The small Pool Calorex unit located on the first floor roof has independent controls which are in terrible condition - these have been corroded also the heating actuator has been broken off allowing no control

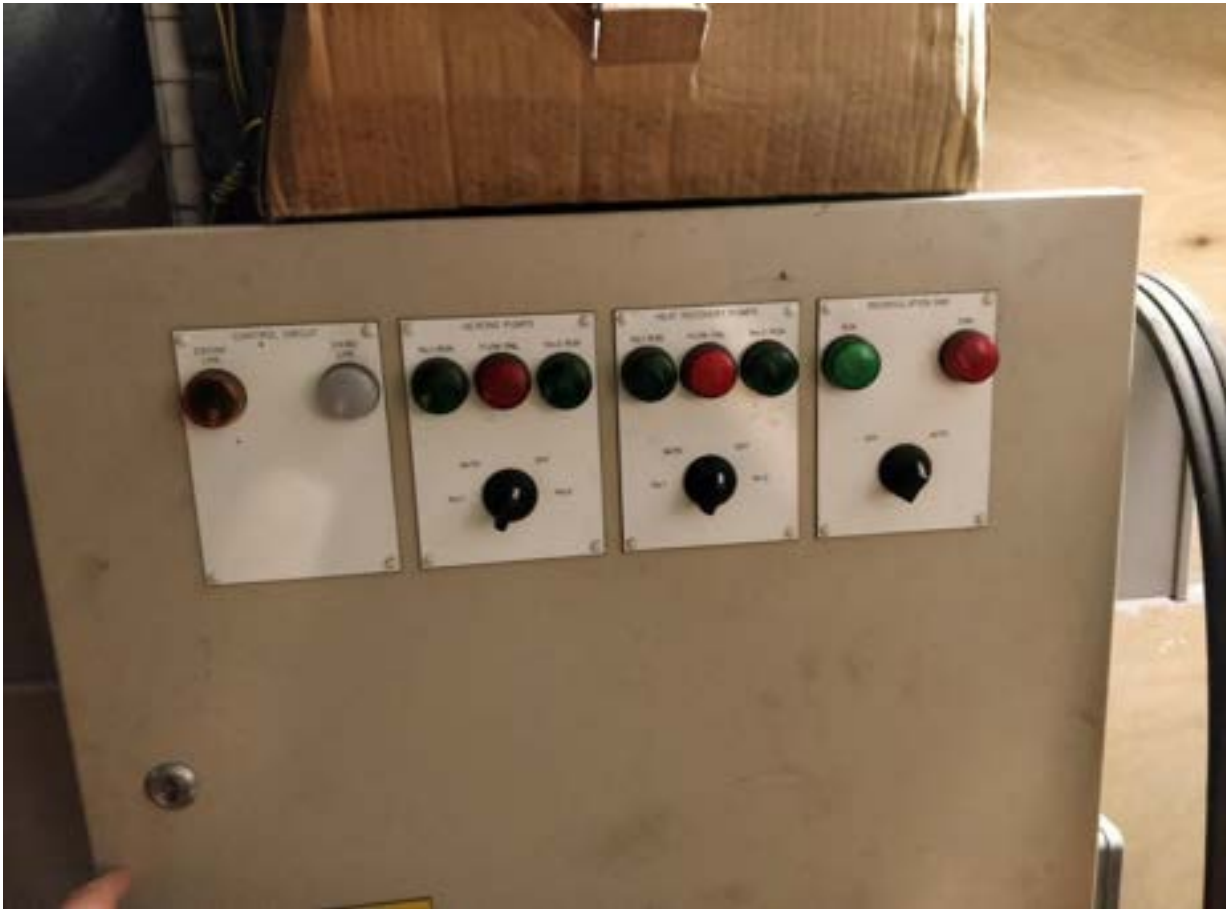
The main pool Calorex unit located on the ground floor plant room has a remote panel to control heating pumps for the supply air heating coil however the heating actuator does not work in auto so members of staff have to enter the AHU and adjust this manually. The integral controls for the supply inverter have also been bridged as they were holding the fan off in fault.

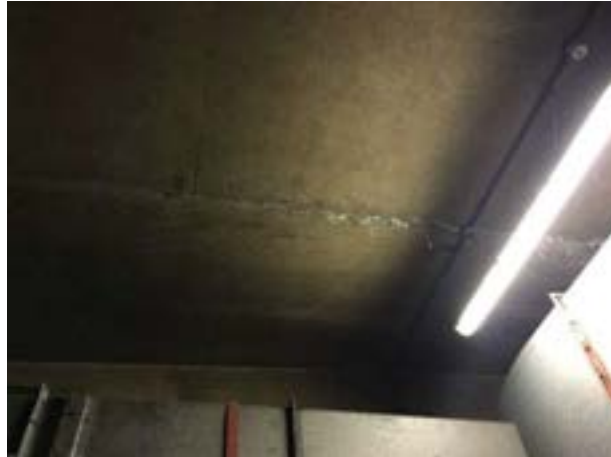
Fig 4.1.2 – The photo above was taken with the basement area.

Historic water ingress issues evident seeping through the original construction joints.

- The concrete soffit is to be fully tanked to ensure no further future water ingress issues occur with a minimum of 20 years warranty.

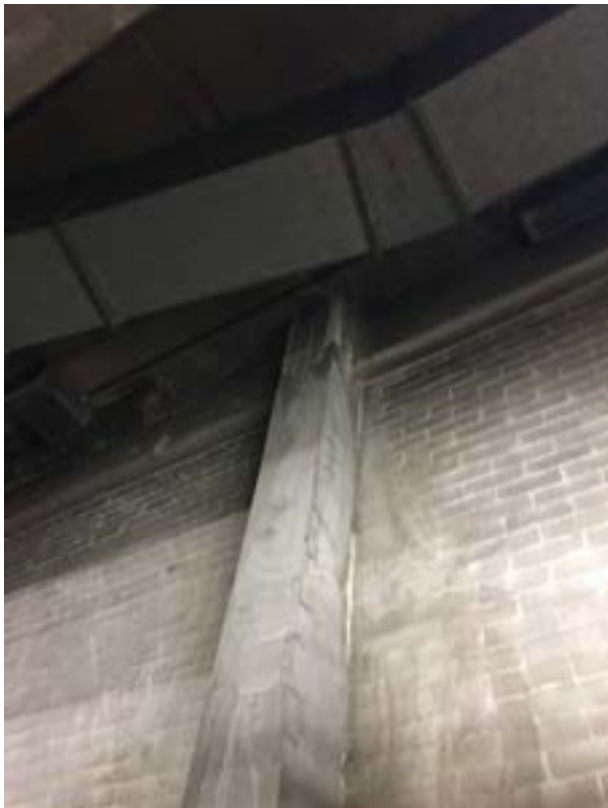
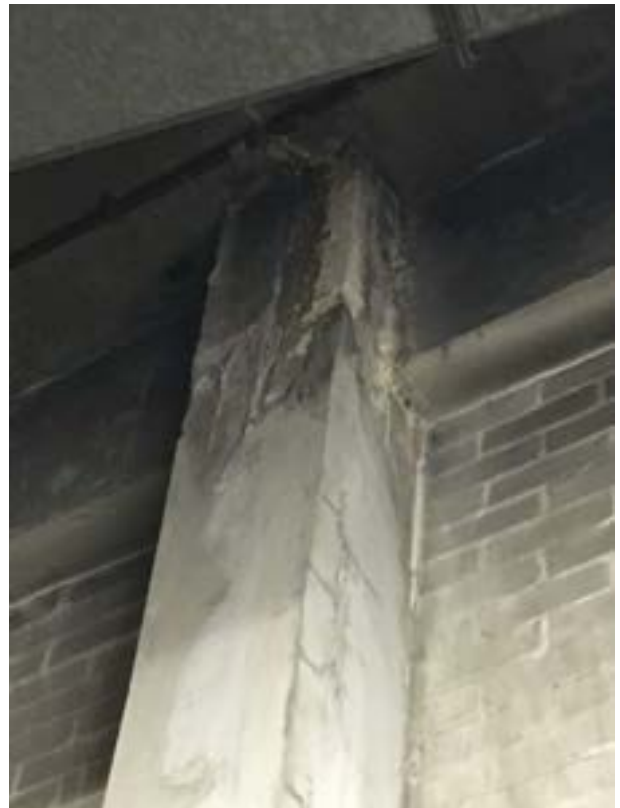
In the photo on the left (Fig 4.1.1.3) it is clear there is water ingress coming from ground floor pool hall level, the water following cracking in the previous concrete repair. This column is referenced TA1 in the Martech condition report carried out in 2007.
