Condition Survey & Report
for the
**Mechanical & Electrical
Services Installation**
at
St Georges Swimming Pool
221 The Highway
London, E1W 3BP

Report produced for
**London Borough of Tower
Hamlets**
Technical Services Team
2nd Floor (Annexe)
Mulberry Place
5 Clove Crescent
London, E14 2BG

Reference	21012-CSR-101a
Prepared by	S Godden
Date	November 2021

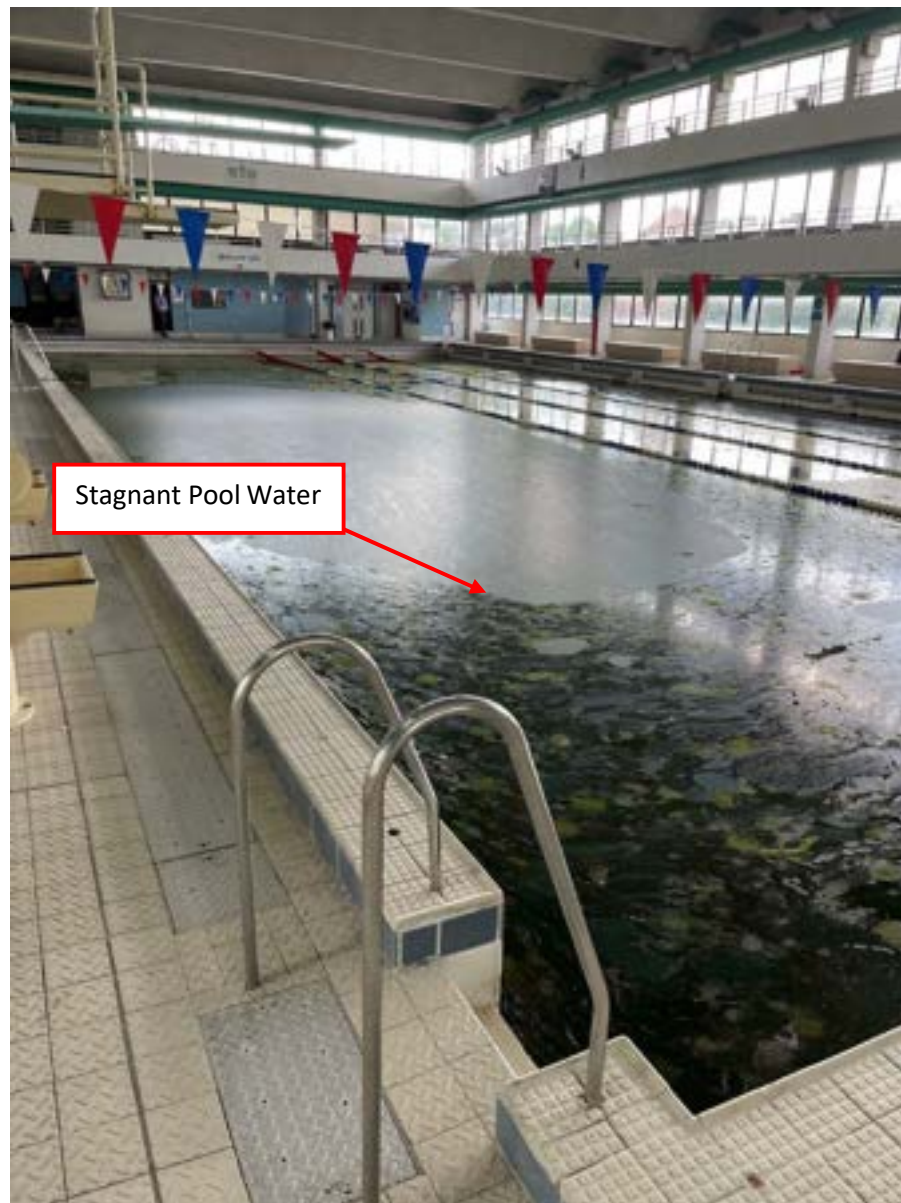
Fig 4.2.1 – The photo above was taken within the main pool area.

The pool had not been drained and the water is now highly contaminated and poses a potential health and safety risk. Mould was present at the time of the survey.

- The pool has not been drained and has been left for 18 months, the pool water and chemicals have now become a **Health and Safety** risk and is most likely causing excessive damage to the sides of the pool. Allowance will need to be made for a deep clean and removal all tiles and grout in the main pool area and around the pool including the tiled seating areas. Re-tile to the client's requirements. Prior to this the pool may require tanking to ensure no future water ingress issues within the basement.

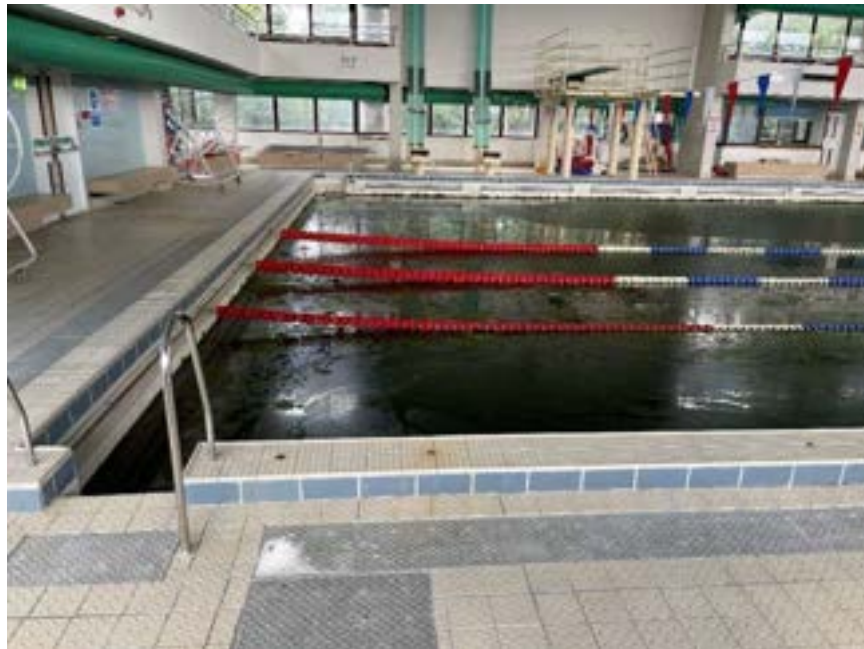
Fig 4.2.2 – The photo above was taken within the main pool area.

The pool had not been drained and the water is now highly contaminated and poses a potential health and safety risk. Mould was present at the time of the survey.

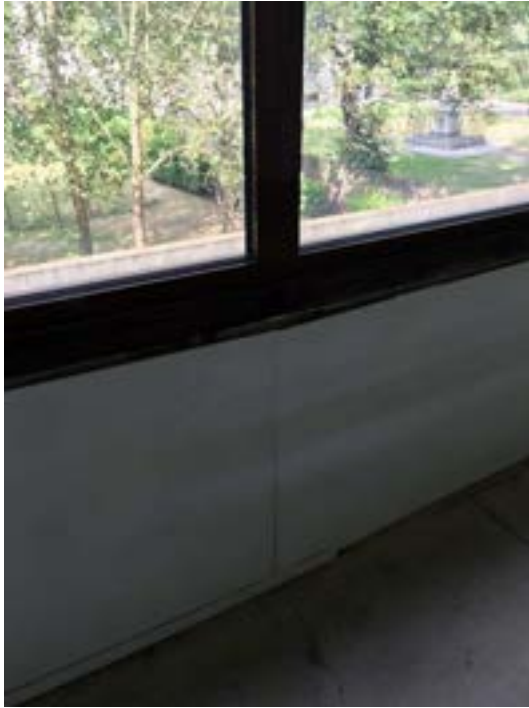
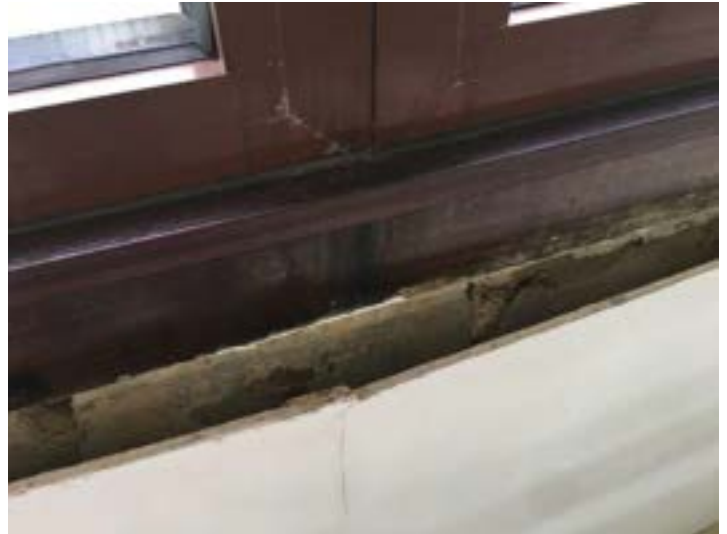
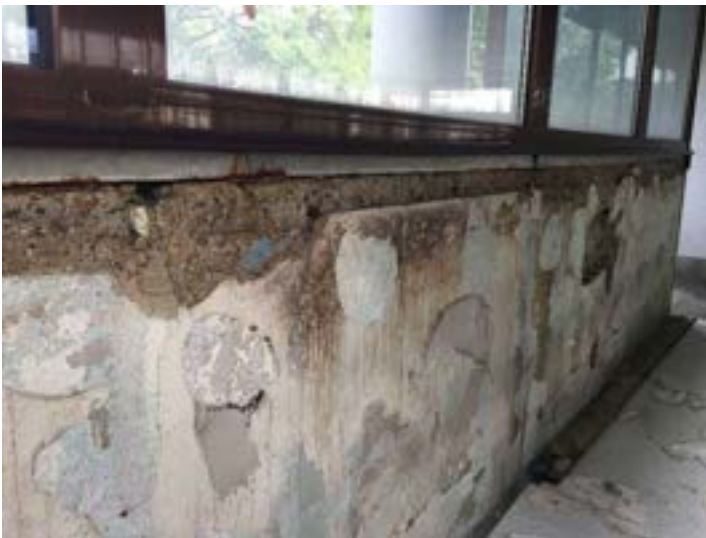
The first-floor level gallery is in fair condition with the internal faces of the walls lined with a board material and decorated in some areas. There were signs of repair works on the ceilings and evidence of wall boarding being removed as shown below:

Typical views of Main Pool Hall spandrel wall and ceiling on the 1st floor level – See CCLLP Drawing 18003-201-R for locations.

- All side walls are recommended to be stripped and replaced in fall. We would recommend that all windows are removed and replaced with new to ensure no future water ingress issues.
- Consideration needs to be given for the main pool ventilations to reduce the main pool area moisture.
- All ceiling needs to be removed and the existing concrete soffits require repair works to any exposed rebar and blown concrete. We would also recommend tanking the underside of the soffit to help seal the concrete from further damage. Further intrusive investigation may be required to ensure that no additional structural supports are required under the soffit.

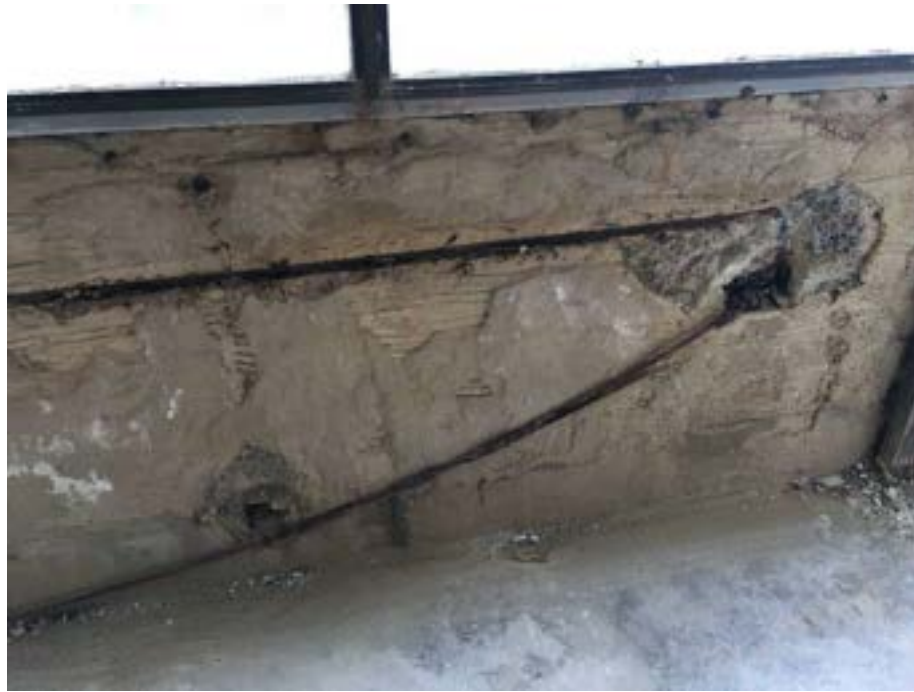
Fig 4.4.4 – The photo above was taken within the main pool area on the second-floor galleries.

Exposed and corroded electrical conduits are visible which has resulted from high moisture in the air from the main pool area. Most likely due to existing poor ventilation systems with the main pool area.

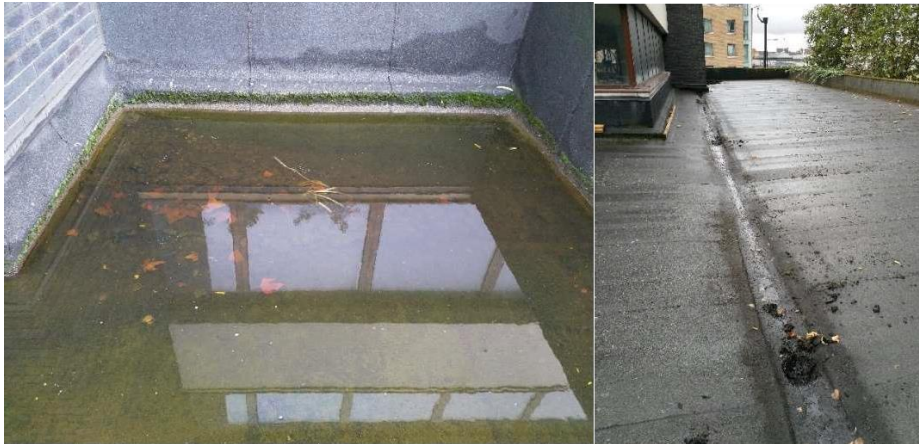
The drains on the west flat roof were blocked by leaves and pooling was evident on the existing roof.

We must advise the drains are to be unblocked and a strategy put in place to prevent future debris.
